# SAFETY RECALL

| Date | Number | Release | Page |
|---|---|---|---|
| 10.2024 | SC0448 | 05 | 1(20) |

## Mack GR, GU Turn Signal Visibility GR, GU

**REV 5: Updated reference part numbers for 2018+ model year trucks.**

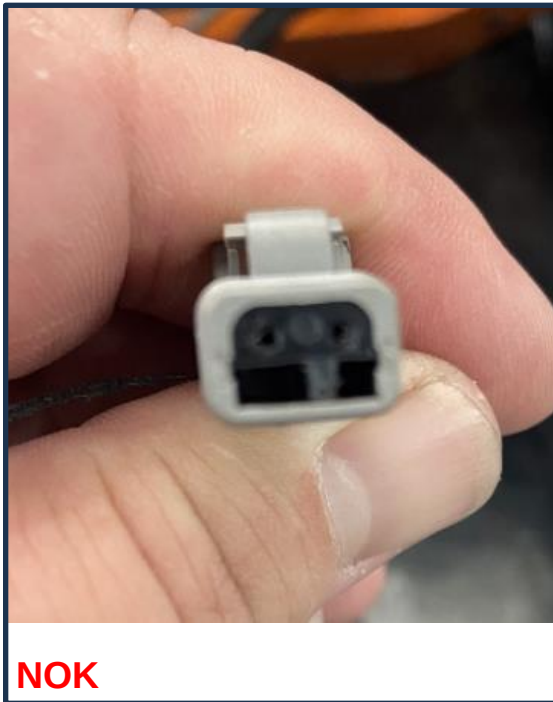
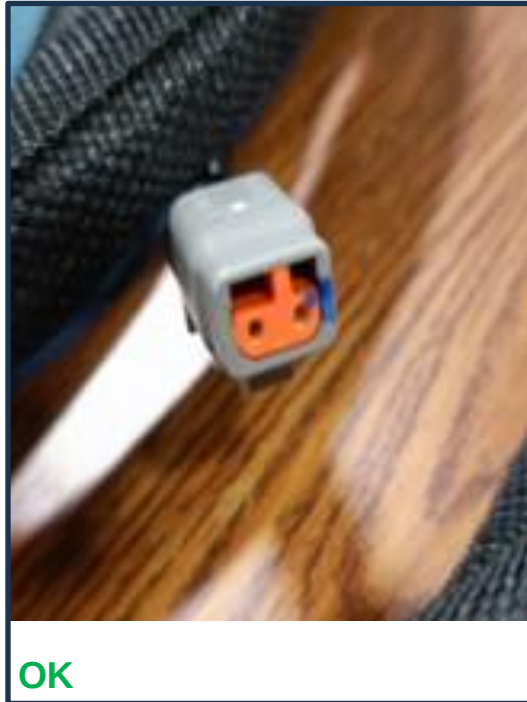
**ATTENTION: HARNESSES ORDERED BEFORE 9/29/2024 MAY HAVE BEEN BUILT WITH THE INCORRECT CONNECTOR WEDGE LOCK NOT ALLOWING THE HARNESS TO CONNECT PROPERLY.**

**REPLACE WEDGE LOCK WITH CORRECT WEDGE LOCK (PN: 85130765) TO REPAIR. FOLLOW CLAIMING INSTRUCTIONS IN THE REIMBURSEMENT TAB.**
