# Safety Recall

## Code: 28H7

Subject Ignition Switch

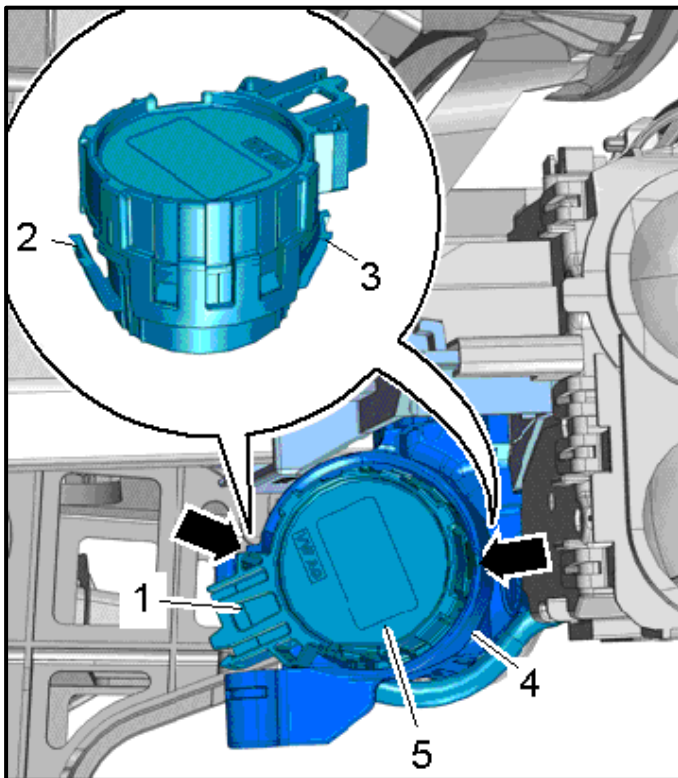
**It is possible to install the new ignition switch incorrectly!**

- See the examples below for switch orientation.
- Disconnect the connector <1>.
- Release the clips <2> and <3> by inserting a suitable screwdriver in the openings <arrows>.
- Remove the ignition/starter Switch <5> from the steering lock housing.
  - During removal, the screwdriver used must remain inserted.
- Replace the ignition/starter switch <5>.

The clips <2> and <3> should audibly engage when the new switch is fully seated.

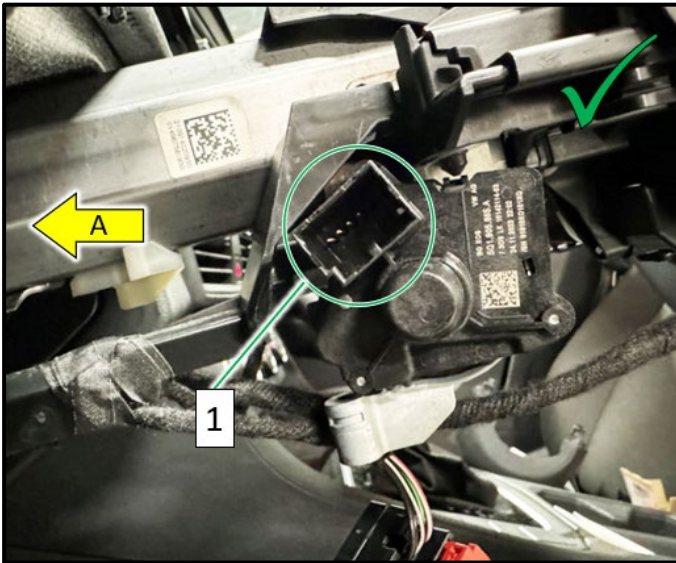
- The ignition switch is installed correctly, note the position of the connector housing <1> and the direction of travel <arrow A>.

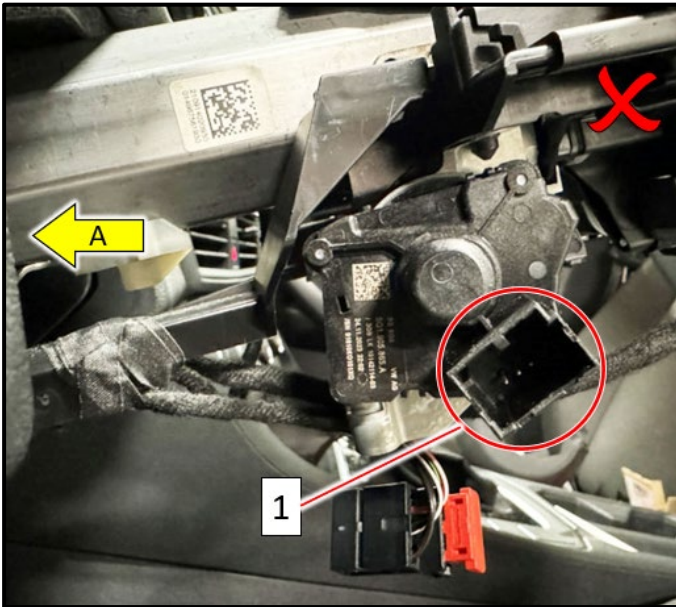
- The ignition switch is not installed correctly, note the position of the connector housing <1> and the direction of travel <arrow A>.
