Safety Recall

Date	Number	Release	Page
09.2023	SC0449	01	1(5)

Mack Medium Duty Steering Gear Hardware Torque MD6 and MD7

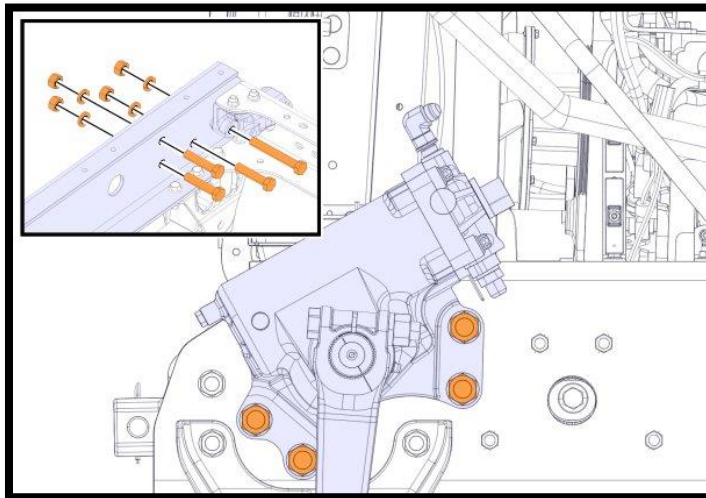
Mack has determined that certain model year 2024 Mack Medium Duty (“MMD”) chassis, were manufactured with a possible under torque condition on the steering gearbox mounting hardware.

The steering gear mounting fasteners to the frame rail may not be torqued to specification. The under-torqued fasteners could result in a loss of clamp load on the steering gearbox. Indication of this occurrence may include steering wander or a feeling of looseness in the steering.

6. Unlatch and raise the hood.
7. Locate the steering gearbox mounting fasteners-driver's side frame rail.
8. Torque the steering gearbox mounting hardware to spec.

Tightening Torque

Screws, Gearbox

540 ± 40Nm (398 ± 30 lb-ft.)

If any steering gearbox mounting hardware is found damaged, Replace it with new. **Refer to Impact instructions: 6421-03-02-01, Steering Gear, Replacement.**
