**SAFETY RECALL**  
 NORTH AMERICA  
**PHEV Charging Cables**

Reference: 98A

Remedy available for  
 2023-2024 model year (GG) Dodge Hornet Plug-in Hybrid Electric Vehicles (PHEVs)

Remedy available for  
 2023-2024 model year (GC) Alfa Romeo Tonale Plug-in Hybrid Electric Vehicles (PHEVs)

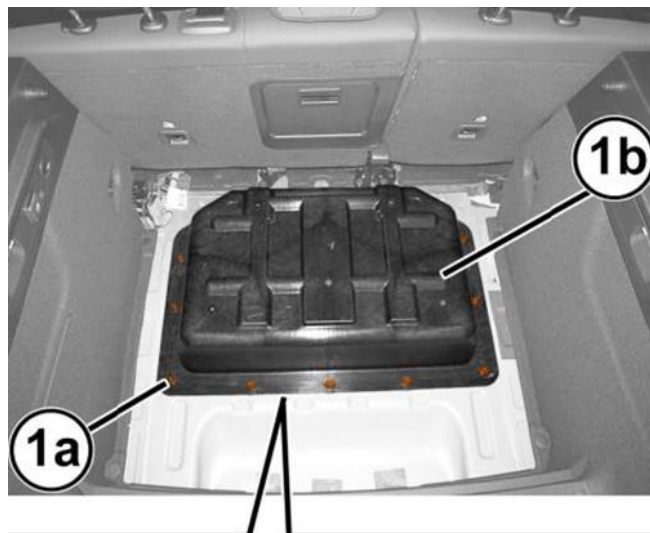
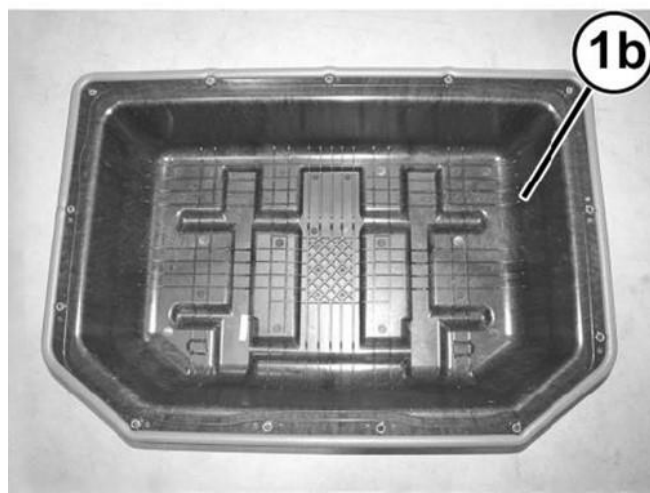
3. Remove the IDCM guard, undo the fixing screws (1a) along the perimeter and remove the shield (1b).

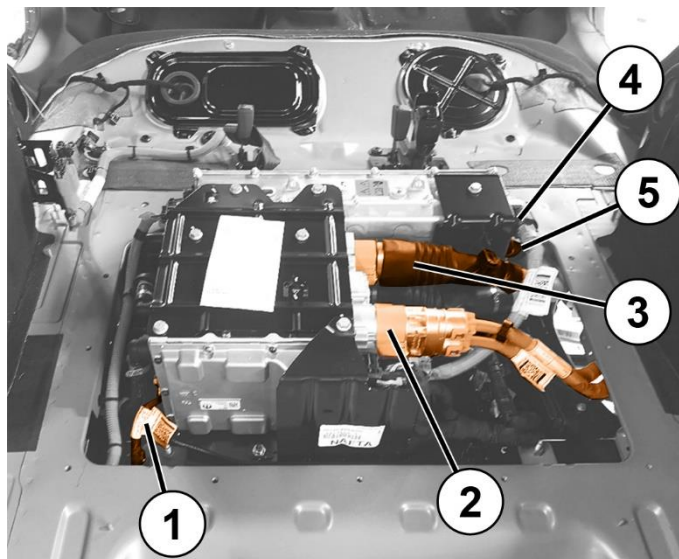
4. Check that the 5 connections are tightened securely.

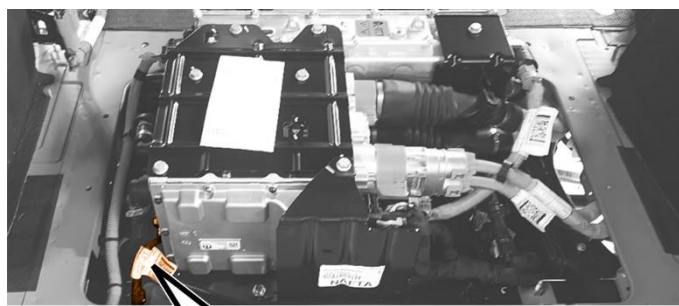
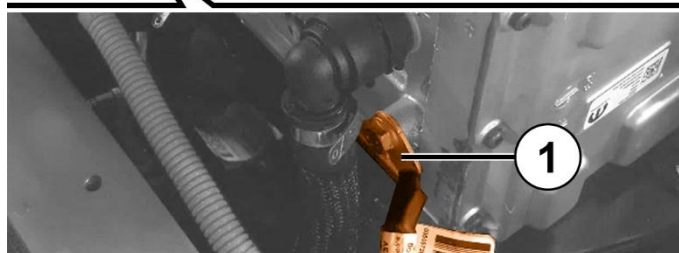
5. Check that the ground cable (1) is tightened to the prescribed torque of 15 Nm (11 Ft. Lbs.).

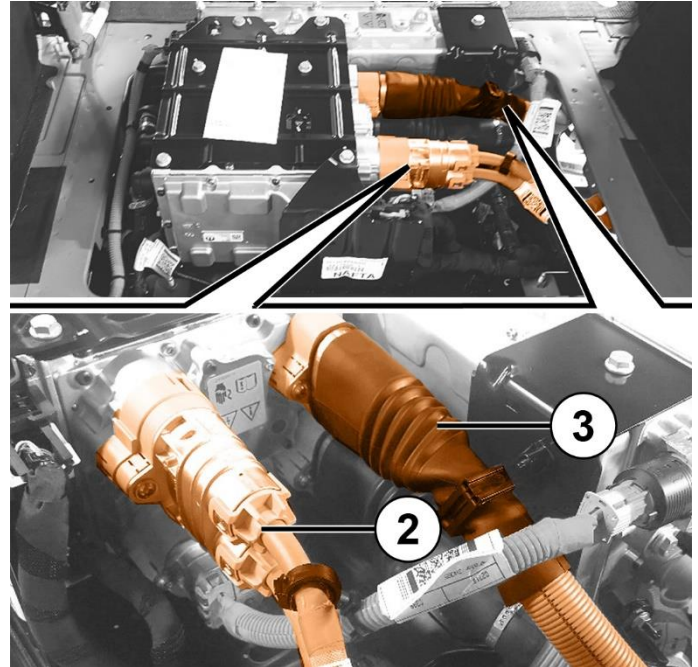
6. Check that the HV connector (2) and (3) are tightened to the prescribed torque of 9 Nm (80 In. Lbs.).

7. Check that the ground cable (4) is tightened to the prescribed torque of 15 Nm (11 Ft. Lbs.).

8. Check the presence of the nut on the charging cable (5).

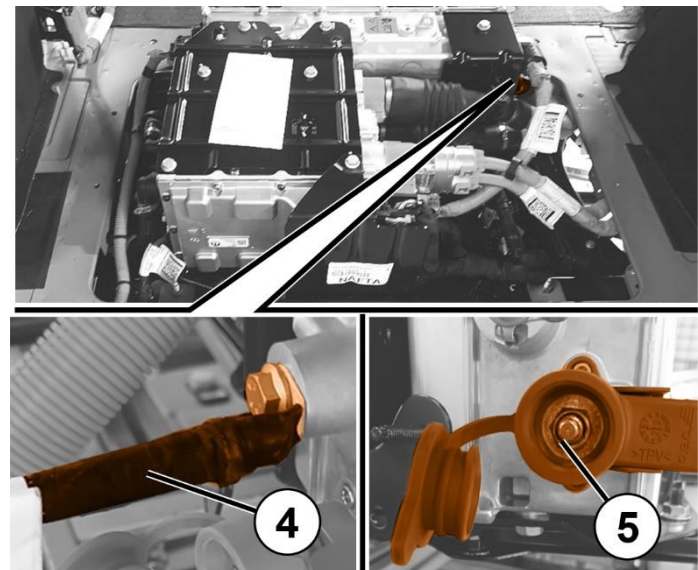
9. If the nut for positive cable from 12V battery to the IDCM is not present, the vehicle is NOT compliant (NOK), proceed with inserting the **NEW** nut and correctly tighten to the prescribed torque of 11 Nm (97 In. Lbs.).

10. If the nut for positive cable from 12V battery to the IDCM is present and correctly tightened at the prescribed torque of 11 Nm (97 In. Lbs.), the vehicle is compliant (OK).
