SAFETY RECALL
NORTH AMERICA
PHEV Charging Cables

Reference: 98A / NHTSA 23V-623

Remedy available for
2023-2024 model year (GG) Dodge Hornet Plug-in Hybrid Electric Vehicles (PHEVs)

Remedy available for
2023-2024 model year (GC) Alfa Romeo Tonale Plug-in Hybrid Electric Vehicles (PHEVs)

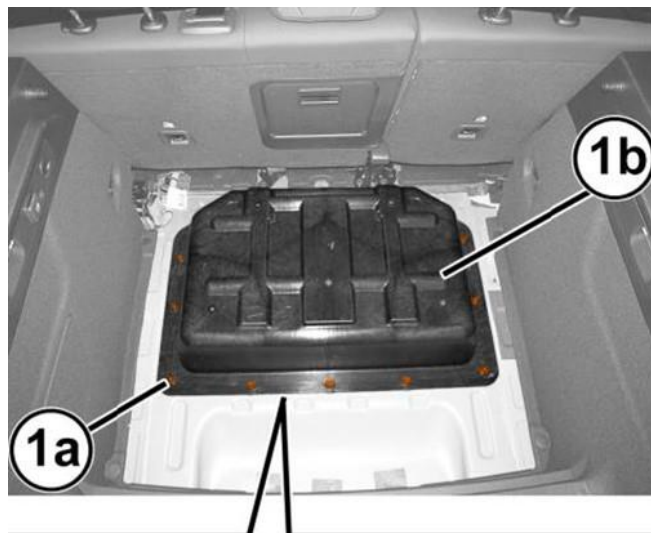
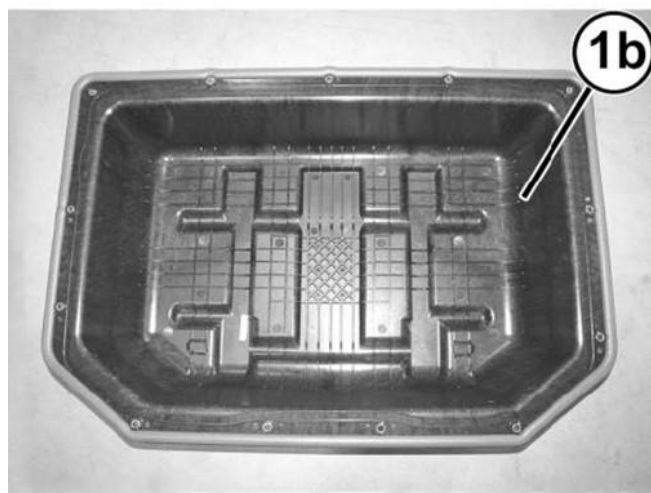
3. Remove the IDCM guard, undo the fixing screws (1a) along the perimeter and remove the shield (1b).

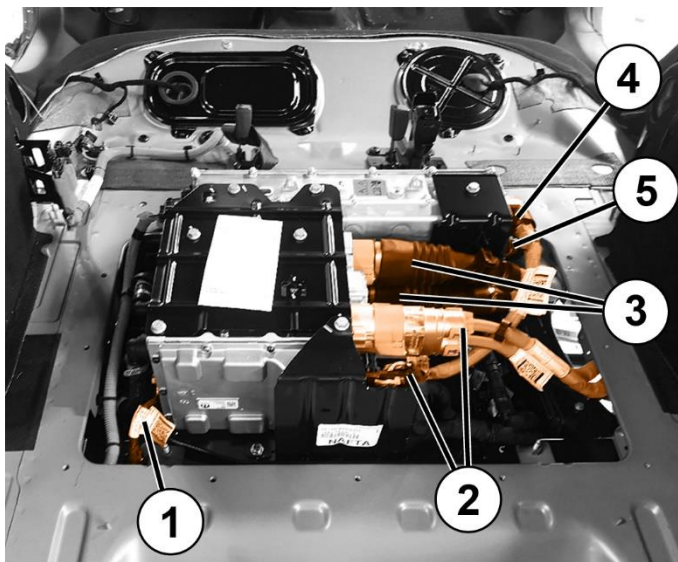
4. Check that the 5 connections are tightened securely.

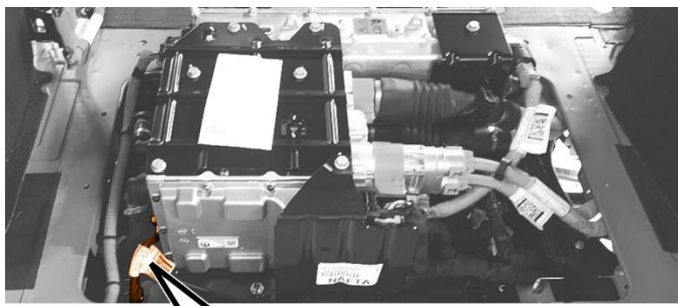
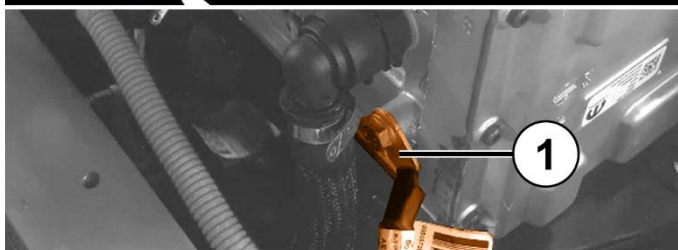
5. Check that the ground cable (1) is tightened to the prescribed torque of 15 Nm (11 Ft. Lbs.).

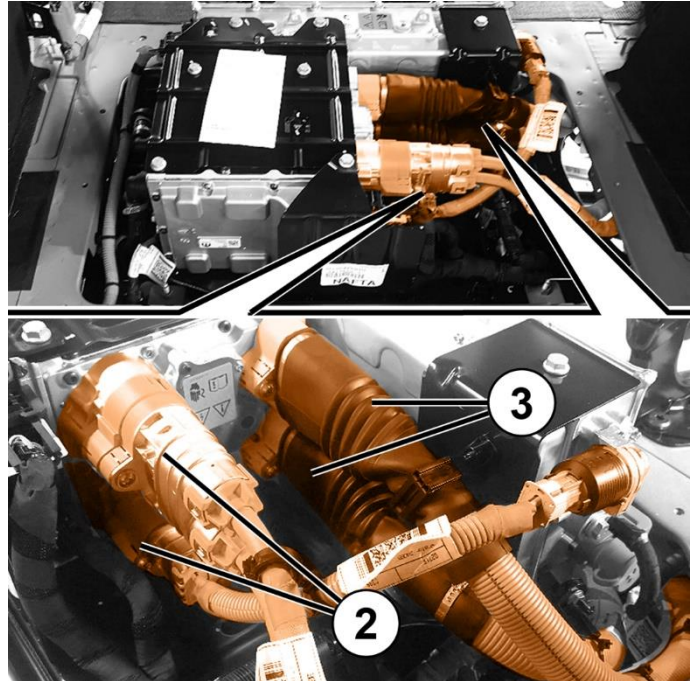
6. Check that the upper and lower HV connectors (2) and (3) are tightened to the prescribed torque of 9 Nm (80 In. Lbs.).

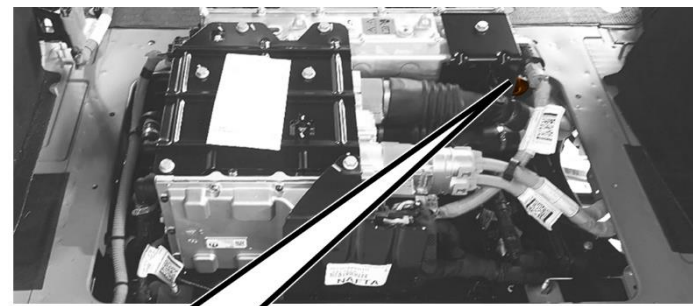
7. Check that the ground cable (4) is tightened to the prescribed torque of 15 Nm (11 Ft. Lbs.).

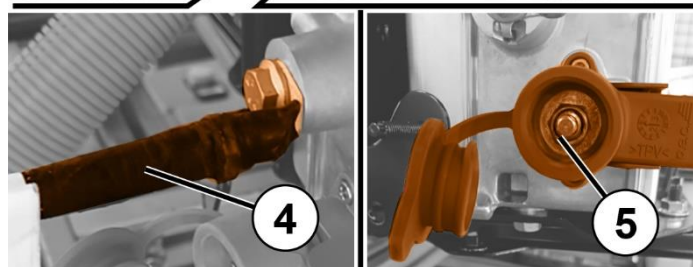
8. Check the presence of the nut on the charging cable (5).

NOTE: Not all vehicles will have a cap covering the nut on the charging cable (5). It is NOT necessary to install a cap if it is not present.

9. If the nut for positive cable from 12V battery to the IDCM is not present, the vehicle is NOT compliant (NOK), proceed with inserting the **NEW** nut and correctly tighten to the prescribed torque of 11 Nm (97 In. Lbs.).
10. If the nut for positive cable from 12V battery to the IDCM is present and correctly tightened at the prescribed torque of 11 Nm (97 In. Lbs.), the vehicle is compliant (OK).

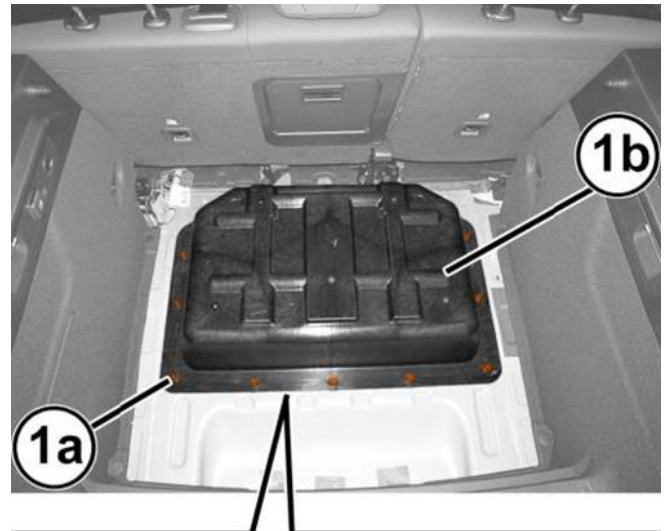
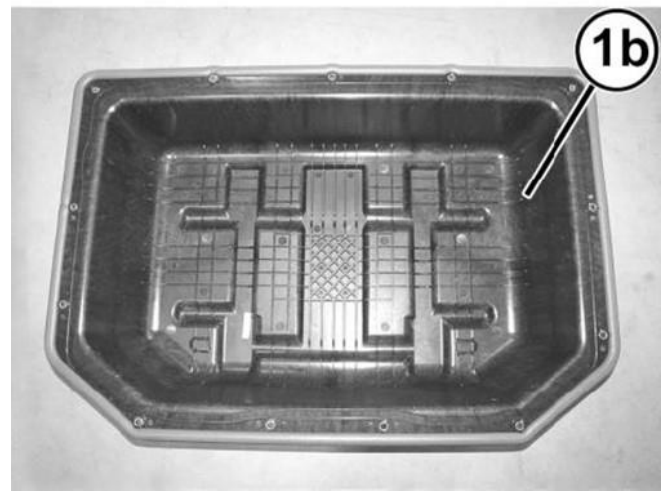
11. Install the IDCM guard, securing the fixing screws (1a) along the perimeter and remove the shield (1b).
