SAFETY RECALL
 NORTH AMERICA
PHEV Charging Cables

Reference: 98A / NHTSA 23V-623

Remedy available for
 2023-2024 model year (GG) Dodge Hornet Plug-in Hybrid Electric Vehicles (PHEVs)

Remedy available for
 2023-2024 model year (GC) Alfa Romeo Tonale Plug-in Hybrid Electric Vehicles (PHEVs)

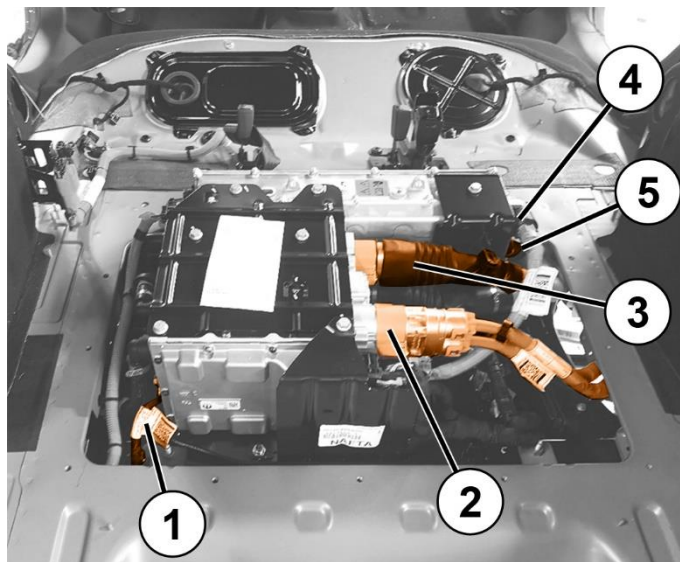
4. Check that the 5 connections are tightened securely.

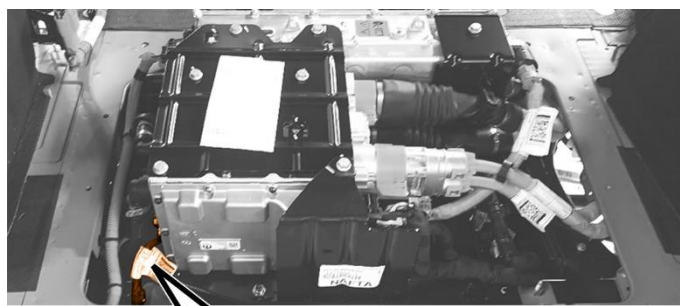
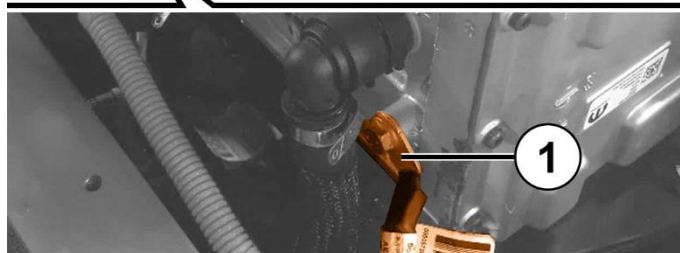
5. Check that the ground cable (1) is tightened to the prescribed torque of 15 Nm (11 Ft. Lbs.).

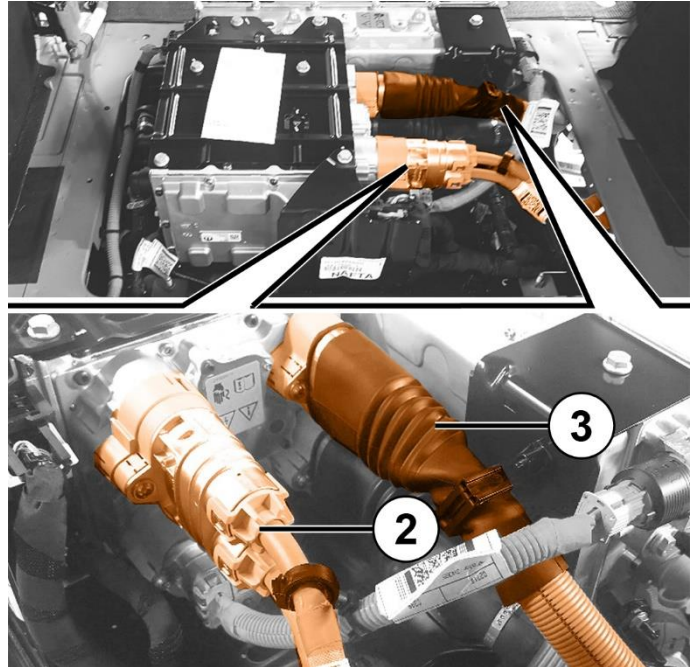
6. Check that the HV connector (2) and (3) are tightened to the prescribed torque of 9 Nm (80 In. Lbs.).

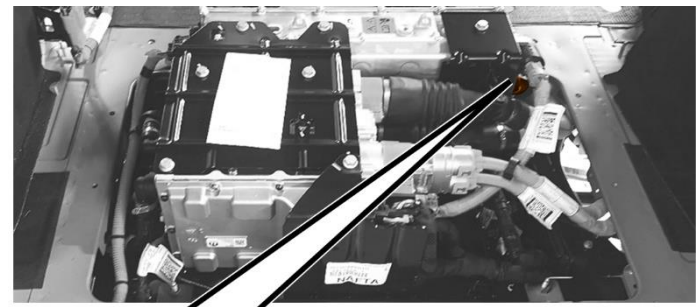
7. Check that the ground cable (4) is tightened to the prescribed torque of 15 Nm (11 Ft. Lbs.).

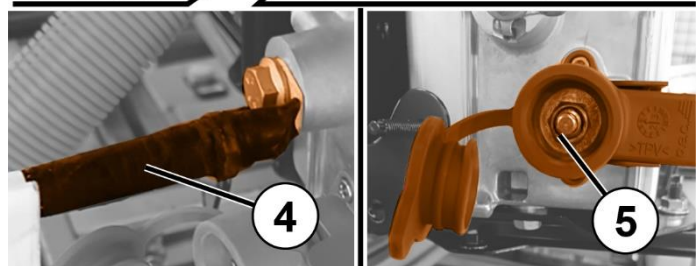
8. Check the presence of the nut on the charging cable (5).

9. If the nut for positive cable from 12V battery to the IDCM is not present, the vehicle is NOT compliant (NOK), proceed with inserting the **NEW** nut and correctly tighten to the prescribed torque of 11 Nm (97 In. Lbs.).

10. If the nut for positive cable from 12V battery to the IDCM is present and correctly tightened at the prescribed torque of 11 Nm (97 In. Lbs.), the vehicle is compliant (OK).
