GROUP	MODEL
Safety Recall Campaign	2018-2021MY Stinger (CK) w/2.0L T-GDI ULEV
NUMBER	DATE
SC281	December 2023

# HIGH-PRESSURE FUEL PUMP INSPECTION/REPLACEMENT AND ECM SOFTWARE UPGRADE (SC281)

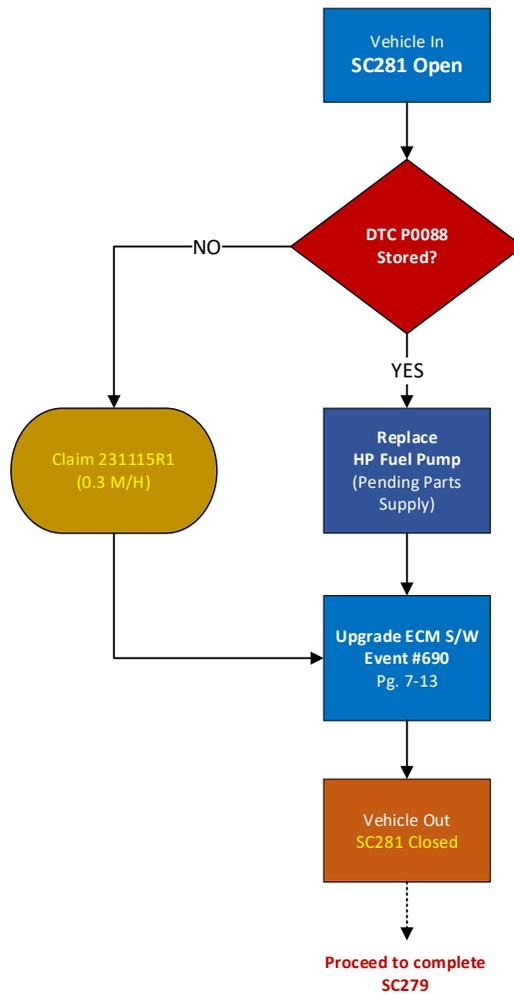
**This Safety Recall Campaign (SC281) must be completed first and then simultaneously Voluntary Emissions Service Campaign (SC279) at the time of vehicle's dealer visit.** Follow the flowchart below to scan the vehicle for DTC P0088 before upgrading the ECM software and (if needed) replace the high-pressure fuel pump.

**\*Vehicles requiring the 'High-Pressure Fuel Pump Kit Replacement' will need to be parked until this TSB is revised to include the complete Parts & Warranty Information. DO NOT attempt to complete the repair until this TSB is revised to include the missing information.**

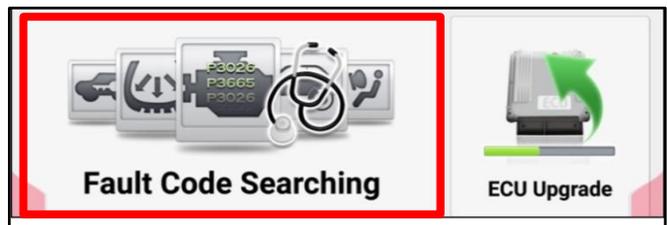
4. Select 'Fault Code Searching'.
  - If DTC P0088 is stored **(NG)**, proceed to the 'Repair Procedure' outlined on page 4.
  - If DTC P0088 is not stored **(OK)**, proceed to 'ECU Upgrade Procedure' outlined on page 6.
