GROUP	MODEL
Noncompliance Safety Recall Campaign	2019MY Sorento (UMa)
NUMBER	DATE
SC282	March 2024

SUBJECT: **REAR VIEW CAMERA INSPECTION & REPLACEMENT (SC282)**

This bulletin provides information to inspect and, based on the inspection results, to replace the rearview camera or apply additional water proofing to the rearview camera on certain 2019MY Sorento (UMa) vehicles produced from August 1, 2018 through June 12, 2019. Due to an error in the manufacturing process, the rearview camera may be susceptible to water intrusion. If water enters the rear of the camera, the camera's image may become blank while in reverse. As a result, the subject vehicles fail to comply with the rear visibility requirement of the Federal Motor Vehicles Safety Standard (FMVSS) 111, ('Rear Visibility'). A rearview camera that does not display what is behind the vehicle increases the risk of a crash. Follow the procedure outlined in this publication to inspect and, if necessary, replace the rearview camera on the applicable vehicle. If no issue is found following inspection, dealers will apply additional water proofing to the camera wiring harness. Before conducting the procedure, verify that the vehic

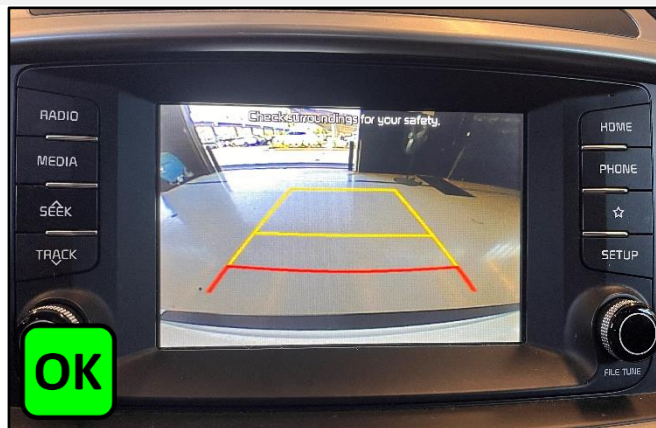
1. Start vehicle and place in reverse 'R' gear.
 - If the image displayed on the infotainment screen is normal (OK), proceed to step 2.

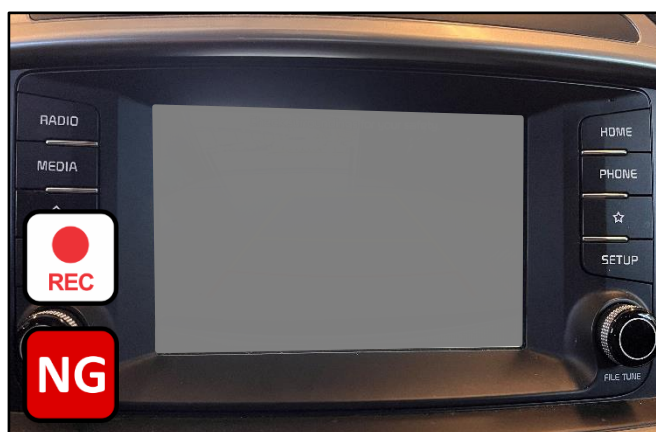
- If the image displayed on the infotainment screen is blank (NG), record a KVID video starting from the VIN label on the door and then showing the NG condition on the infotainment screen. Proceed to the 'Replacement Procedure' on page 5.

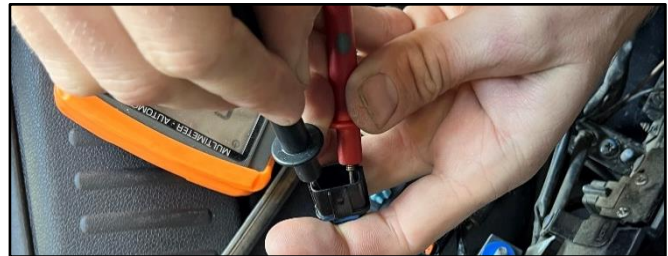
- Using the multimeter (SST DT-830D), measure the resistance between; PIN 1 & PIN 4 and PIN 1 & PIN 2.

- If **no** resistance is found 'O.L.' (OK), proceed to the 'Repair Procedure' on page 5.
- If resistance **is** found (NG), proceed to 'Replacement Procedure' on page 6.

(+) Probe		(-) Probe		Specification
Connector	PIN	Connector	PIN	
(R37) Rear Camera Connector	1 (Power)	(R37) Rear Camera Connector	4 (Ground)	O.L Ω
(R37) Rear Camera Connector	1 (Power)	(R37) Rear Camera Connector	2 (Video Signal)	O.L Ω
