GROUP	MODEL
Noncompliance Safety Recall Campaign	2019MY Sorento (UMa)
NUMBER	DATE
SC282 (Rev 1, 04/04/2024)	March 2024

SUBJECT: **REARVIEW CAMERA INSPECTION & REPLACEMENT (SC282)**

This bulletin provides information to inspect and, based on the inspection results, to replace the rearview camera or apply additional water proofing to the rearview camera on certain 2019MY Sorento (UMa) vehicles produced from August 1, 2018 through June 12, 2019. Due to an error in the manufacturing process, the rearview camera may be susceptible to water intrusion. If water enters the rear of the camera, the camera's image may become blank while in reverse. As a result, the subject vehicles fail to comply with the rear visibility requirement of the Federal Motor Vehicles Safety Standard (FMVSS) 111, ('Rear Visibility'). A rearview camera that does not display what is behind the vehicle increases the risk of a crash. Follow the procedure outlined in this publication to inspect and, if necessary, replace the rearview camera on the applicable vehicle. If no issue is found following inspection, dealers will apply additional water proofing to the camera wiring harness. Before conducting the procedure, ve

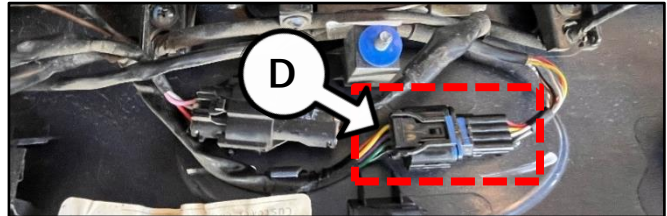
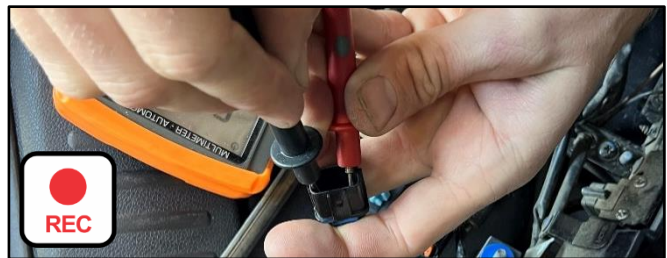
- Disconnect the rearview camera connector (D).
- Using the multimeter (SST DT-830D), measure the resistance of the rearview camera between; PIN 1 & PIN 4 and PIN 1 & PIN 2.

- If **no** resistance is found 'O.L.' (OK), proceed to the 'Repair Procedure' on page 5.
- If resistance **is** found (NG), record a KVID video starting from the VIN label on the door and then show the meter reading, then proceed to 'Replacement Procedure' on page 6.
