GROUP	MODEL
Noncompliance Safety Recall Campaign	2019MY Sorento (UMa)
NUMBER	DATE
SC282 (Rev 2, 05/15/2024)	March 2024

SUBJECT: **REARVIEW CAMERA INSPECTION & REPLACEMENT (SC282)**

This bulletin provides information to inspect and, based on the inspection results, to replace the rearview camera or apply additional water proofing to the rearview camera on certain 2019MY Sorento (UMa) vehicles produced from August 1, 2018 through June 12, 2019. Due to an error in the manufacturing process, the rearview camera may be susceptible to water intrusion. If water enters the rear of the camera, the camera's image may become blank while in reverse. As a result, the subject vehicles fail to comply with the rear visibility requirement of the Federal Motor Vehicles Safety Standard (FMVSS) 111, ('Rear Visibility'). A rearview camera that does not display what is behind the vehicle increases the risk of a crash. Follow the procedure outlined in this publication to inspect and, if necessary, replace the rearview camera on the applicable vehicle. If no issue is found following inspection, dealers will apply additional water proofing to the camera wiring harness. Before conducting the procedure, ve

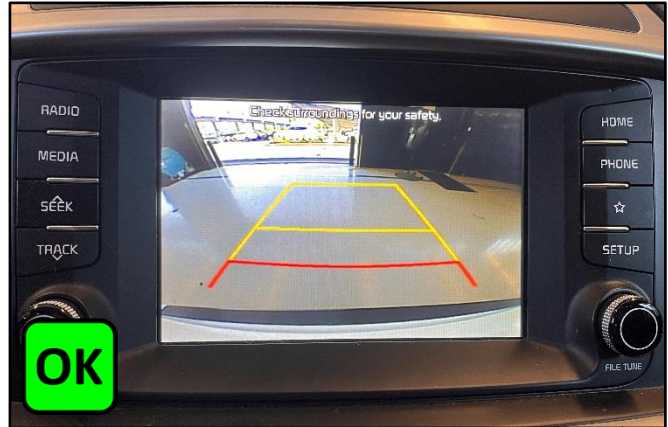
1. Start vehicle and place in reverse 'R' gear.
 - If the image displayed on the infotainment screen is normal (OK), proceed to step 2.

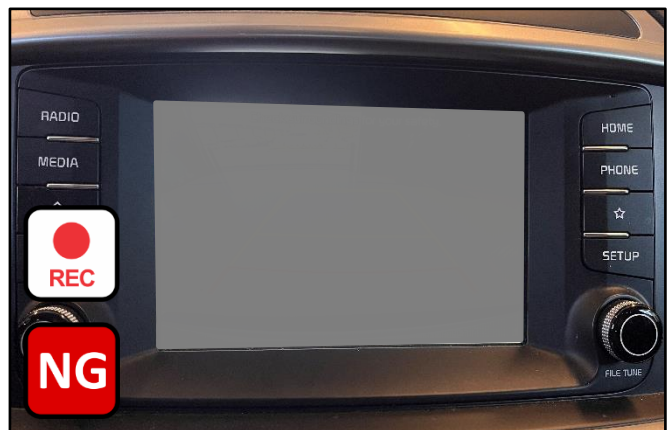
- If the image displayed on the infotainment screen is blank (NG), record a KVID video starting from the VIN label on the door and then show the NG condition on the infotainment screen, then proceed to the 'Replacement Procedure' on page 6.

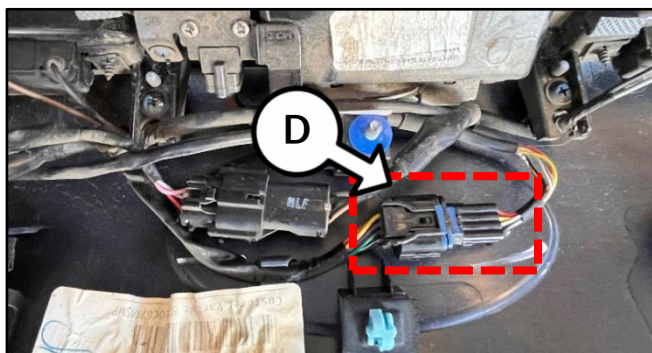
4. Disconnect the rearview camera connector (D).
5. Using the multimeter (SST DT-830D), set the meter range to 2MΩ and measure the resistance of the rearview camera for a minimum of ten (10) seconds between:

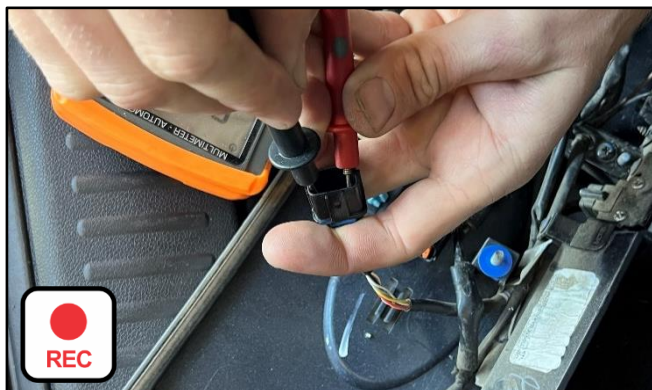
- PIN 1 (Red) & PIN 4 (Black)
- PIN 1 (Red) & PIN 2 (Yellow)

- If the resistance reading is greater than or equal to 2MΩ or 'O.L / O.F' (OK), proceed to the 'Repair Procedure' on page 6.
- If the resistance found is less than 2MΩ (NG), record a KVID video starting from the VIN label on the door and then show the meter reading, then proceed to 'Replacement Procedure' on page 7.
