Remedy available for
 2022-2023 (JL) Jeep Wrangler
 2022-2023 (JT) Jeep Gladiator

SAFETY RECALL
 NORTH AMERICA
Gear Position Sensor

Reference: 92A / NHTSA 23V-641

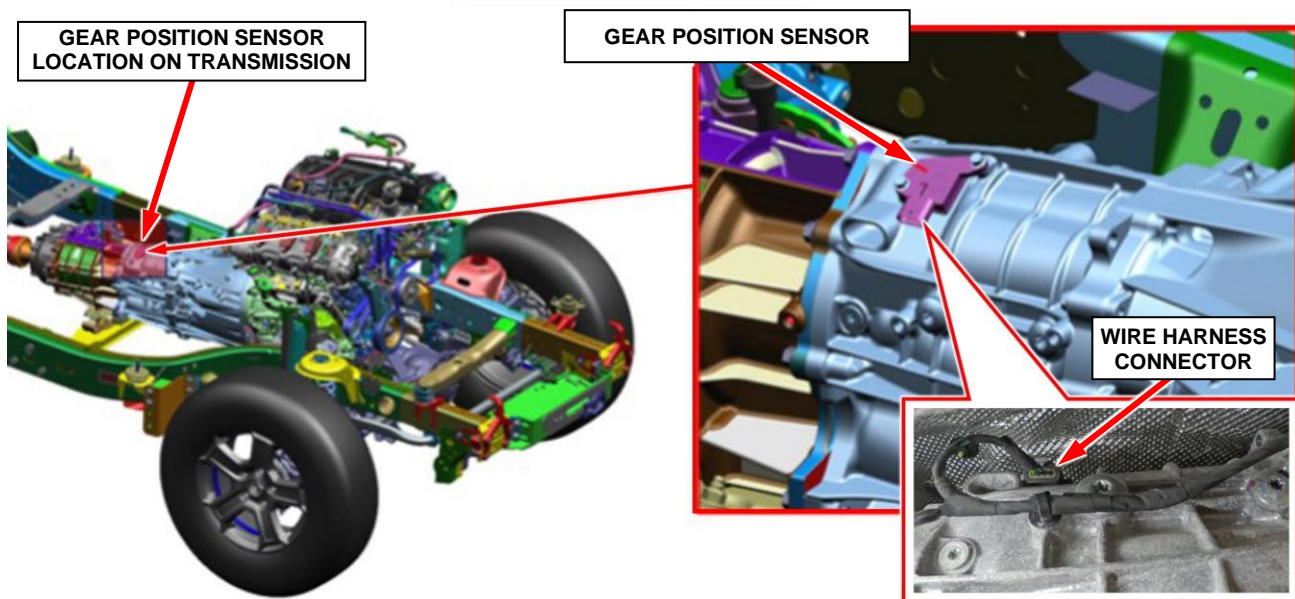
Figure 1 – Gear Position Sensor

The manual transmission on about 6,298 of the above vehicles may have been built with an improperly manufactured Gear Position Sensor / All Gear Sensor (AGS) which may cause the reverse lights and back-up camera to be disabled. Vehicles with a suspect gear position sensor / AGS may not display the rearview image or activate the backup lamps during a backing event. The vehicle operator will notice that the rearview image is not displayed if attempting to reference the image while backing. If this warning is not heeded, backing without verifying it is safe to do so could lead to an increased risk of injury to people outside the vehicle. Failure to illuminate the backup lamps may not adequately illuminate the roadway behind the vehicle or indicate to other drivers or pedestrians the intention to backup, which can cause a crash without prior warning.

1. Ensure the ignition switch is in the OFF position.
2. Raise and support the vehicle.
3. Clean the area surrounding the gear position sensor removing any dirt or debris.
4. Disconnect the gear position sensor wire harness connector (Figure 1).
5. Remove and **DISCARD** the two bolts securing the gear position sensor to the transmission then remove the gear position sensor from the transmission (Figure 1).
6. Render the suspect gear position sensor unusable and **DISCARD**.

7. Position the **NEW** gear position sensor to the transmission, then install the gear position sensor using **NEW** bolts and tighten to 3 N·m (24 In. Lbs.) (Figure 1).

CAUTION: Do not overtighten the gear position sensor bolts.

8. Connect the gear position sensor wire harness connector (Figure 1).
9. Lower the vehicle.
10. Using wiTECH, perform the Learn Gear Shift Sensor Routine steps in Section B of this service procedure.
