SIB 61 22 23

RECALL 23V-644: WIPER LINKAGE

E-Series	Model Description	Production Date
G70	7 Series Sedan	October 13, 2022 – January 26, 2023

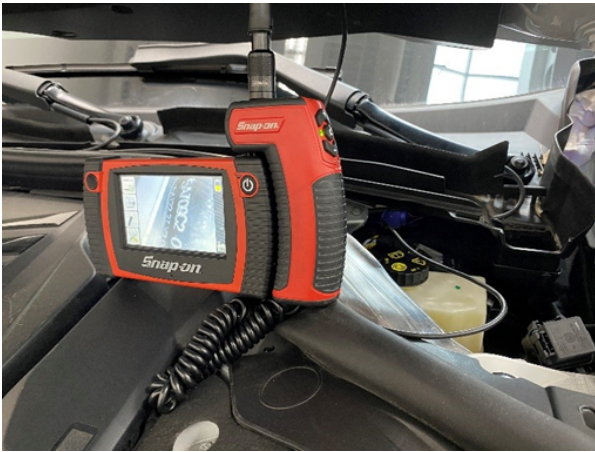
1. Remove the cover of the engine compartment at the rear left (driver side).
2. If available, utilize a borescope device to inspect and record the wiper motor batch code; then proceed to step 6.
3. If a borescope is not available, please proceed to step 4.

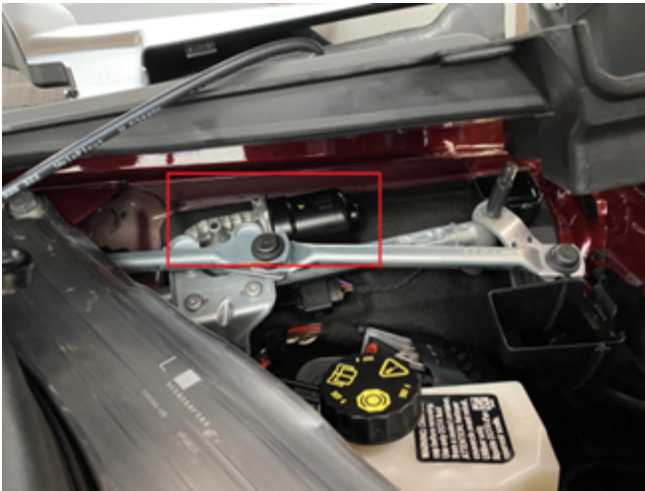
4. Remove the driver side wiper arm following the repair instructions **“Removing and installing/replacing both windshield wiper arms 61 61 100 | REP-REP-P-6161100-G70 – V.1”** (detach wiper arm with special tool **0 493 441 (61 6 060)** when necessary.)

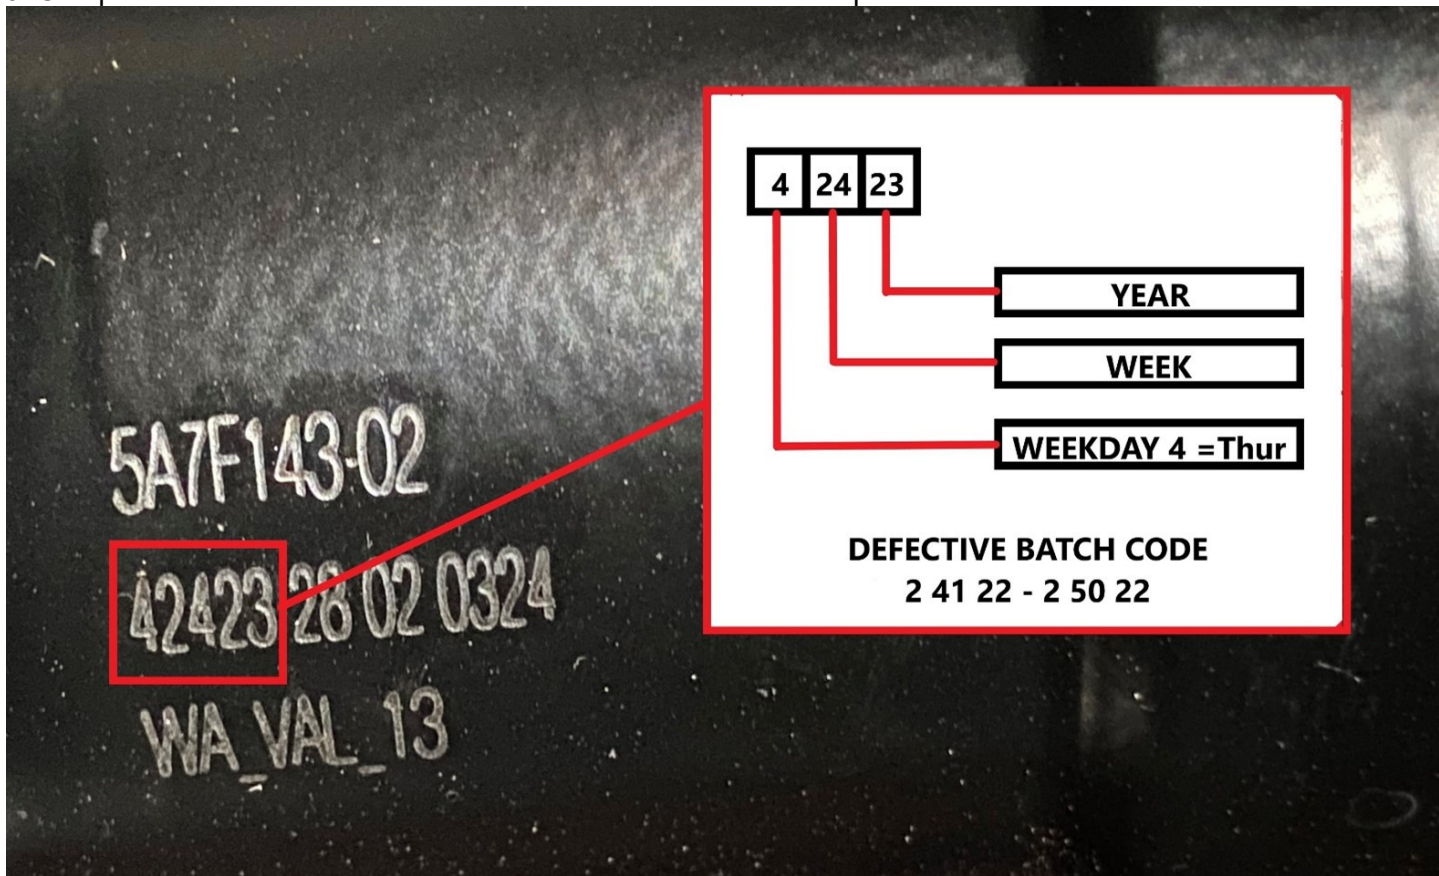
6. Compare the defective batch code and dates of the installed wiper motor.

7. When the batch code falls under the affected dates (from **2 41 22** to **2 50 22**), the wiper linkage must be replaced. Refer to repair instructions **“Replace the console for the windshield wiper system 61 61 271 | REP-REP-P-6161271-G70 - V.3”** available with ISTA 4.40.5X.
