SIB 61 22 23

2023-10-24

RECALL 23V-644: WIPER LINKAGE

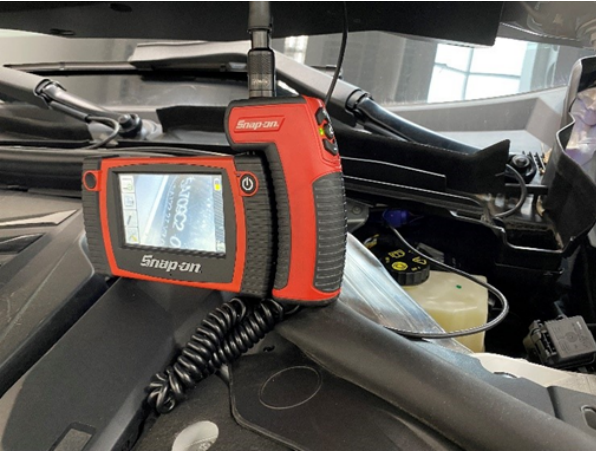
1. Remove the cover of the engine compartment at the rear left (driver side).
 2. If available, utilize a borescope device to inspect and record the wiper motor batch code; then proceed to step 6.
 3. If a borescope is not available, please proceed to step 4.

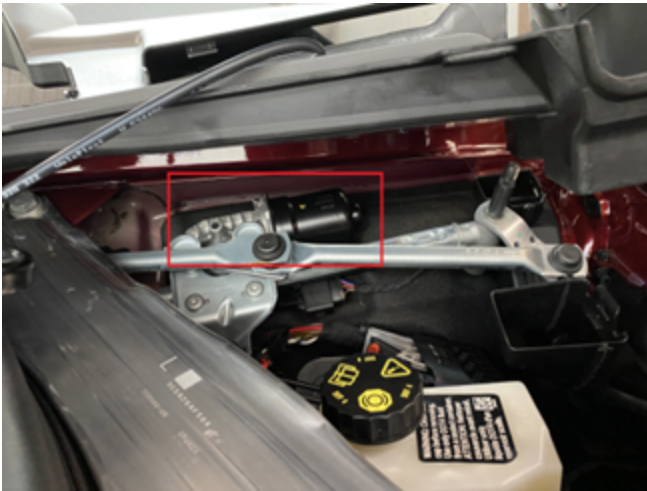
4. Remove the driver side wiper arm following the repair instructions “**Removing and installing/replacing both windshield wiper arms** 61 61 100 | REP-REP-P-6161100-G70 – V.1” (detach wiper arm with special tool **0 493 441 (61 6 060)** when necessary.)

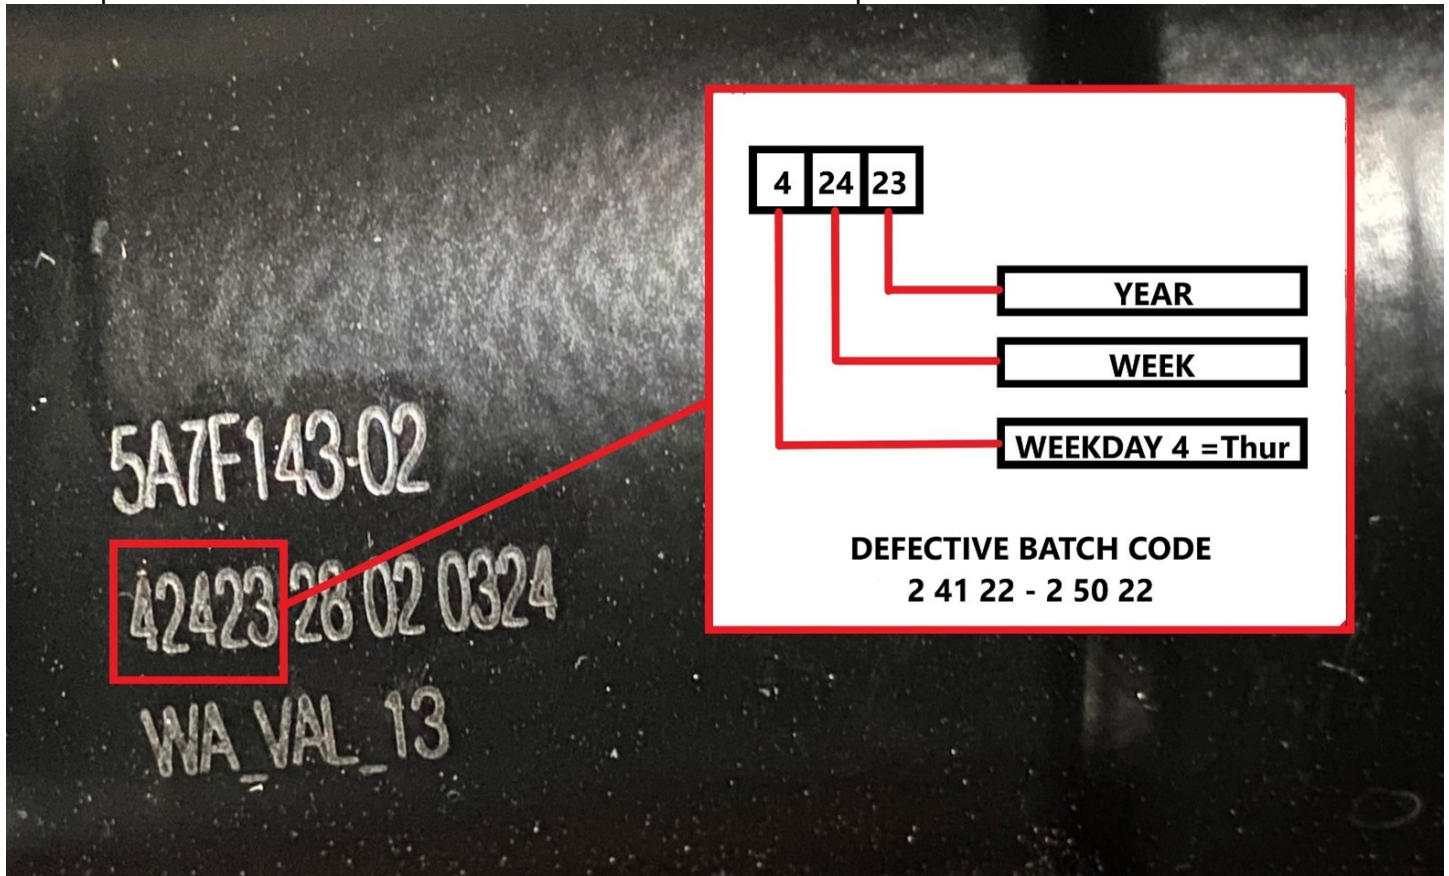
6. Compare the defective batch code and dates of the installed wiper motor.

7. When the batch code falls under the affected dates (from **2 41 22** to **2 50 22**), the wiper linkage must be replaced. Refer to repair instructions **“Replace the console for the windshield wiper system 61 61 271 | REP-REP-P-6161271-G70 - V.3”** available with ISTA 4.40.5X.
