## Aftersales Bulletin

### A 09 2023 02 U - 00 51 70 05 00 – Ghost RR21 RR2 Safety Recall 23V-645 – Instrument Cluster Glass

This Technical Campaign (Safety Recall) affects Rolls-Royce Ghost (RR21/22, including BB) models produced from February 17th, 2020, to December 8th, 2022.

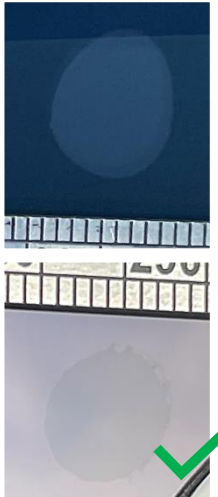
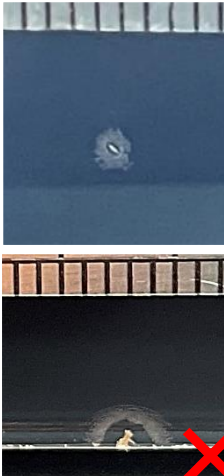
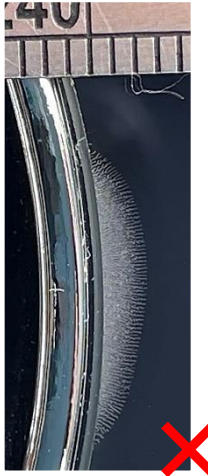
**Table of Defects** (as observed 24 hours after the application):

a) Fluid pocket without inclusions	b) Fluid pocket with inclusions / frosting	c) Dust Particles	d) Bad Positioning	e) Not centered around the air vent

<p>Will take several days to dry/evaporate/disappear.</p>	<p>Bubble may disappear/inclusions will remain.</p>	<p>Does not disappear/improve.</p>	<p>Does not improve.</p>	<p>Does not improve.</p>
<p>If does not disappear after 5 days, new protective coating application required.</p>	<p>New protective coating application required.</p>	<p>New protective coating application required.</p>	<p>New protective coating application required.</p>	<p>New protective coating application required.</p>

⚠ Minor clear fluid pockets (see the Table of Defects below, Figure 'a') should evaporate over time. Check the application daily until the pockets disappear. Do not hand back the vehicle to the customer until all fluid pockets have evaporated completely. If the pockets do not disappear after 5 days, carefully remove the protective coating, and replace with a new one from the kit, repeating all the previous process steps.

⚠ If any other defects are visible, as per the examples shown in the Table of Defects below (see Figures 'b' to 'e'), carefully remove the **protective coating** and replace with a new one from the kit, repeating all the previous process steps.
