HYUNDAI
Technical Service Bulletin

GROUP RECALL	NUMBER 24-01-027H-5
DATE JUNE 2024	MODEL(S) SEE APPLICABLE MODEL LIST

SUBJECT: ANTI-LOCK BRAKING SYSTEM (ABS) FUSE REPLACEMENT
 (RECALL 251)

This TSB supersedes TSB#24-01-027H-4 to add 2015MY Azera (HG).

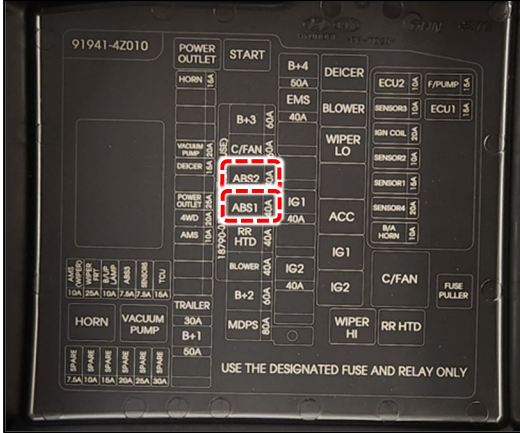
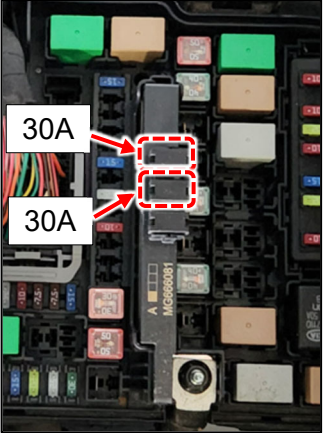
Model	Fuse Changes	Images	
<p>Santa Fe Sport (AN)</p>	<p>ABS1: 40A → 30A ABS2: 40A → 30A</p>

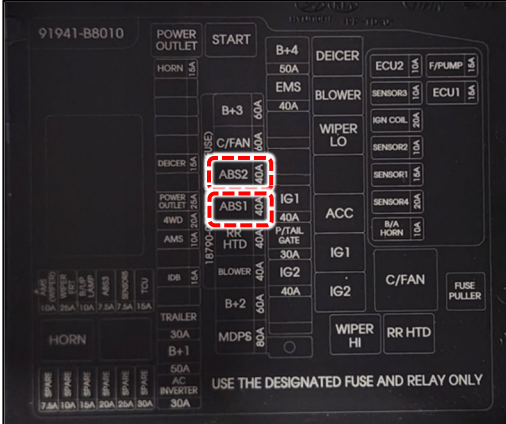
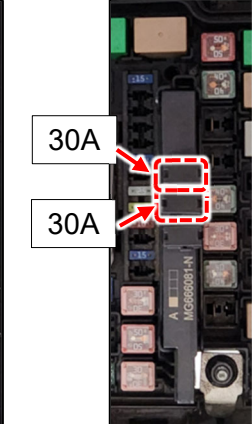
<p>Santa Fe (NC)</p>	<p>ABS1: 40A → 30A ABS2: 40A → 30A</p>

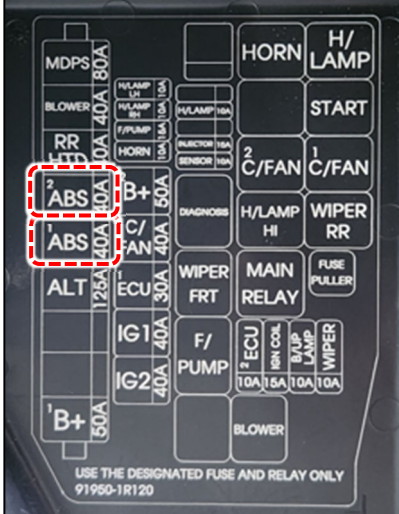
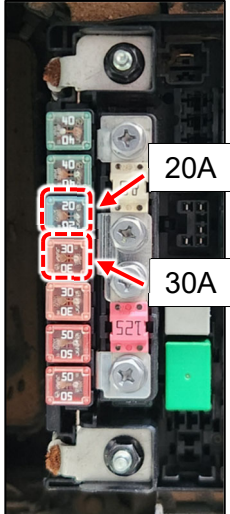
<p>Accent (RB)</p>	<p>ABS1: 40A → 30A ABS2: 40A → 20A</p>

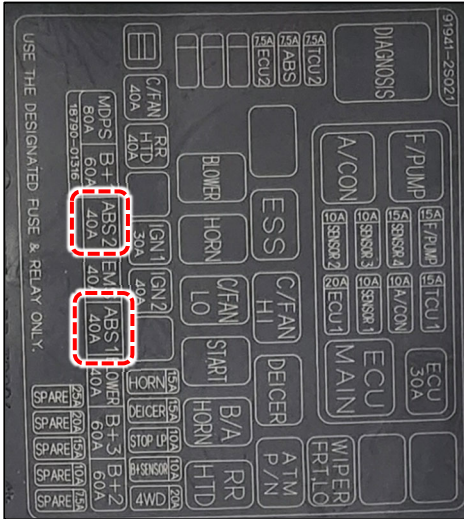
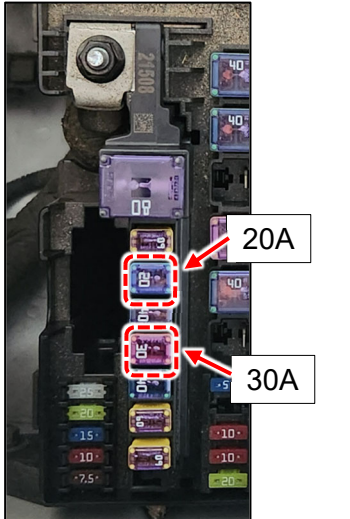
<p>Tucson (LM)</p>	<p>ABS1: 40A → 30A ABS2: 40A → 20A</p>

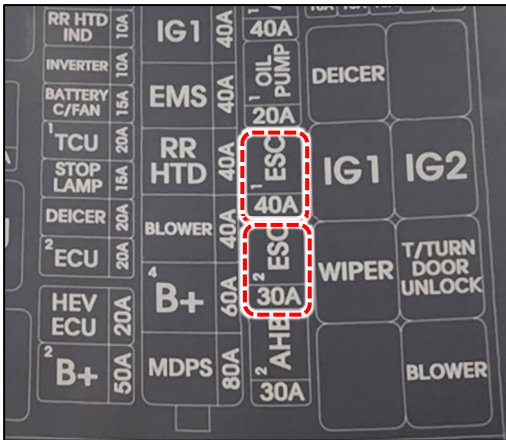
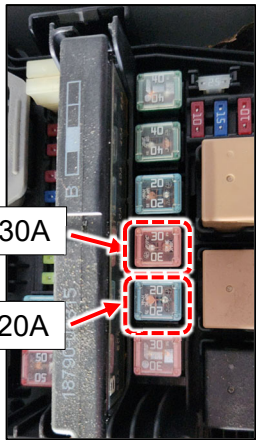
Model	Fuse Changes	Images	
<p>Sonata Hybrid (YF HEV)</p>	<p>ESC1: 40A → 30A ESC2: 30A → 20A</p>

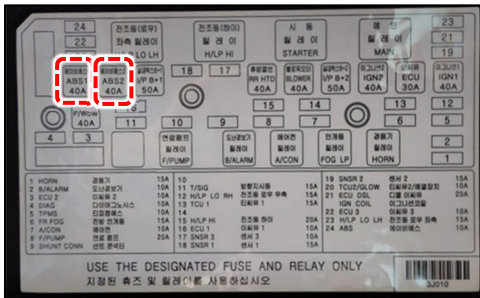
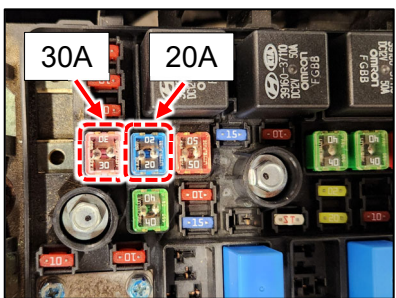
<p>Veracruz (EN)</p>	<p>ABS1: 40A → 30A ABS2: 40A → 20A</p>

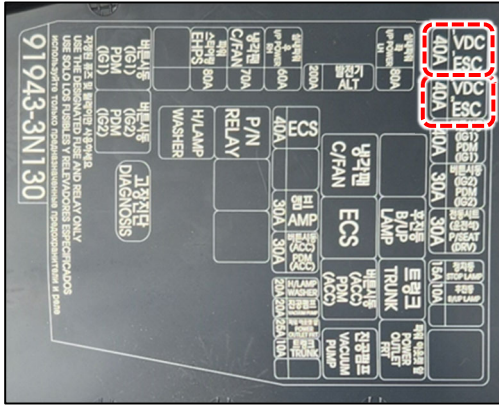
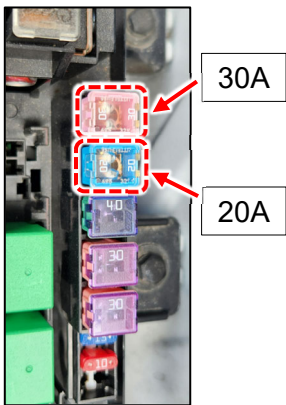
<p>Equus (VI)</p>	<p>ESC1: 40A → 30A ESC2: 40A → 20A</p>

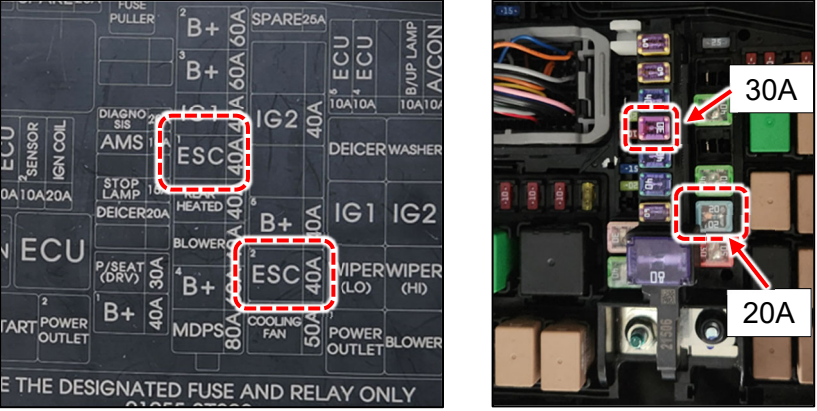
Model	Fuse Changes	Images
Azera (HG)	ESC1: 40A → 30A ESC2: 40A → 20A

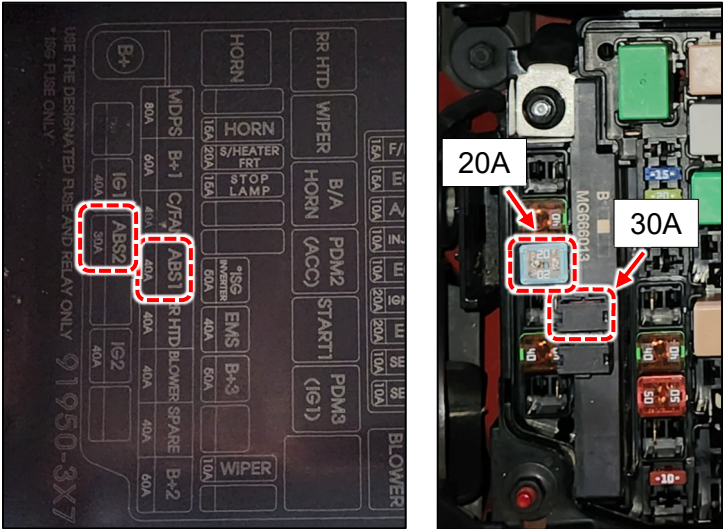
Elantra (MD/UD) & Elantra Coupe (JK)	ABS1: 40A → 30A ABS2: 30A → 20A
