HYUNDAI
Technical Service Bulletin

| GROUP RECALL | NUMBER 24-01-027H-9 |

SUBJECT: ANTI-LOCK BRAKING SYSTEM (ABS) FUSE REPLACEMENT
 (RECALL 251)

This TSB supersedes TSB#24-01-027H-8 to revise the starting production date ranges for Tucson (LM) and Veracruz (EN) models.

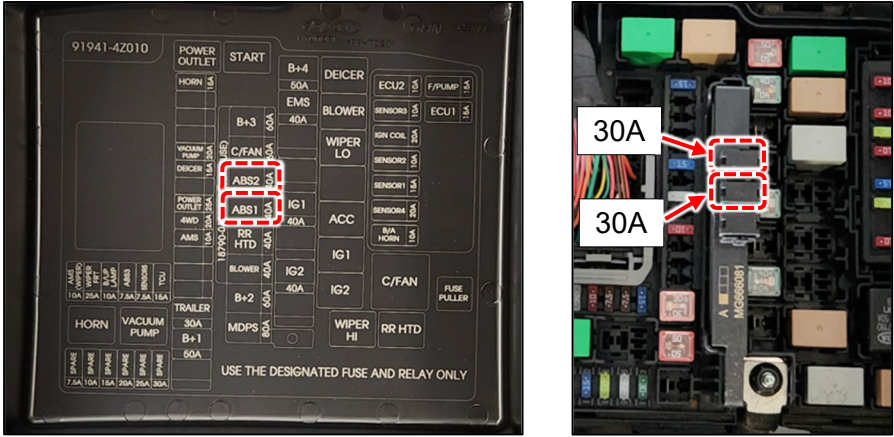
| Model | Fuse Changes | Images |
|---|--|--|
| <p>Santa Fe Sport (AN)</p> | <p>ABS1: 40A → 30A ABS2: 40A → 30A</p> | |

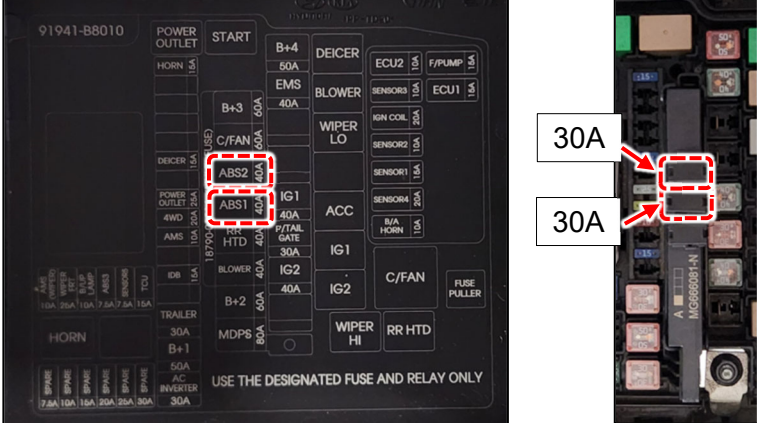
| Model | Fuse Changes | Images |
|---|--|--|
| <p>Santa Fe (NC)</p> | <p>ABS1: 40A → 30A ABS2: 40A → 30A</p> | |

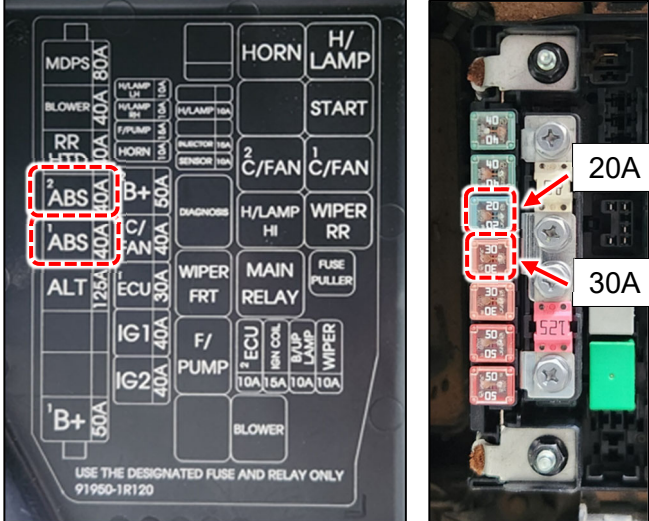
| Model | Fuse Changes | Images |
|---|--|--|
| <p>Accent (RB)</p> | <p>ABS1: 40A → 30A ABS2: 40A → 20A</p> | |

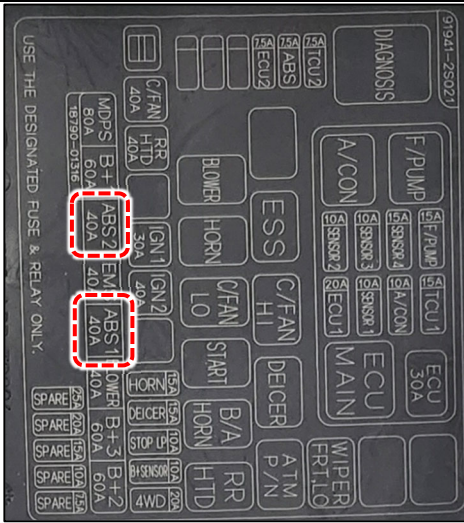
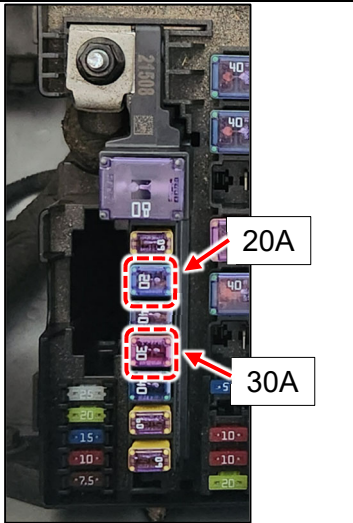
| <p>Tucson (LM)</p> | <p>ABS1: 40A → 30A ABS2: 40A → 20A</p> | | |

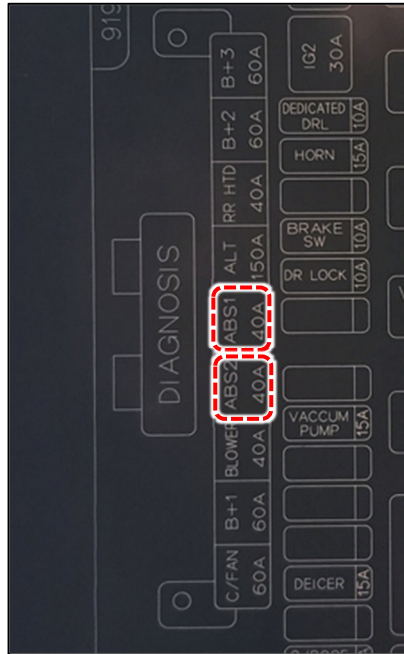
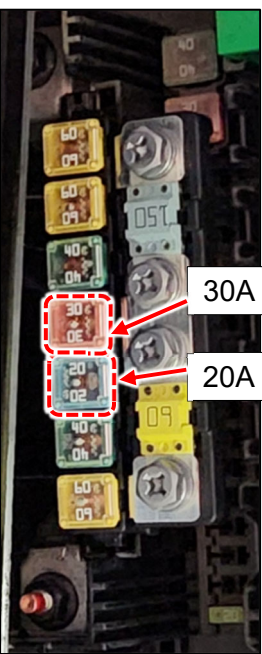
| <p>Genesis Coupe (BK)</p> | <p>ABS1: 40A → 30A ABS2: 40A → 20A</p> | | |

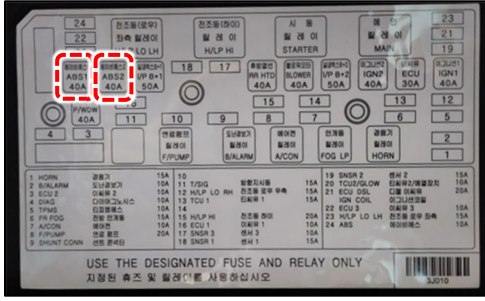
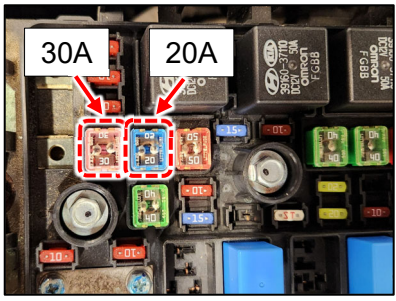
| <p>Veracruz (EN)</p> | <p>ABS1: 40A → 30A ABS2: 40A → 20A</p> | | |

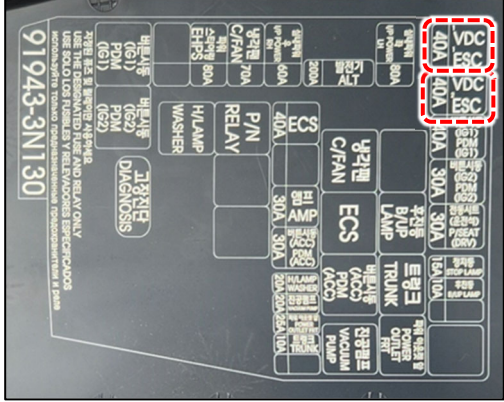
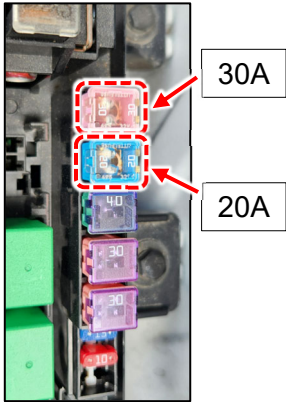
| <p>Equus (VI)</p> | <p>ESC1: 40A → 30A ESC2: 40A → 20A</p> | | |

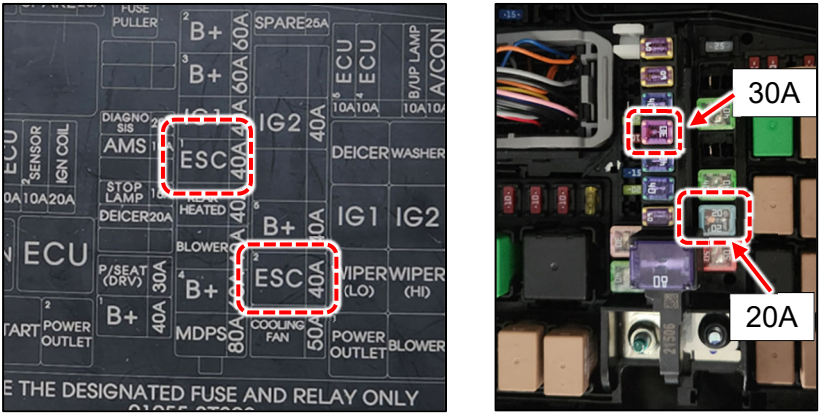
| Model | Fuse Changes | Images |
|---|---|--|
| Azera (HG) | ESC1: 40A → 30A ESC2: 40A → 20A | |

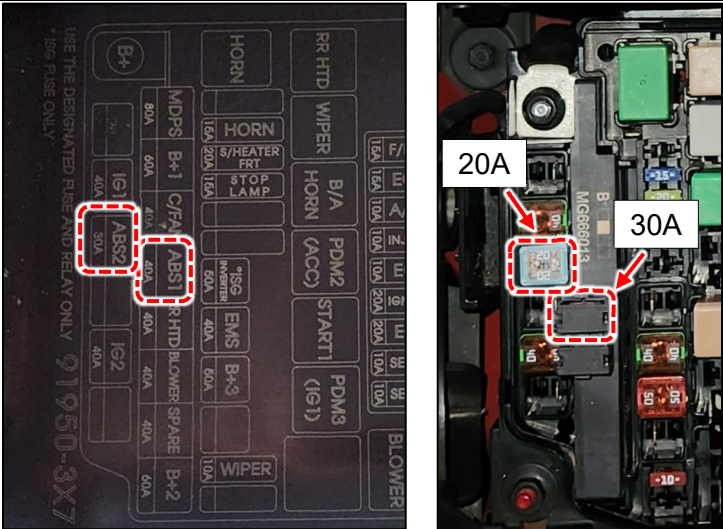
| Model | Fuse Changes | Images |
|---|---|--|
| Elantra (MD/UD) & Elantra Coupe (JK) | ABS1: 40A → 30A ABS2: 30A → 20A | |

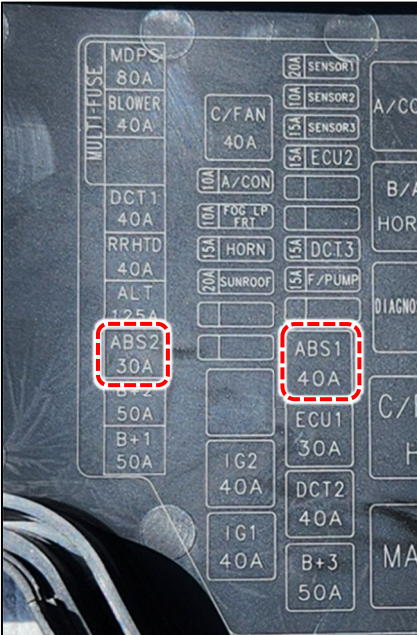
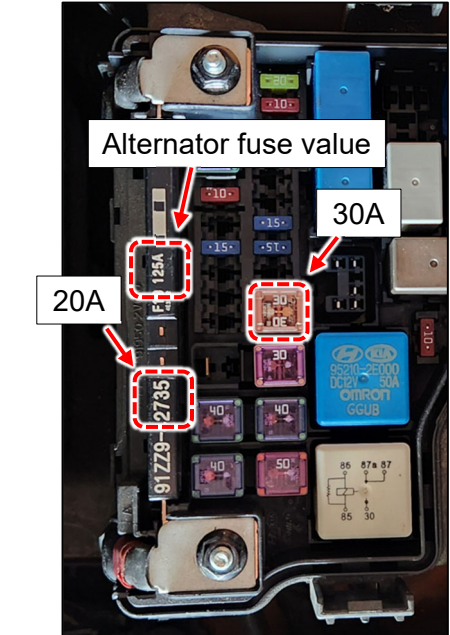
| <p>Veloster (FS)</p> | <p>ABS1: 40A → 30A ABS2: 30A → 20A</p> <p>Veloster Turbo uses a 150A alternator fuse</p> <p>Veloster Non-turbo uses a 125A alternator fuse</p> <p>The multi-fuse is labeled with the alternator fuse value</p> | | |
