GROUP	NUMBER
RECALL	24-01-027H
DATE	MODEL(S)
	SANTA FE SPORT (AN)
APRIL 2024	(AN) SONATA HYBRID

ANTI-LOCK BRAKING SYSTEM (ABS) FUSE REPLACEMENT (RECALL 251)

Description: Certain 2013MY Santa Fe Sport (AN) and 2011-2015MY Sonata Hybrid (YF HEV) vehicles may develop an electrical short in the Anti-Lock Brake System (ABS) module, increasing the risk of an engine compartment fire. Follow the procedures in the bulletin to replace either the ABS multifuse (on Santa Fe Sport/AN) or the two individual ABS single fuses depending on the model.

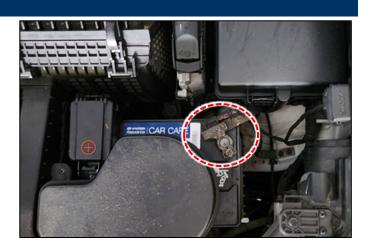
1. Record customer's radio presets, then disconnect the negative (–) battery terminal.

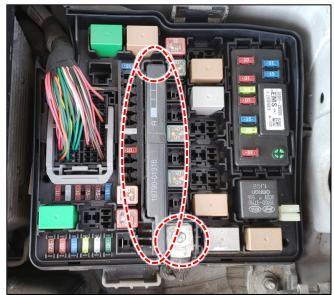
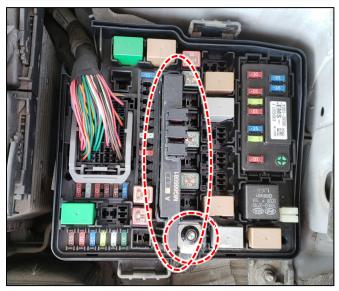
3. Remove the multi-fuse nut and junction box cable. Release the locking tab and remove the multi-fuse.

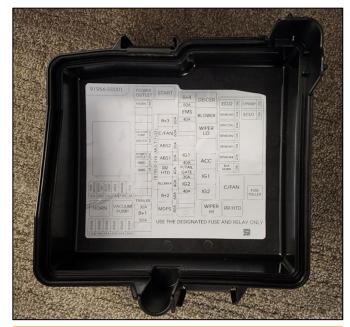
5. Clean the surface, then apply the supplied label to the new upper cover.

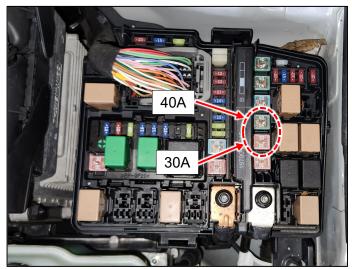
3. Locate the HECU fuses, 40A (ESC1) and 30A (ESC2). Remove the HECU fuses.

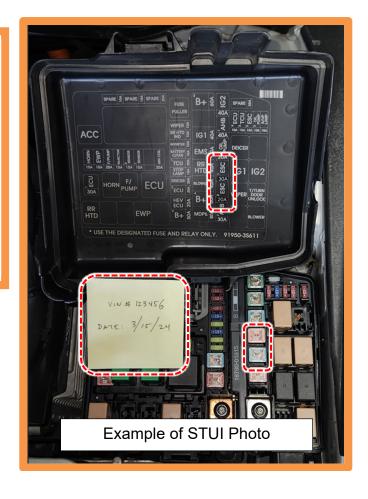
Using STUI, take one photo with the last 6 digits of the VIN and the date of repair on a piece of paper. Photo must show:

- New fuses installed in junction box
- Junction box cover with newly applied labels
