HYUNDAI
Technical Service Bulletin

GROUP RECALL	NUMBER 24-01-027H-2
DATE MAY 2024	MODEL(S) SEE APPLICABLE MODEL LIST

SUBJECT: ANTI-LOCK BRAKING SYSTEM (ABS) FUSE REPLACEMENT
 (RECALL 251)

This TSB supersedes TSB#24-01-027H-1 to add Accent (RB) and Santa Fe (NC) models.

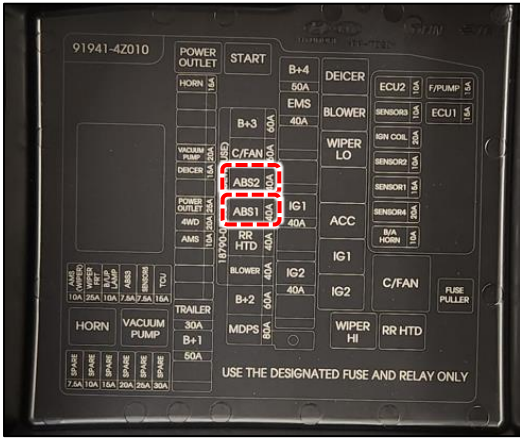
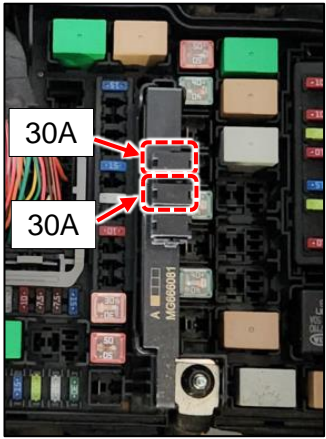
Model	Fuse Changes	Images	
<p>Santa Fe Sport (AN)</p>	<p>ABS1: 40A → 30A ABS2: 40A → 30A</p>

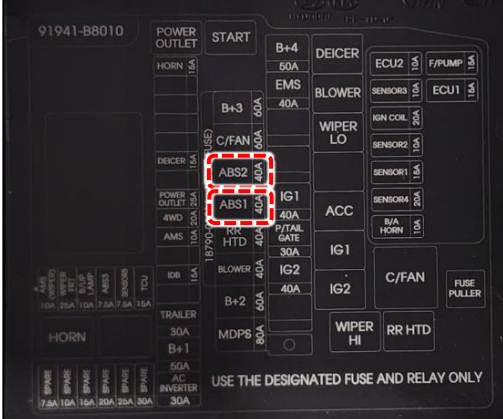
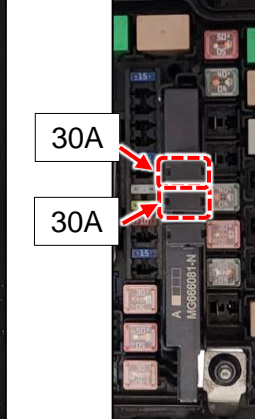
<p>Santa Fe (NC)</p>	<p>ABS1: 40A → 30A ABS2: 40A → 30A</p>

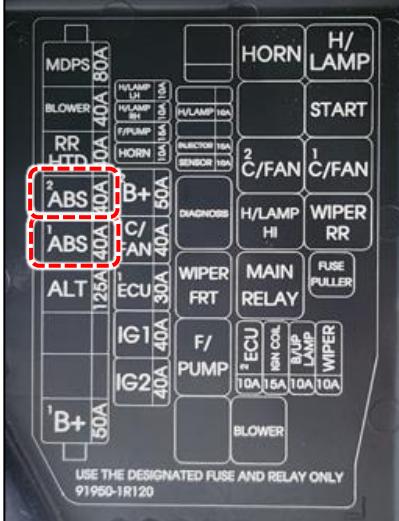
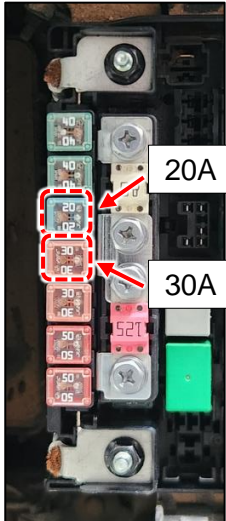
<p>Accent (RB)</p>	<p>ABS1: 40A → 20A ABS2: 40A → 30A</p>

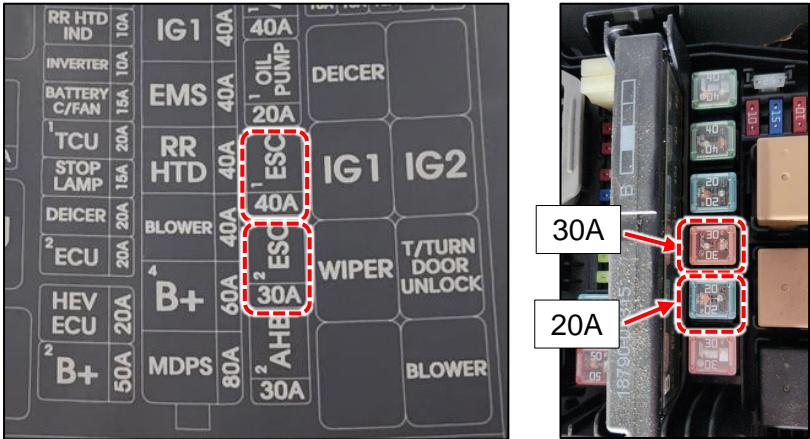
Model	Fuse Changes	Images
<p>Sonata Hybrid (YFE)</p>	<p>ESC1: 40A → 30A ESC2: 30A → 20A</p>

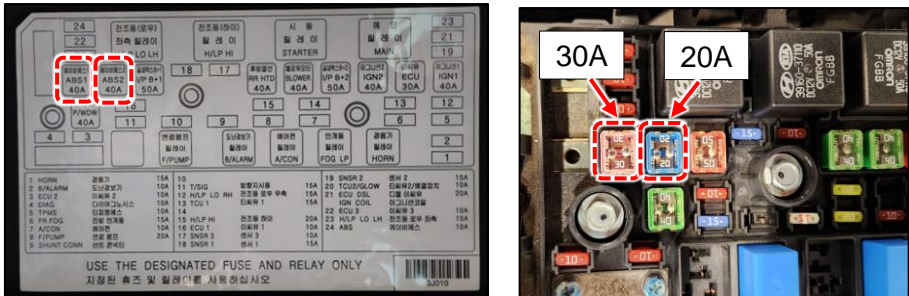
<p>Veracruz (EN)</p>	<p>ABS1: 40A → 30A ABS2: 40A → 20A</p>

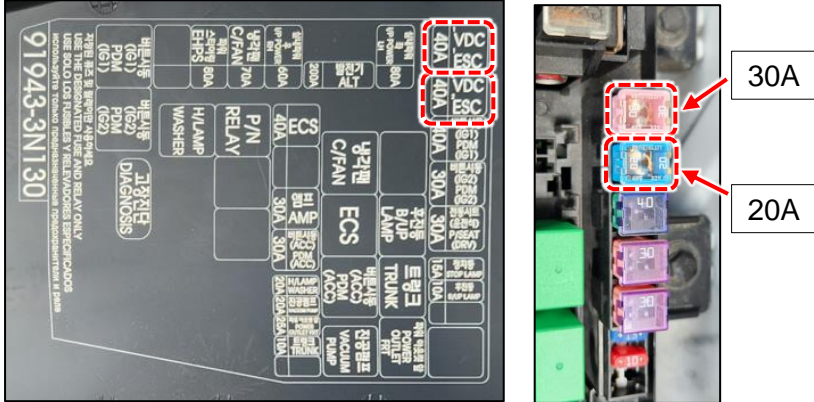
<p>Equus (VI)</p>	<p>ESC1: 40A → 30A ESC2: 40A → 20A</p>
