HYUNDAI
Technical Service Bulletin

GROUP RECALL	NUMBER 24-01-027H-4
DATE MAY 2024	MODEL(S) SEE APPLICABLE MODEL LIST

SUBJECT: ANTI-LOCK BRAKING SYSTEM (ABS) FUSE REPLACEMENT
 (RECALL 251)

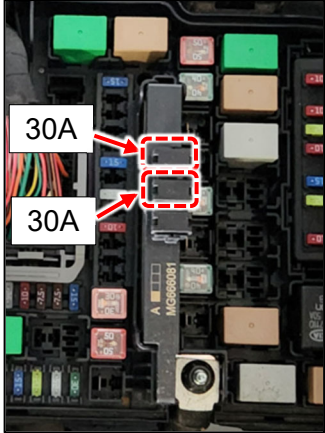
Model	Fuse Changes	Images	
<p>Santa Fe Sport (AN)</p>	<p>ABS1: 40A → 30A ABS2: 40A → 30A</p>

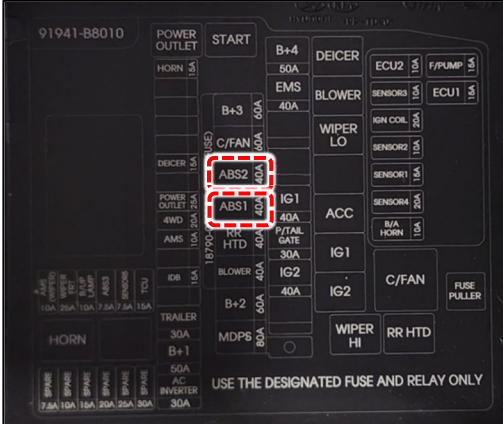
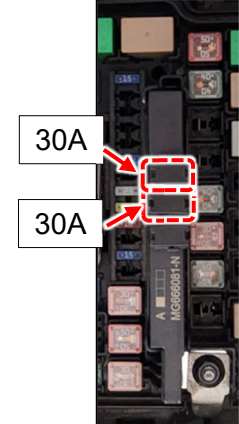
<p>Santa Fe (NC)</p>	<p>ABS1: 40A → 30A ABS2: 40A → 30A</p>

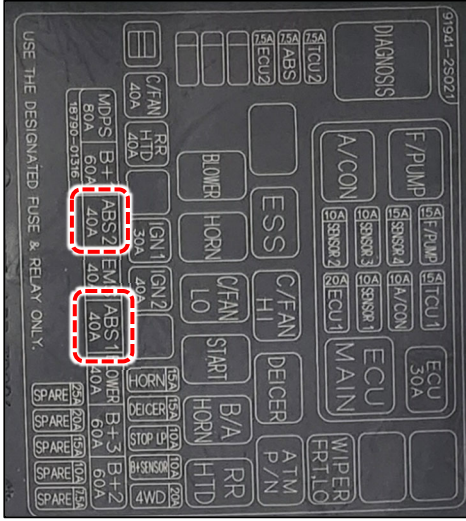
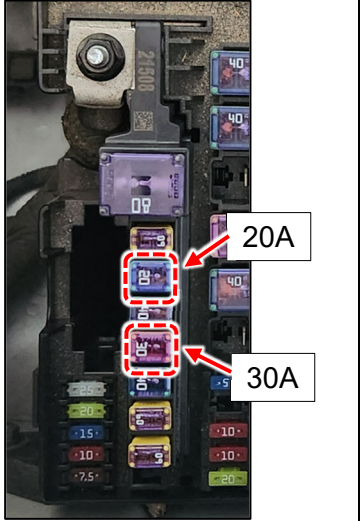
<p>Tucson (LM)</p>	<p>ABS1: 40A → 30A ABS2: 40A → 20A</p>

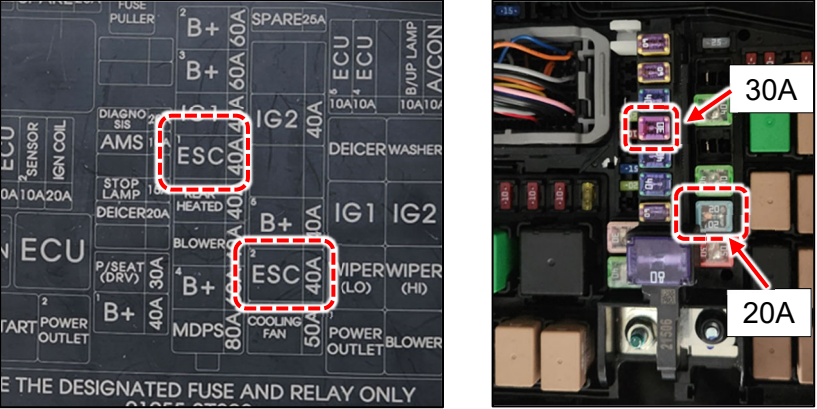
Model	Fuse Changes	Images
Azera (HG)	ESC1: 40A → 30A ESC2: 40A → 20A

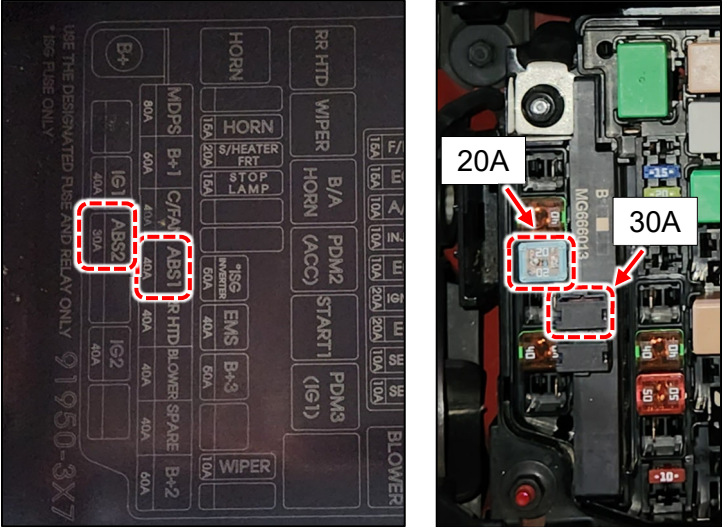
Elantra (MD/UD) & Elantra Coupe (JK)	ABS1: 40A → 30A ABS2: 30A → 20A
