**HYUNDAI**  
**Technical Service Bulletin**

GROUP <b>RECALL</b>	NUMBER <b>24-01-027H-7</b>
DATE <b>JUNE 2024</b>	MODEL(S) <b>SEE APPLICABLE MODEL LIST</b>

**SUBJECT:** ANTI-LOCK BRAKING SYSTEM (ABS) FUSE REPLACEMENT  
 (RECALL 251)

This TSB supersedes TSB#24-01-027H-6 to add 2011-2015MY Genesis Coupe (BK).

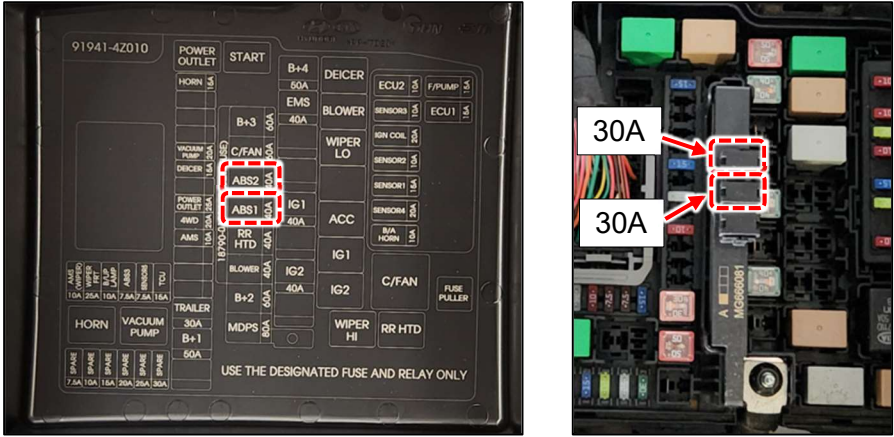
Model	Fuse Changes	Images
<p>Santa Fe Sport (AN)</p>	<p>ABS1: 40A → 30A ABS2: 40A → 30A</p>

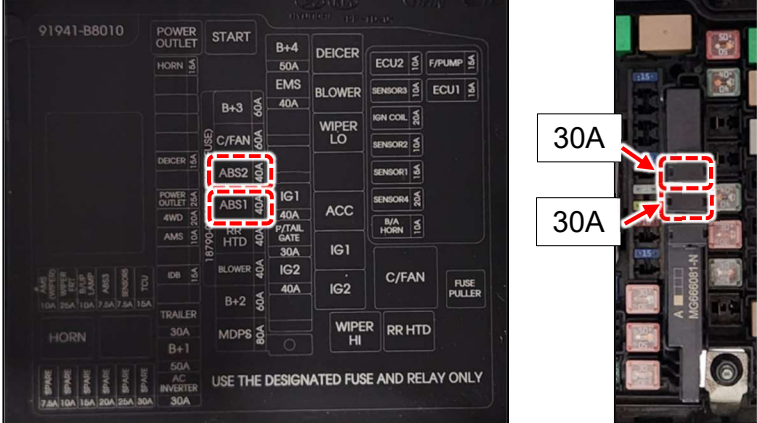
<p>Santa Fe (NC)</p>	<p>ABS1: 40A → 30A ABS2: 40A → 30A</p>

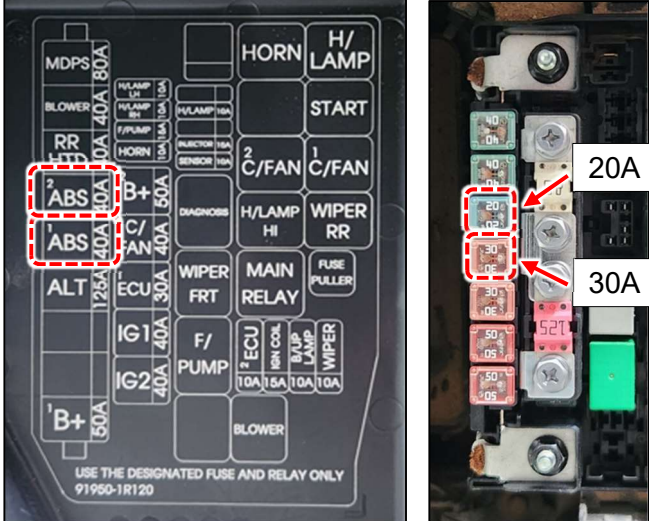
<p>Accent (RB)</p>	<p>ABS1: 40A → 30A ABS2: 40A → 20A</p>

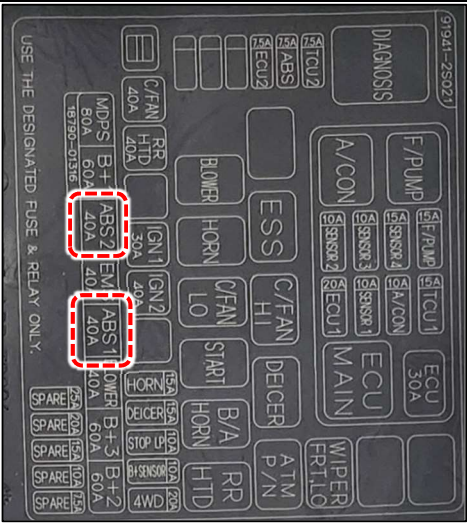
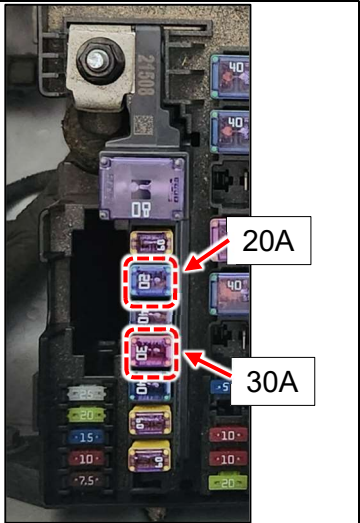
<p>Tucson (LM)</p>	<p>ABS1: 40A → 30A ABS2: 40A → 20A</p>

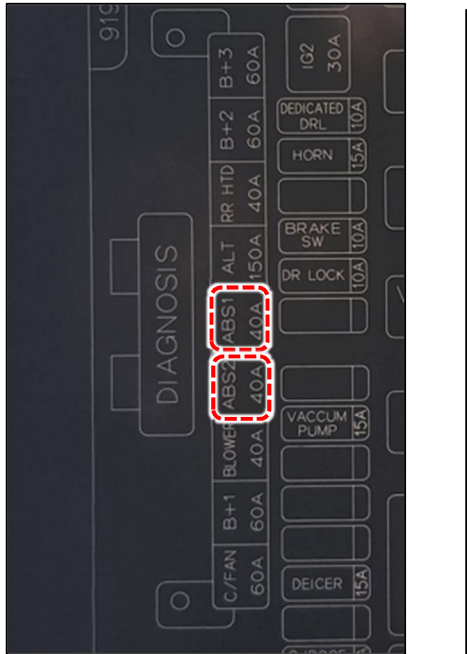
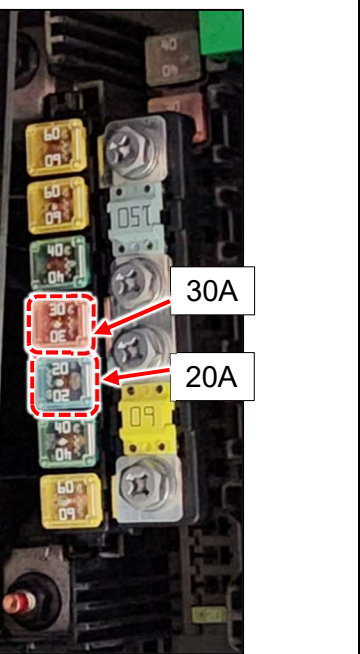
<p>Genesis Coupe (BK)</p>	<p>ABS1: 40A → 30A ABS2: 40A → 20A</p>

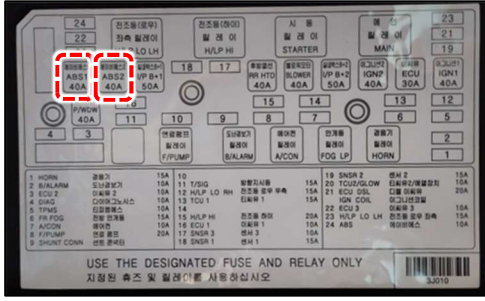
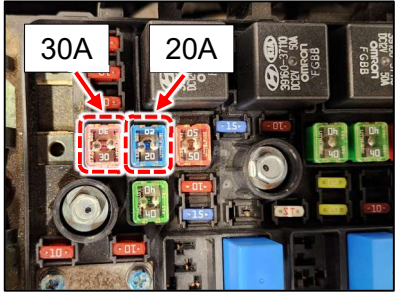
<p>Veracruz (EN)</p>	<p>ABS1: 40A → 30A ABS2: 40A → 20A</p>

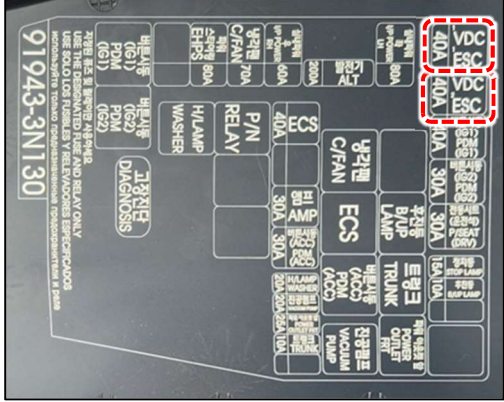
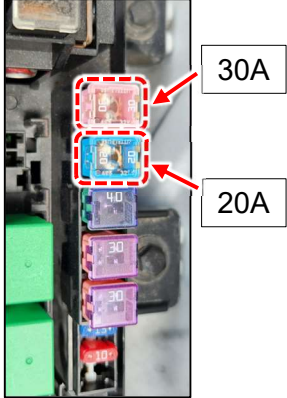
<p>Equus (VI)</p>	<p>ESC1: 40A → 30A ESC2: 40A → 20A</p>

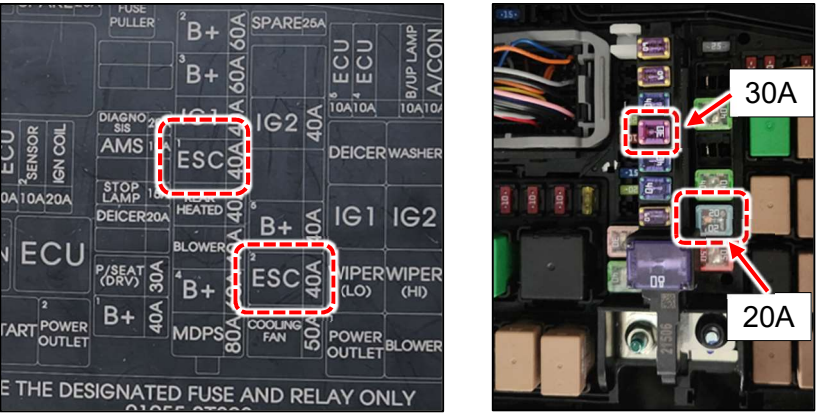
Model	Fuse Changes	Images
Azera (HG)	ESC1: 40A → 30A ESC2: 40A → 20A

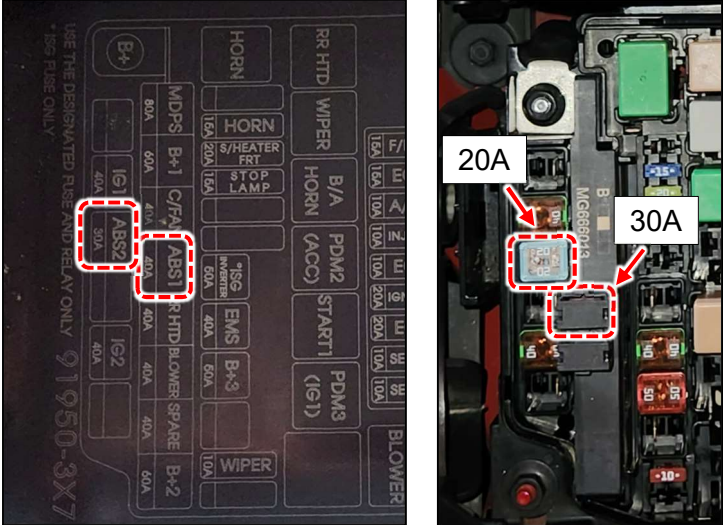
Elantra (MD/UD) & Elantra Coupe (JK)	ABS1: 40A → 30A ABS2: 30A → 20A
