HYUNDAI
Technical Service Bulletin

GROUP	NUMBER
RECALL	24-01-027H-8
DATE	MODEL(S)
JULY 2024	SEE APPLICABLE MODEL LIST

SUBJECT: ANTI-LOCK BRAKING SYSTEM (ABS) FUSE REPLACEMENT (RECALL 251)

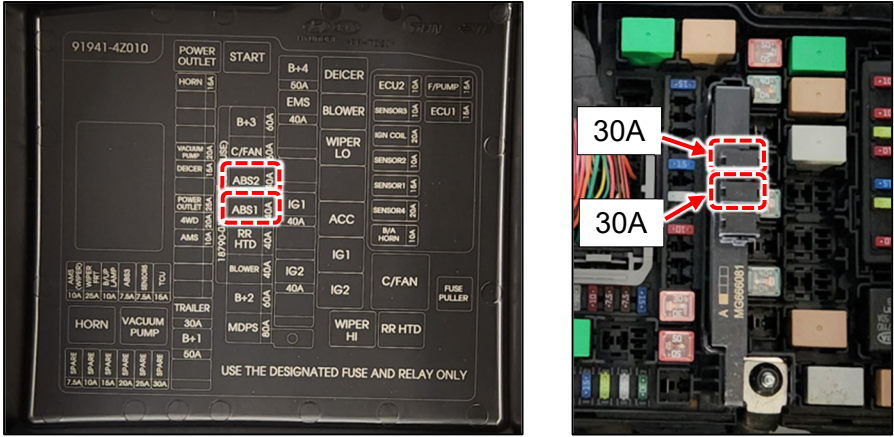
Model	Fuse Changes	Images
<p>Santa Fe Sport (AN)</p>	<p>ABS1: 40A → 30A ABS2: 40A → 30A</p>

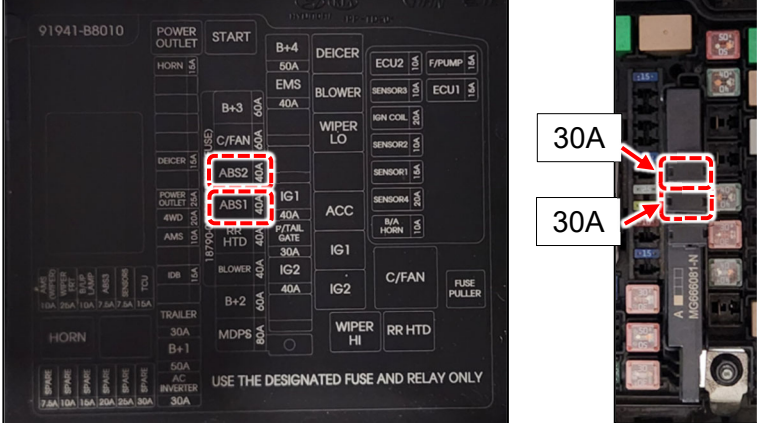
<p>Santa Fe (NC)</p>	<p>ABS1: 40A → 30A ABS2: 40A → 30A</p>

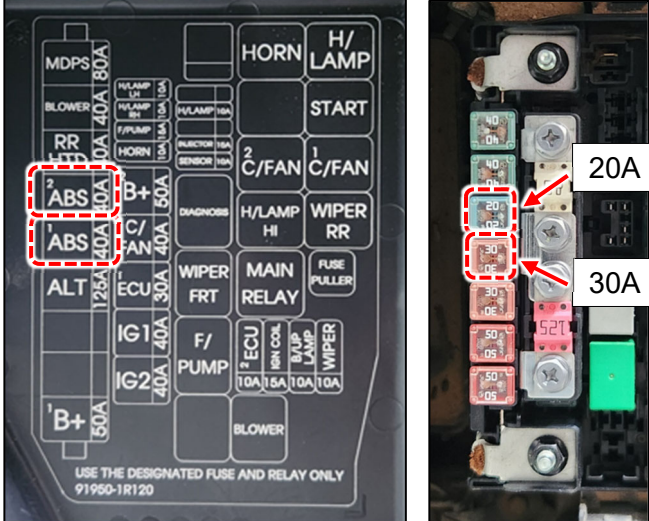
<p>Accent (RB)</p>	<p>ABS1: 40A → 30A ABS2: 40A → 20A</p>

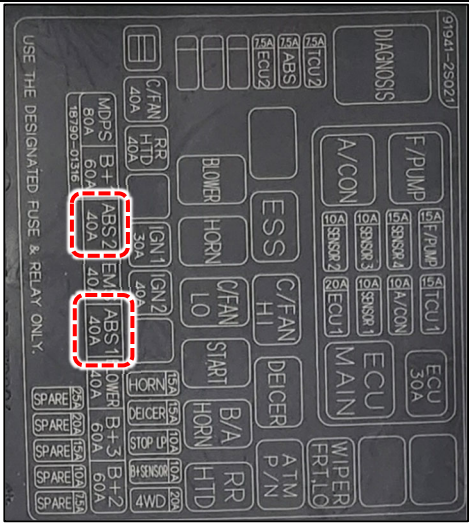
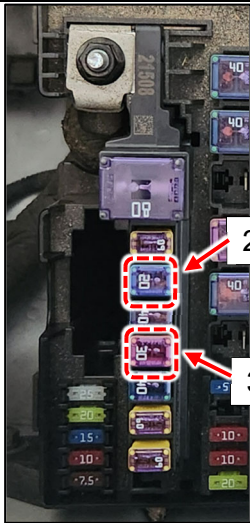
<p>Tucson (LM)</p>	<p>ABS1: 40A → 30A ABS2: 40A → 20A</p>

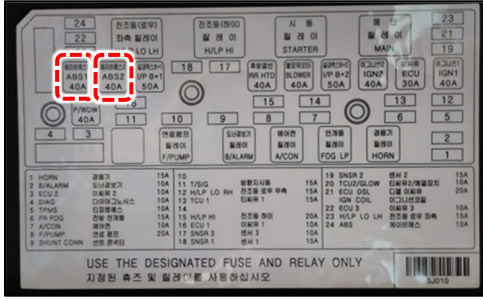
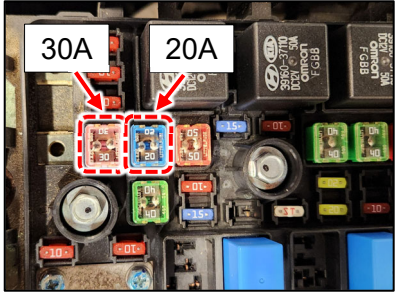
<p>Veracruz (EN)</p>	<p>ABS1: 40A → 30A ABS2: 40A → 20A</p>

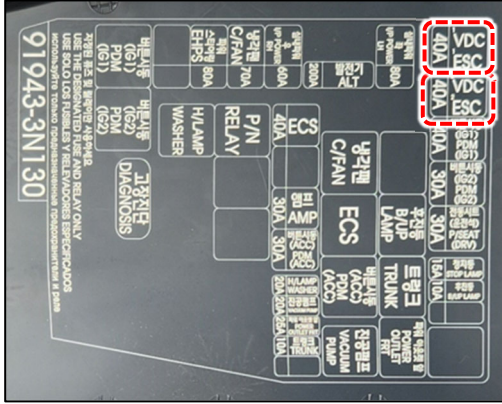
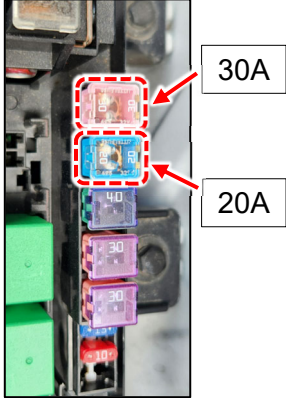
<p>Equus (VI)</p>	<p>ESC1: 40A → 30A ESC2: 40A → 20A</p>

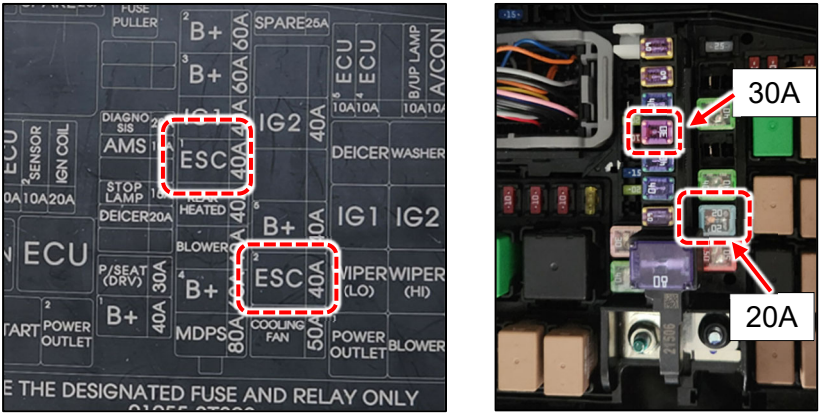
Model	Fuse Changes	Images
Azera (HG)	ESC1: 40A → 30A ESC2: 40A → 20A

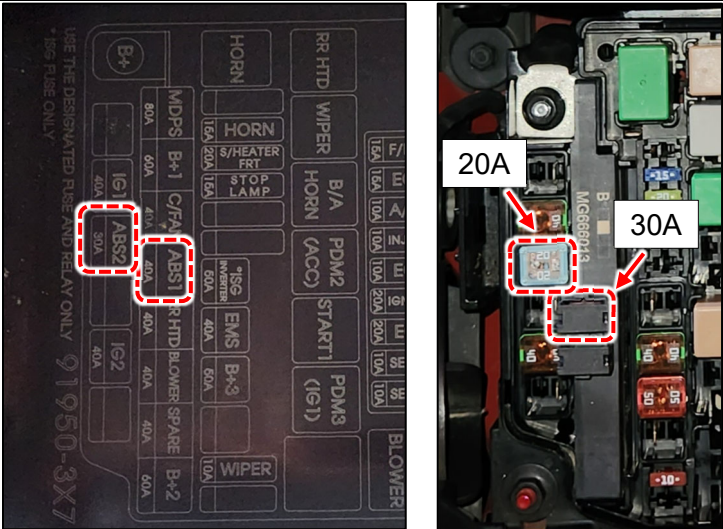
Elantra (MD/UD) & Elantra Coupe (JK)	ABS1: 40A → 30A ABS2: 30A → 20A

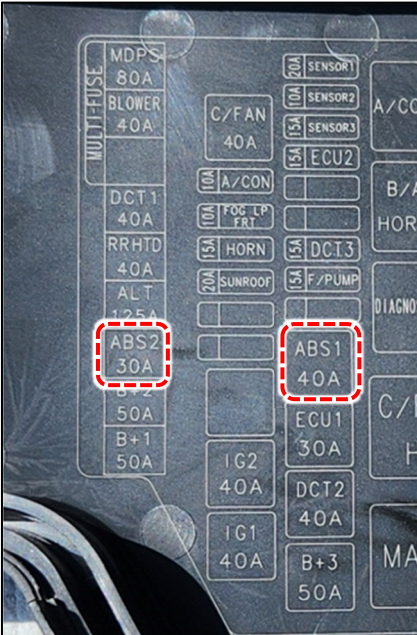
<p>Veloster (FS)</p>	<p>ABS1: 40A → 30A ABS2: 30A → 20A</p> <p>Veloster Turbo uses a 150A alternator fuse</p> <p>Veloster Non-turbo uses a 125A alternator fuse</p> <p>The multi-fuse is labeled with the alternator fuse value</p>
