HYUNDAI
Technical Service Bulletin

GROUP RECALL	NUMBER 24-01-027H-6
DATE JUNE 2024	MODEL(S) SEE APPLICABLE MODEL LIST

SUBJECT: ANTI-LOCK BRAKING SYSTEM (ABS) FUSE REPLACEMENT
 (RECALL 251)

This TSB supersedes TSB#24-01-027H-5 to add 2012-2015MY Veloster (FS).

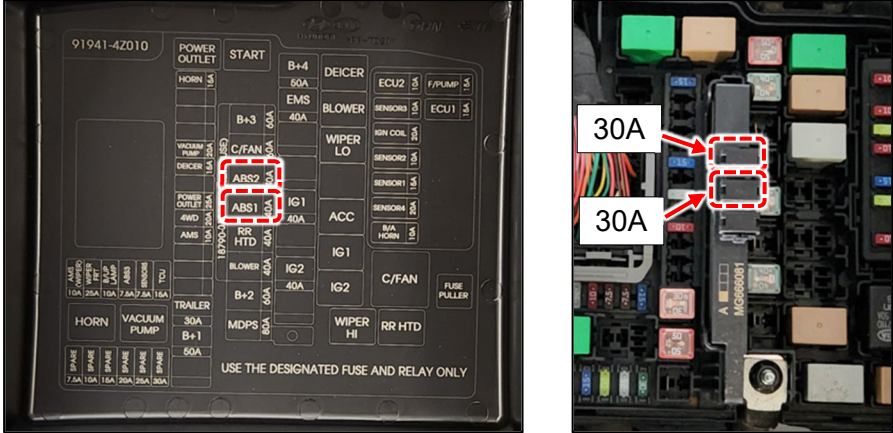
Model	Fuse Changes	Images
<p>Santa Fe Sport (AN)</p>	<p>ABS1: 40A → 30A ABS2: 40A → 30A</p>

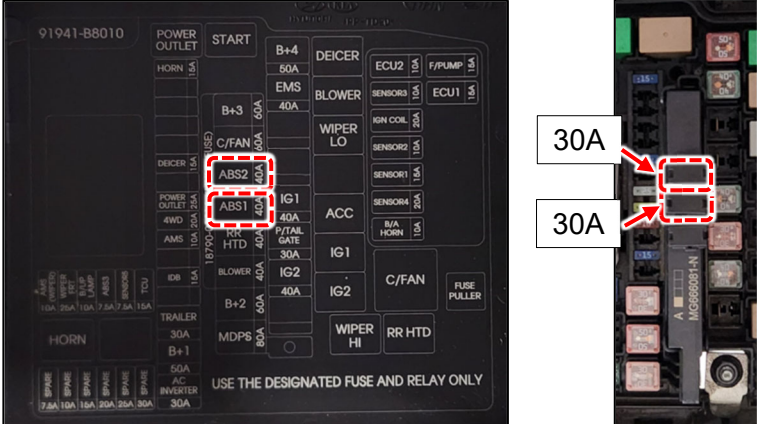
<p>Santa Fe (NC)</p>	<p>ABS1: 40A → 30A ABS2: 40A → 30A</p>

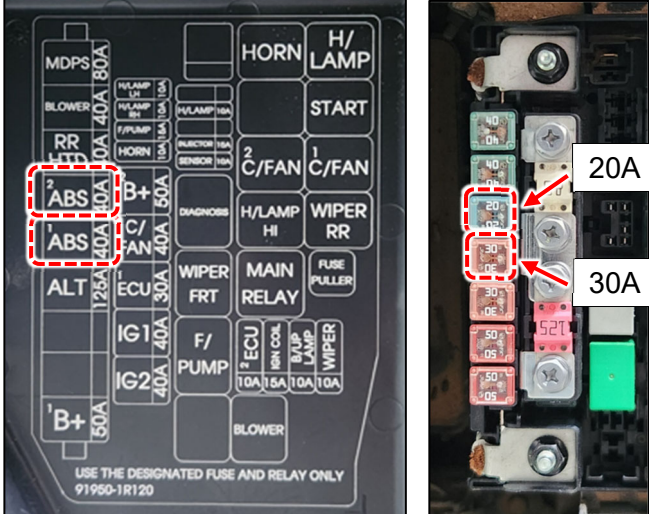
<p>Accent (RB)</p>	<p>ABS1: 40A → 30A ABS2: 40A → 20A</p>

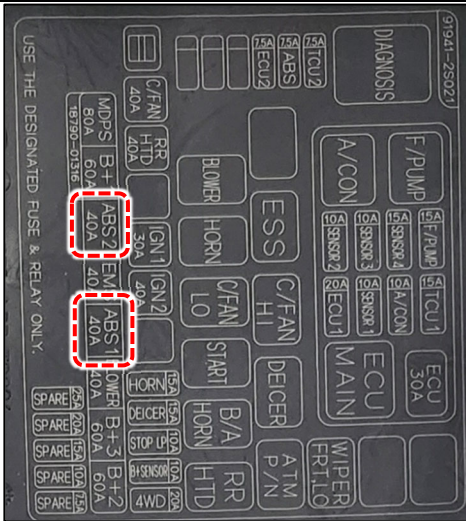
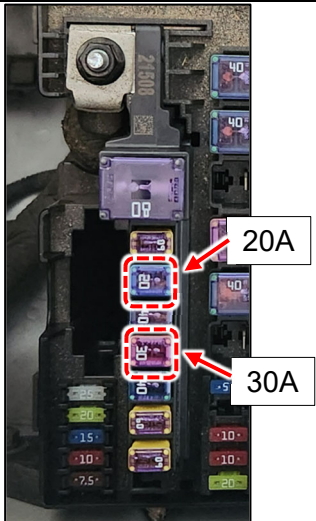
<p>Tucson (LM)</p>	<p>ABS1: 40A → 30A ABS2: 40A → 20A</p>

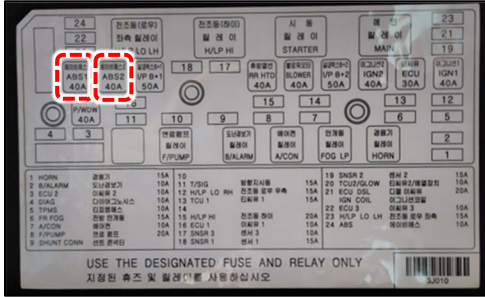
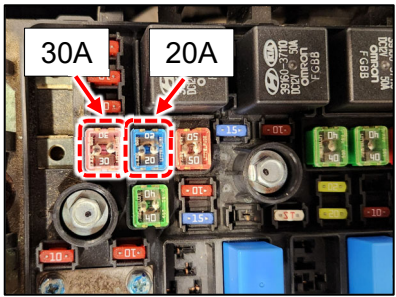
<p>Veracruz (EN)</p>	<p>ABS1: 40A → 30A ABS2: 40A → 20A</p>

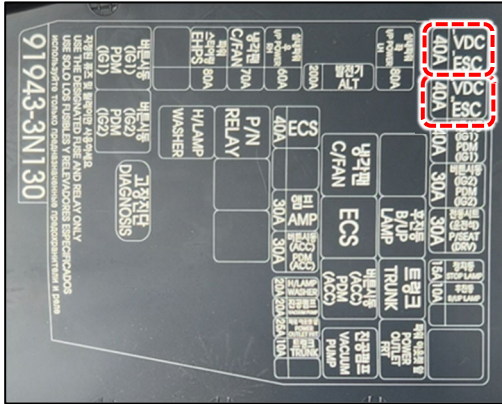
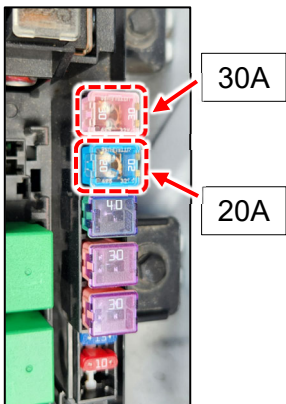
<p>Equus (VI)</p>	<p>ESC1: 40A → 30A ESC2: 40A → 20A</p>

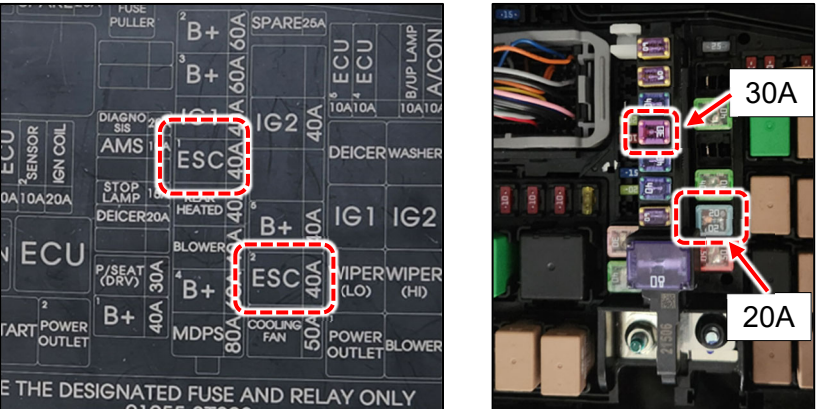
Model	Fuse Changes	Images
Azera (HG)	ESC1: 40A → 30A ESC2: 40A → 20A

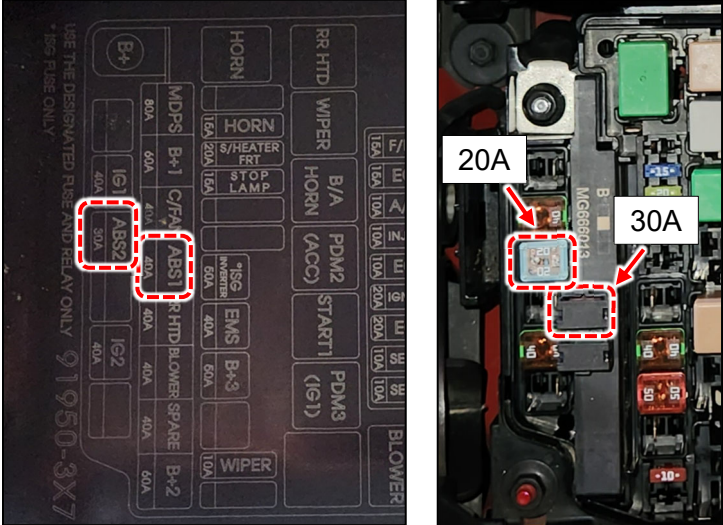
Elantra (MD/UD) & Elantra Coupe (JK)	ABS1: 40A → 30A ABS2: 30A → 20A

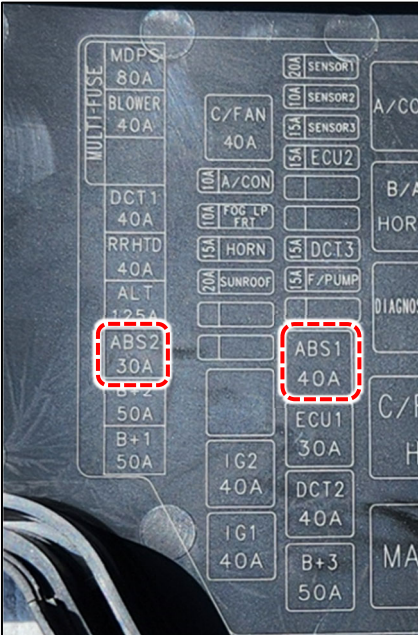
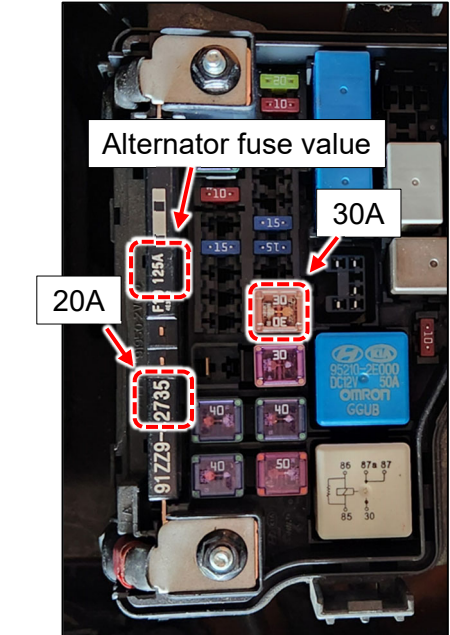
<p>Veloster (FS)</p>	<p>ABS1: 40A → 30A ABS2: 30A → 20A</p> <p>Veloster Turbo uses a 150A alternator fuse</p> <p>Veloster Non-Turbo uses a 125A alternator fuse</p> <p>The multi-fuse is labeled with the alternator fuse value</p>
