| Safety Recall Campaign | 2011-2015MY Optima (TF) |
| SC284TF (Rev 1, 5/31/2024) | May 2024 |

HECU MULTI FUSE REPLACEMENT (SC284TF)

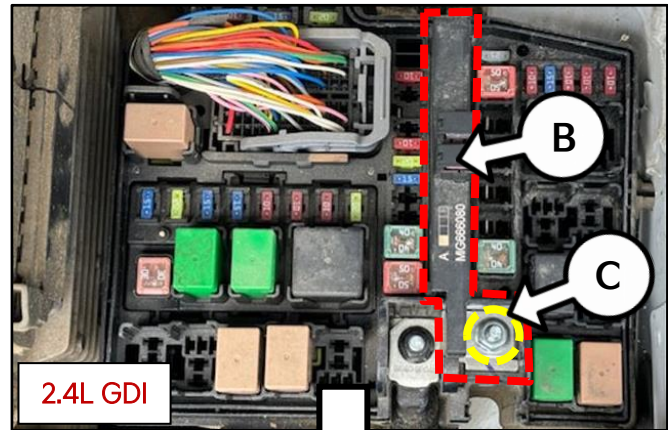
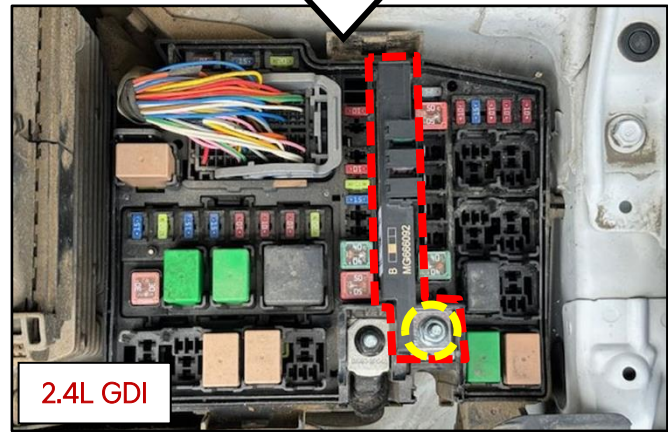
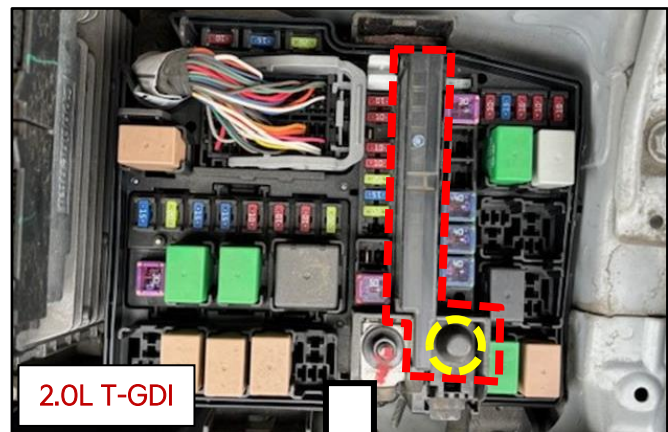
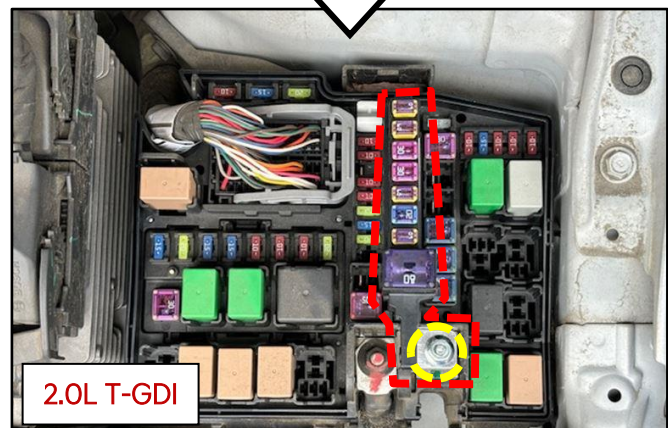
Note: The Multi Fuse designs differ between 2.4L GDI and 2.0L T-GDI vehicles.

- 5a. Locate the Multi Fuse (B) for ABS1 and loosen the 10mm Multi Fuse retaining nut (C) and remove the Multi Fuse.
- 5b. Install the **new** Multi Fuse (B) and tighten the retaining nut (C).

Tightening torque for retaining nut (B):
7.2 - 8.7 lb.ft (9.8 - 11.8 N.m)

Note: Drill a hole through the center of the removed Multi Fuse. DO NOT reuse.
