| GROUP | MODEL |
|---|---|
| Safety Recall Campaign | 2012-2013MY Optima (QF) |
| SC284QF | April 2024 |

HECU MULTI FUSE REPLACEMENT (SC284QF)

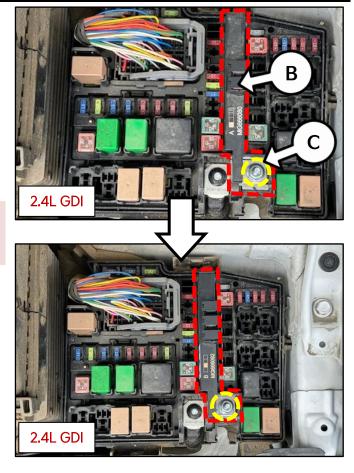
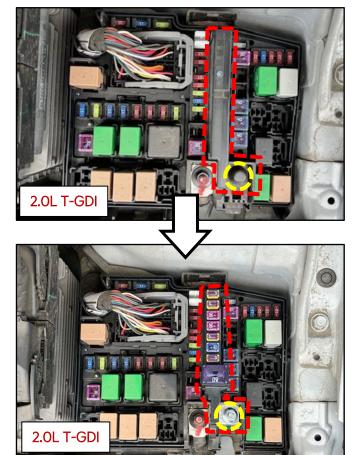
Note: The Multi Fuse designs differ between 2.4L GDI and 2.0L T-GDI vehicles.

- 5a. Locate the Multi Fuse (B) for ABS1 and loosen the 10mm Multi Fuse retaining nut (C) and remove the Multi Fuse.
- 5b. Install the <u>new</u> Multi Fuse (B) and tighten the retaining nut (C).

Note: Drill a hole through the center of the removed Multi Fuse. DO NOT reuse.
