GROUP	MODEL
Safety Recall Campaign	2011-2015MY Optima (TF)
NUMBER	DATE
SC284TF (Rev 2, 9/19/2024)	May 2024

HECU MULTI FUSE REPLACEMENT (SC284TF)

This bulletin provides information to replace the multi fuse of the Hydraulic Electronic Control Unit (HECU) and junction box fuse cover and install an updated junction box label on certain 2011-2015MY Optima (TF) vehicles produced from August 12, 2010 to July 23, 2015. An engine compartment fire may occur in the area where the HECU is located. The HECU may experience an internal electrical short circuit condition that can result in overcurrent, thereby increasing the risk of an engine compartment fire while the vehicle is driven or while parked. Dealers are to install new fuses to prevent an electrical short circuit condition in the HECU's electrical circuit board. Customers may experience Illumination of the Malfunction Indicator Lamp (MIL), ABS warning light, burning/melting smell, and/or smoke from the engine compartment. Follow the procedure outlined in this publication to install a new multi fuse, junction box fuse cover and label on the applicable vehicle. Before conducting the procedure, verify that the vehicle is included in the

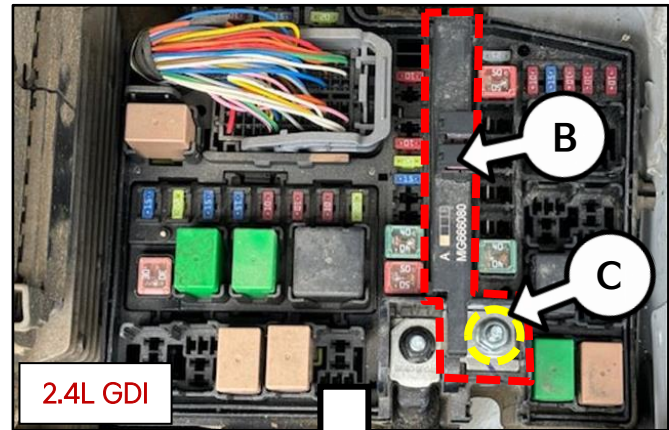
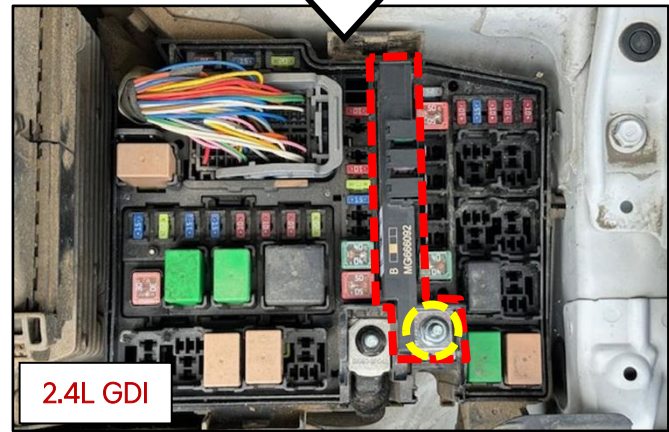
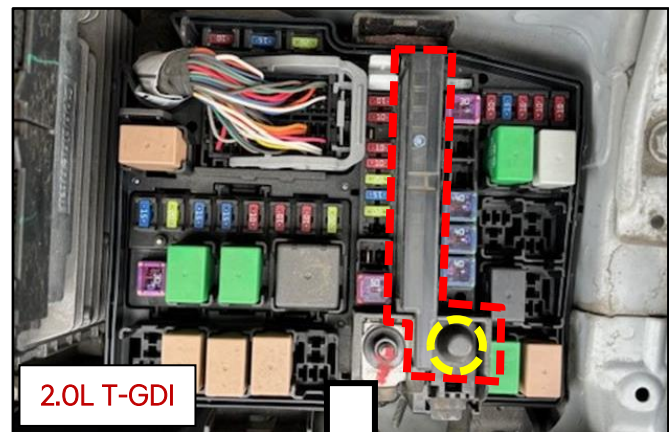
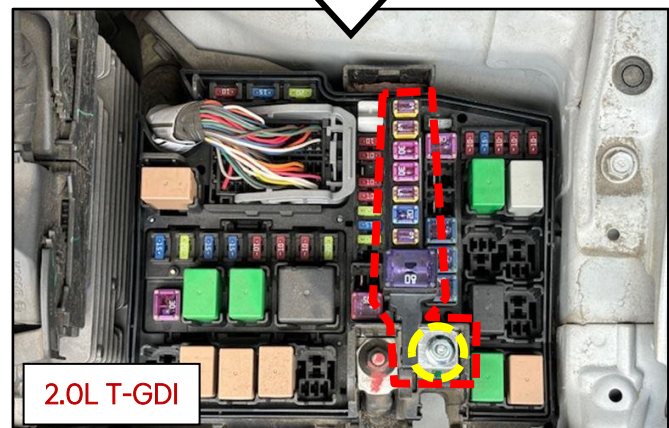
Note: The Multi Fuse designs differ between 2.4L GDI and 2.0L T-GDI vehicles.

- 5a. Locate the Multi Fuse (B) for ABS1 and loosen the 10mm Multi Fuse retaining nut (C) and remove the Multi Fuse.
- 5b. Install the **new** Multi Fuse (B) and tighten the retaining nut (C).

Tightening torque for retaining nut (B):
7.2 - 8.7 lb.ft (9.8 - 11.8 N.m)

Note: Drill a hole through the center of the removed Multi Fuse. DO NOT reuse.
