GROUP	MODEL
Safety Recall Campaign	2011-2013MY Soul (AM)
NUMBER	DATE
SC284AM	June 2024

SAFETY RECALL CAMPAIGN

HECU MULTI FUSE REPLACEMENT (SC284AM)

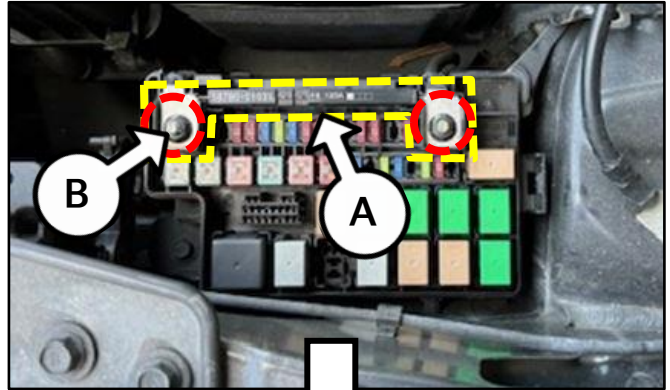
This bulletin provides information to replace the multi fuse of the Hydraulic Electronic Control Unit (HECU) and install an updated junction box label on certain 2011-2013MY Soul (AM) vehicles produced from June 9, 2010 through October 2, 2013. An engine compartment fire may occur in the area where the HECU is located. The HECU may experience an internal electrical short circuit condition that can result in overcurrent, thereby increasing the risk of an engine compartment fire while the vehicle is driven or while parked. Dealers are to install new fuses to prevent an electrical short circuit condition in the HECU's electrical circuit board. Customers may experience illumination of the Malfunction Indicator Lamp (MIL), ABS warning light, burning/melting smell, and/or smoke from the engine compartment. Follow the procedure outlined in this publication to install a new multi fuse and junction box cover label on the applicable vehicle. Before conducting the procedure, verify that the vehicle is included in the list of affected VINs.

- 4a. Locate the Multi Fuse (A) for ABS1 and ABS2 loosen the two (2) 10mm Multi Fuse retaining nuts (B) and remove the Multi Fuse.
