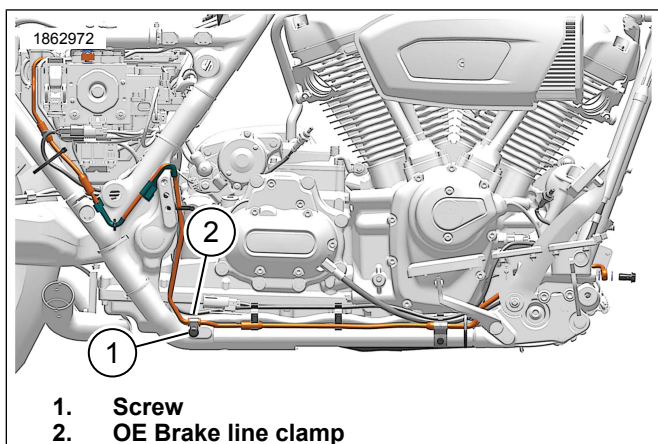
Figure 1. Rear Master Cylinder Brake Line (exhaust removed for clarity)

3. See Figure 1. Remove and retain screw (1).
4. Remove and discard Original Equipment (OE) brake line clamp (2).
5. See Figure 2. Install **new** P-Clamp (3) from recall kit (Part No. 91500116).
 - a. Make sure P-Clamp (3) is properly orientated.
6. Install screw (1). Tighten.
Torque: 9–11 N·m (80–97 **in-lbs**)

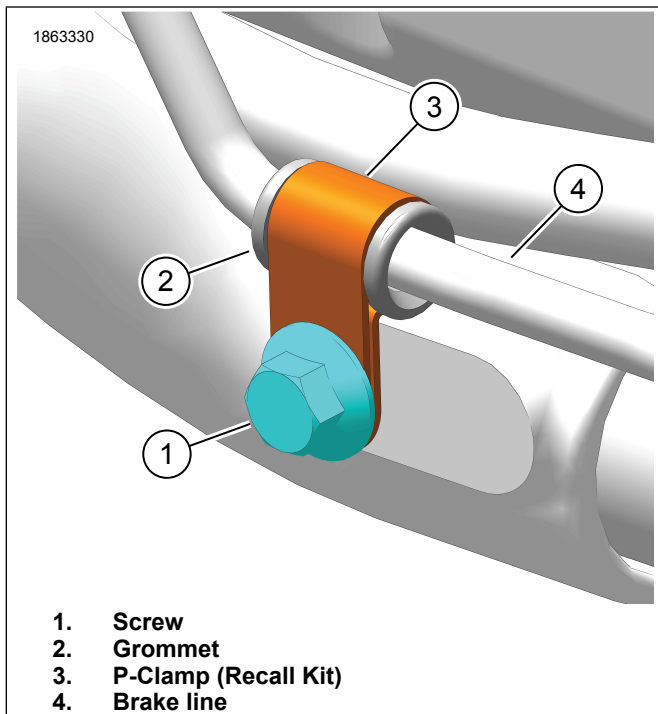
Figure 2. P-Clamp Orientation
