# Safety Recall

## N232408494 Both Roof Rail Airbag Inflators May Rupture

**Release Date:** April 2025

**Revision:** 02

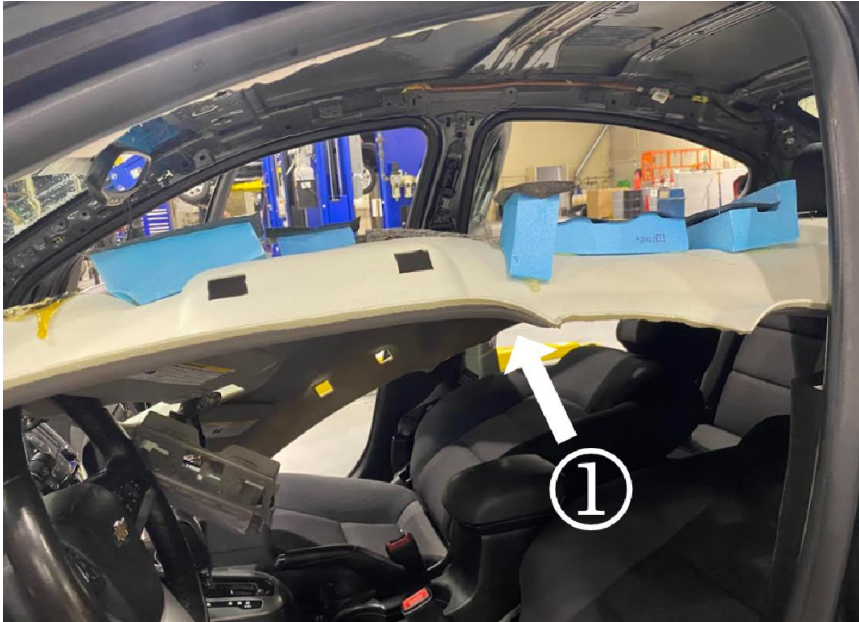
**Note:** The Headlining Trim Panel only needs to be lowered NOT removed. DO NOT remove the seats as the SI document states. Seat removal is ONLY for headliner removal NOT headliner lowering.

3. Lower the Headlining Trim Panel onto the headrests of the seats (1) as shown above. Refer to *Headlining Trim Panel Replacement* in SI.
4. Remove and replace BOTH the Left Hand and Right Hand Roof Side Rail Airbags. Refer to *Roof Side Rail Airbag Replacement* in SI.
5. Reinstall the Headlining Trim Panel. Refer to Refer to *Headlining Trim Panel Replacement* in SI.
6. Enable the SIR system. Refer to *SIR Disabling and Enabling* in SI.
7. Return the Front Seats to their original location.
8. Return the used RRAB following the return instructions at the top of this bulletin.
