Safety Recall

N232408491 Left Roof Rail Airbag Inflator May Rupture

Release Date: June 2024

Condition	General Motors has decided that a defect which relates to motor vehicle safety exists in certain 2014 model year Buick Verano and Chevrolet Cruze vehicles. In these vehicles, the left and/or right side roof-rail airbag ("RRAB") inflators, which are located on the roof rails above the headliner, may contain a manufacturing defect that may result in rupture at the inflator weld joint. If the RRAB inflator ruptures at the weld joint, the compressed gas will escape, causing a partial inflation of the RRAB where one or more sections of the inflator may enter or exit the vehicle. This may potentially cause injury if a person is in or around the vehicle during the event.
Correction	Dealers will replace suspect left side RRAB modules.

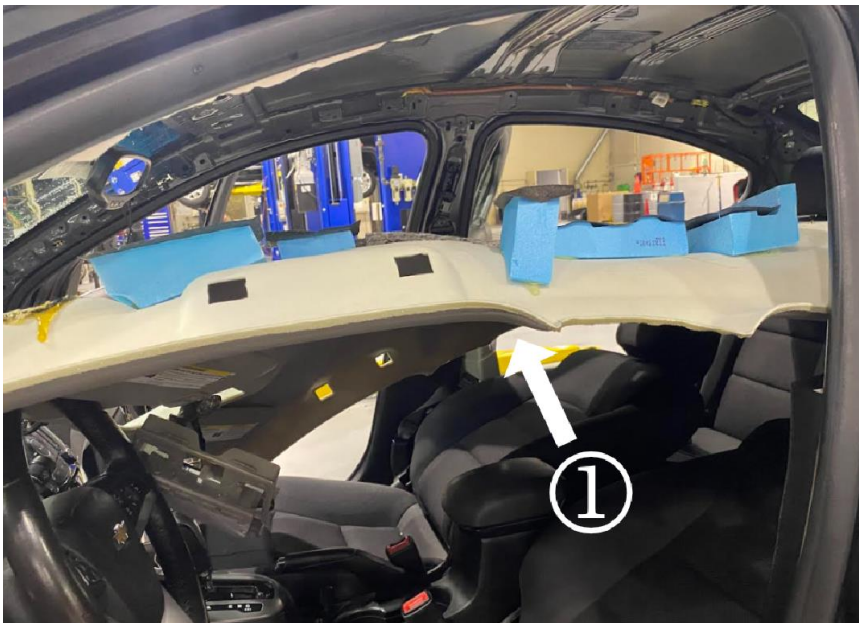
6449517

Note: The Headlining Trim Panel only needs to be lowered NOT removed. DO NOT remove the seats as the SI document states. Seat removal is ONLY for headliner removal NOT headliner lowering.

3. Lower the Headlining Trim Panel onto the headrests of the seats (1) as shown above. Refer to *Headlining Trim Panel Replacement* in SI.
4. Remove and replace the Left Hand Roof Side Rail Airbag. Refer to *Roof Side Rail Airbag Replacement* in SI.
5. Reinstall the Headlining Trim Panel. Refer to *Headlining Trim Panel Replacement* in SI.
6. Enable the SIR system. Refer to *SIR Disabling and Enabling* in SI.
