Safety Recall

N232408492 Right Roof Rail Airbag Inflator May Rupture

Release Date: June 2024

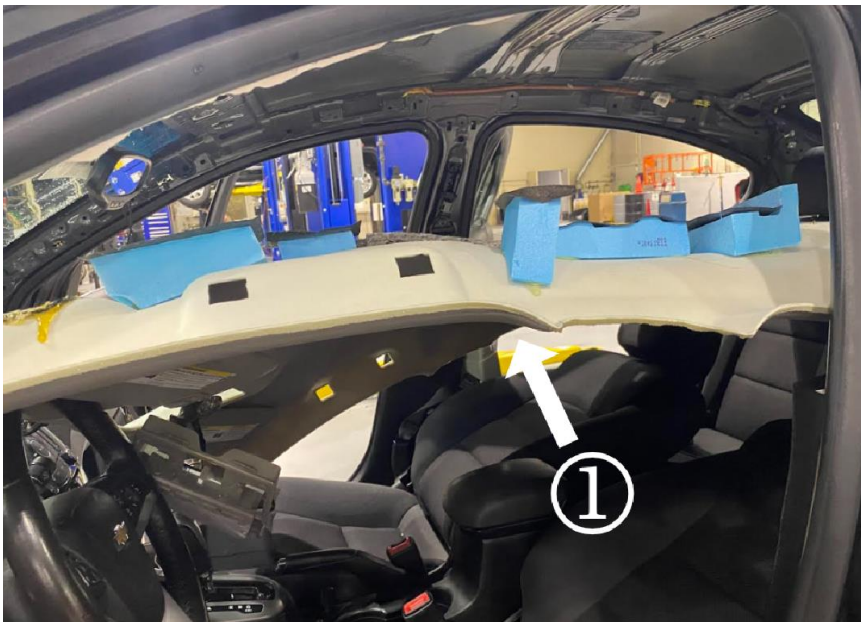
Note: The Headlining Trim Panel only needs to be lowered NOT removed. DO NOT remove the seats as the SI document states. Seat removal is ONLY for headliner removal NOT headliner lowering.

Note: Left side shown, right side similar.

3. Lower the Headlining Trim Panel onto the headrests of the seats (1) as shown above. Refer to *Headlining Trim Panel Replacement* in SI.
4. Remove and replace the Right Hand Roof Side Rail Airbag. Refer to *Roof Side Rail Airbag Replacement* in SI.
5. Reinstall the Headlining Trim Panel. Refer to Refer to *Headlining Trim Panel Replacement* in SI.
6. Enable the SIR system. Refer to *SIR Disabling and Enabling* in SI.
7. Return the Front Seats to their original location.
