Safety Recall

N232408492 Right Roof Rail Airbag Inflator May Rupture

Release Date: September 2024

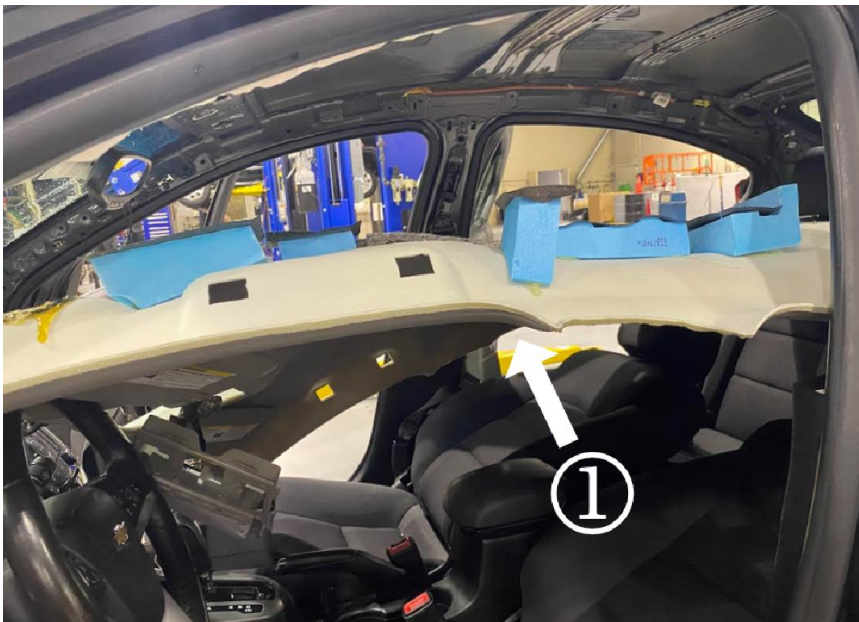
6449517

Note: The Headlining Trim Panel only needs to be lowered NOT removed. DO NOT remove the seats as the SI document states. Seat removal is ONLY for headliner removal NOT headliner lowering.

Note: Left side shown, right side similar.

3. Lower the Headlining Trim Panel onto the headrests of the seats (1) as shown above. Refer to *Headlining Trim Panel Replacement* in SI.
4. Remove and replace the Right Hand Roof Side Rail Airbag. Refer to *Roof Side Rail Airbag Replacement* in SI.
5. Reinstall the Headlining Trim Panel. Refer to *Headlining Trim Panel Replacement* in SI.
6. Enable the SIR system. Refer to *SIR Disabling and Enabling* in SI.
7. Return the Front Seats to their original location.
