# Safety Recall

## N232408490 Both Roof Rail Airbag Inflators May Rupture

**Release Date:** September 2024

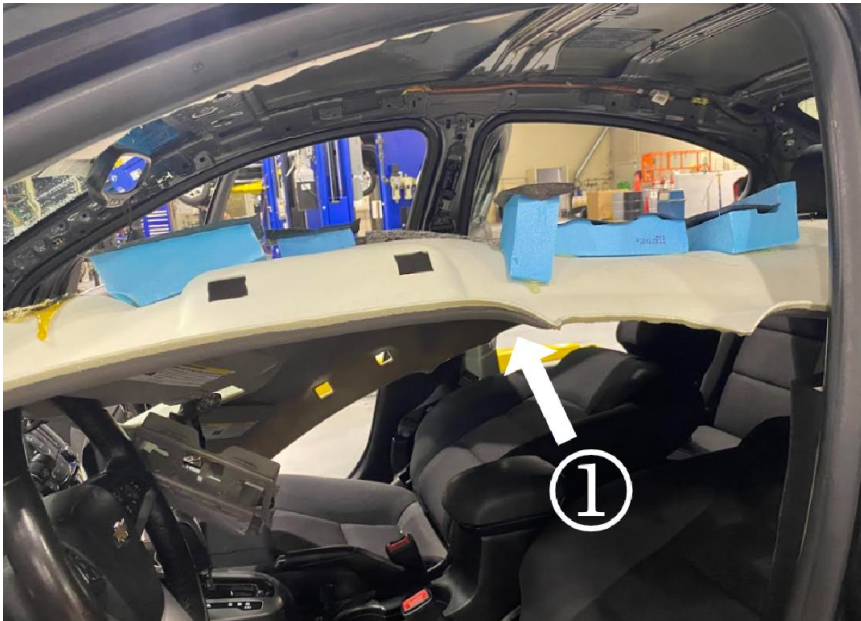
**Note:** The Headlining Trim Panel only needs to be lowered NOT removed. DO NOT remove the seats as the SI document states. Seat removal is ONLY for headliner removal NOT headliner lowering.

3. Lower the Headlining Trim Panel onto the headrests of the seats (1) as shown above. Refer to *Headlining Trim Panel Replacement* in SI.
4. Remove and replace BOTH the Left Hand and Right Hand Roof Side Rail Airbags. Refer to *Roof Side Rail Airbag Replacement* in SI.
5. Reinstall the Headlining Trim Panel. Refer to *Headlining Trim Panel Replacement* in SI.
6. Enable the SIR system. Refer to *SIR Disabling and Enabling* in SI.
