# Safety Recall

## N232408494 Both Roof Rail Airbag Inflators May Rupture

**Release Date:** September 2024

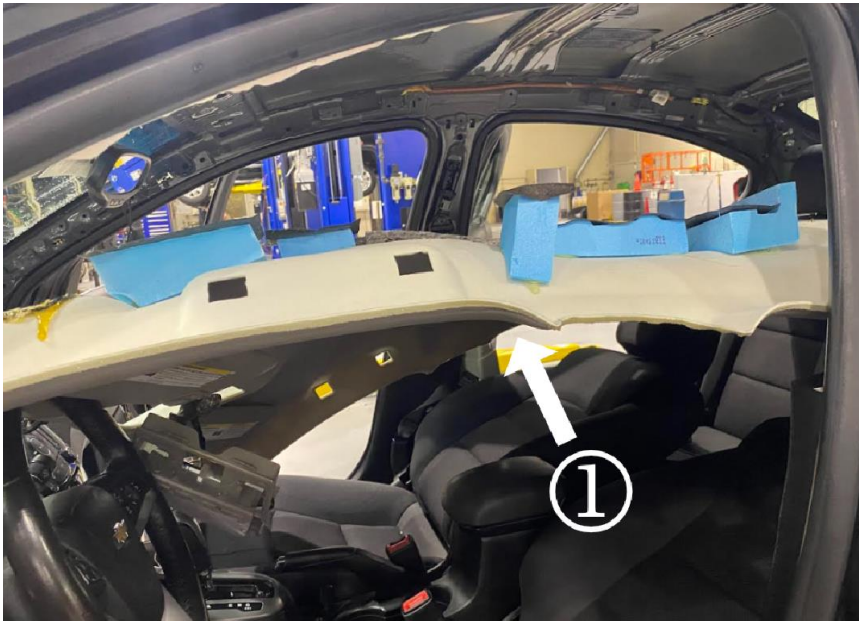
6449517

**Note:** The Headlining Trim Panel only needs to be lowered NOT removed. DO NOT remove the seats as the SI document states. Seat removal is ONLY for headliner removal NOT headliner lowering.

3. Lower the Headlining Trim Panel onto the headrests of the seats (1) as shown above. Refer to *Headlining Trim Panel Replacement* in SI.
4. Remove and replace BOTH the Left Hand and Right Hand Roof Side Rail Airbags. Refer to *Roof Side Rail Airbag Replacement* in SI.
5. Reinstall the Headlining Trim Panel. Refer to *Headlining Trim Panel Replacement* in SI.
6. Enable the SIR system. Refer to *SIR Disabling and Enabling* in SI.
7. Return the Front Seats to their original location.
