Recall Campaign Bulletin

Campaign No. 2023100014, November 2023

SUBJECT: **Model SL (232 platform)**
Model Year 2022-2023

Inspect 12V Starter/Alternator Wiring Harness

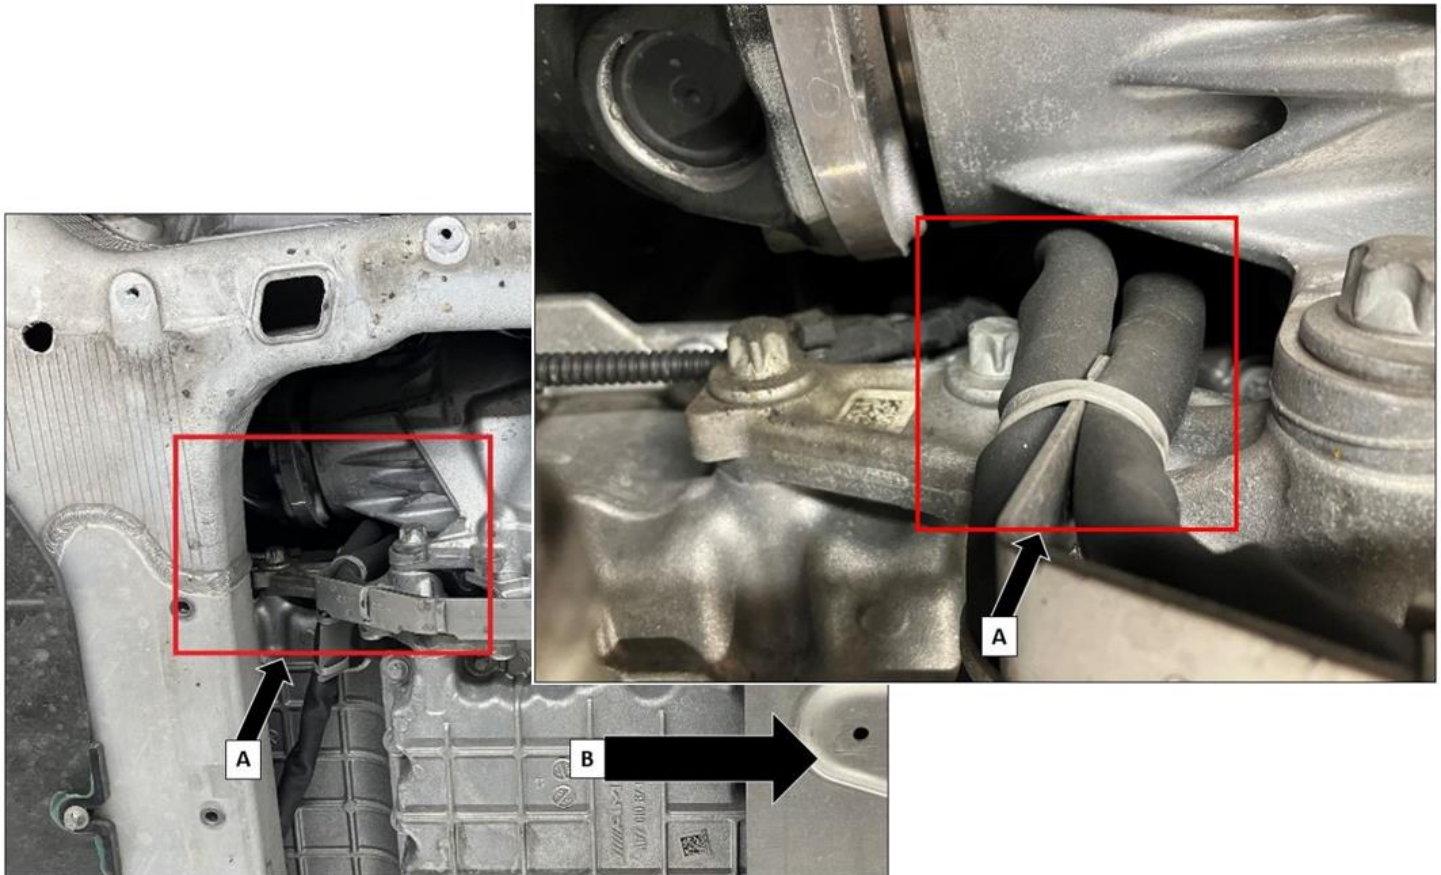
Mercedes-Benz AG (“MBAG”), the manufacturer of Mercedes-Benz vehicles, has determined that on certain Model Year (“MY”) 2022-2023 SL (232 platform) vehicles with the M177 engine, the routing of the 12V starter/alternator wiring harness might not meet specifications. The wiring harness might contact the drive shaft and chafe, which may result in a short circuit. A loss of propulsion cannot be ruled out, which could increase the risk of a crash. Additionally, due to the high electrical currents potentially flowing through this wiring harness, the temperature in this area might increase. Therefore, a risk of fire cannot be ruled out. An authorized Mercedes-Benz dealer will inspect and secure the 12V-starter/alternator wiring harness on the affected vehicles.

2. Check if the 12V starter/alternator wiring harness is too close to the propeller shaft and inspect it for damage near the propeller shaft (**A, Figure 1**).

Figure 1: Inspect starter/alternator wiring harness near propeller shaft (**arrow A**), direction of travel (**arrow B**)

- a. Starter/alternator wiring harness **not damaged**, carry out **Work Procedure 1**.
- b. Starter/alternator wiring harness **damaged**, carry out **Work Procedure 2**.

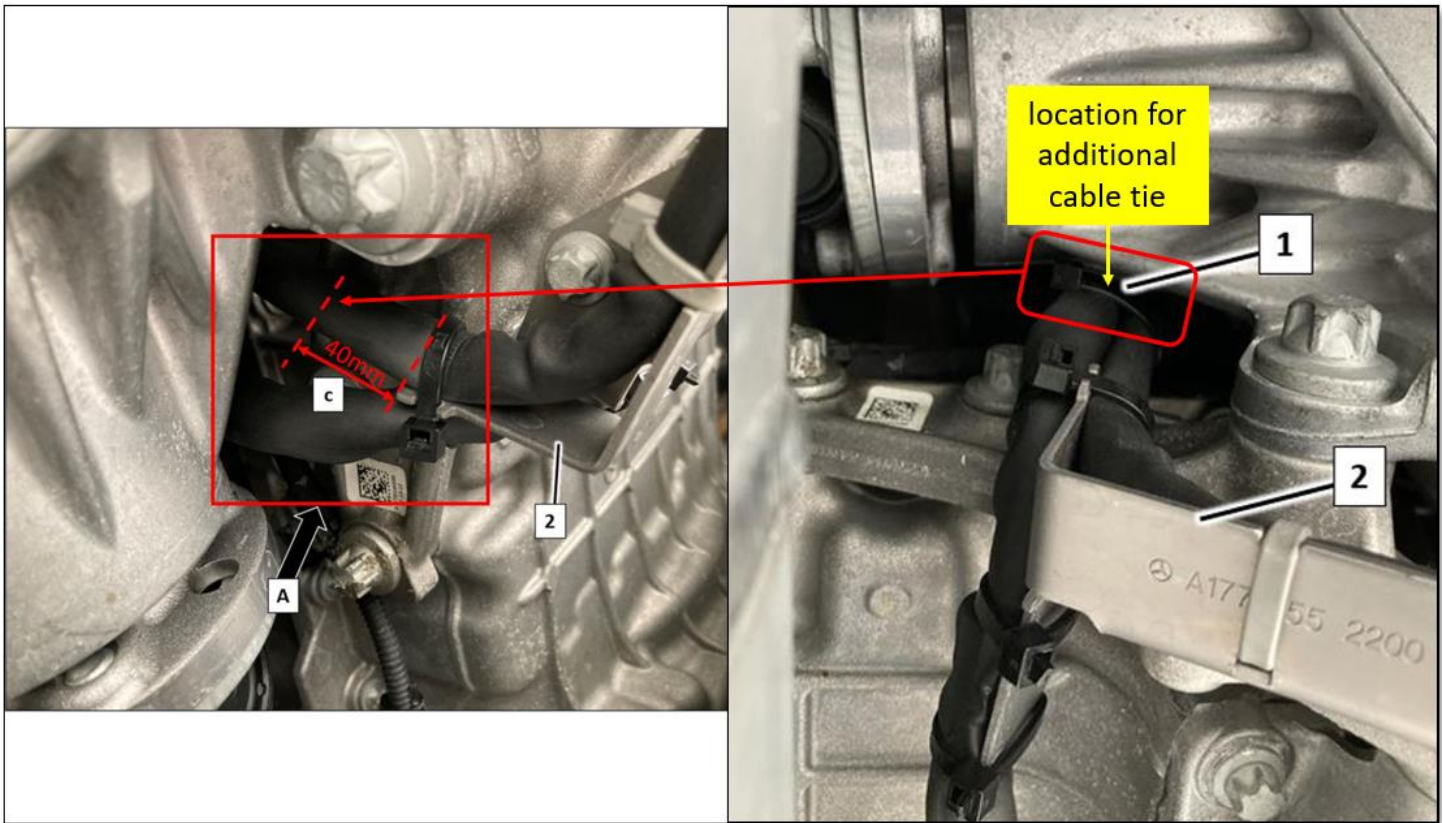
Figure 2: Install cable tie on starter/alternator wiring harness

1. If the starter/alternator wiring harness is **not damaged**, install an additional cable tie (1, **Figure 2**) in area near the propeller shaft at approx. 40 mm (**dimension c, Figure 2**) above the bracket (2, **Figure 2**).
