SAFETY RECALL

Volvo Trucks North America

Date	Number	Release	Page
10. 2023	RVXX2311	01	1(5)

Draglink Castle Nut Torque

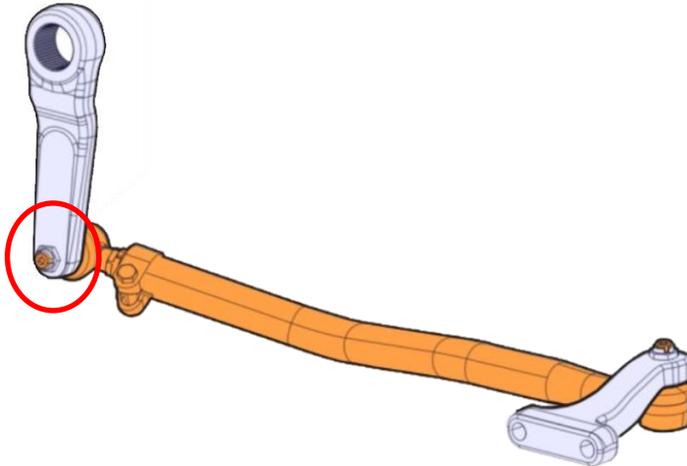
7. Locate the castle nut on the link rod connected to the pitman arm.

8. Inspect drag link end for excessive play.
 - a. If movement is found, replace components as needed.
 - b. If no movement is found, continue to step 9.
9. Remove cotter pin.
10. Set torque wrench to **200 Nm (148 lb-ft)**. Check torque in tightening direction.
11. Torque tighten the nut to specified torque.
 - a. Tighten the nut to the next split pin hole.
