SIB 32 03 23

### RECALL 23V-700: STEERING WHEEL GROUND CONNECTIONS

This Service Information Bulletin (Revision 3) replaces SI B32 03 23 **dated October 2023**.

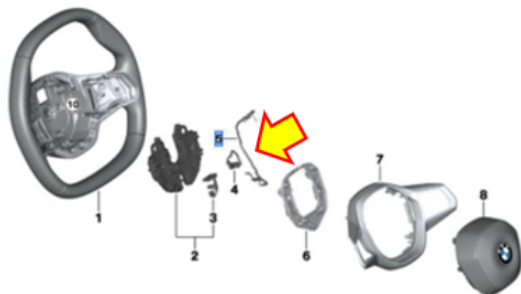
A ground wire might not be properly fastened in the steering wheel. This can cause a loose connection which indicates hands are ON the steering wheel even when being driven with hands-off.

Remove the steering wheel airbag. Check the ground wire at the steering wheel horn pad bracket for correct tightness and lack of movement.

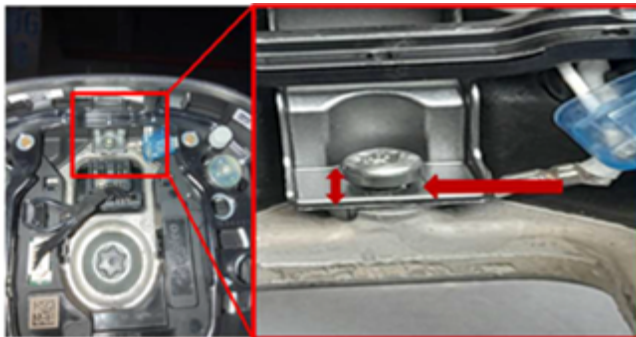
2. Remove the steering wheel airbag following the repair instructions listed in ISTA/AIR 32 34 030 and check the ground screw.

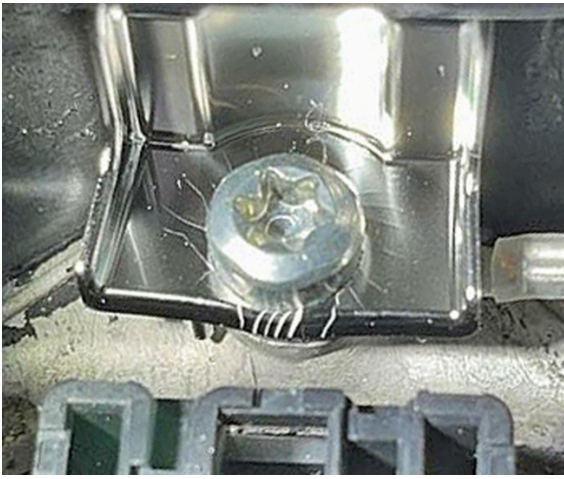
3. Using a magnifying glass, visually inspect the ground screw to determine if the screw is fully seated against the horn plate bracket.

Is the ground screw in contact with the horn plate bracket? **YES**, or **NO**?

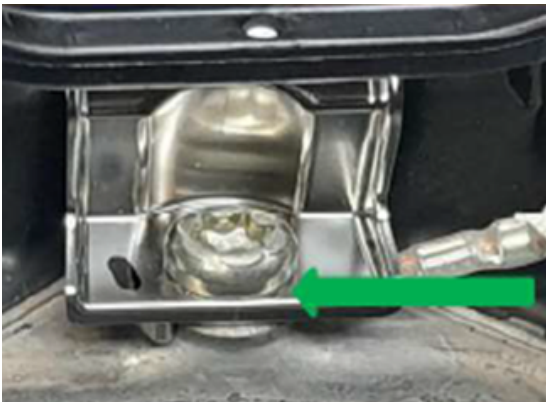
4. If the ground screw is NOT in contact with horn plate bracket, the screw must be removed, and the threads on the screw and in the steering wheel must be inspected for any burr formation.

**Note: If there is ANY burr formation on the screw itself and/or in the steering wheel, the steering wheel will need to be replaced along with the screw.**

5. If there is NO burr formation on the screw and/or steering wheel, the screw can then be reinstalled with two (1 mm) washers under the screw head and tightened to (2.5 Nm +/- 0.5 Nm).

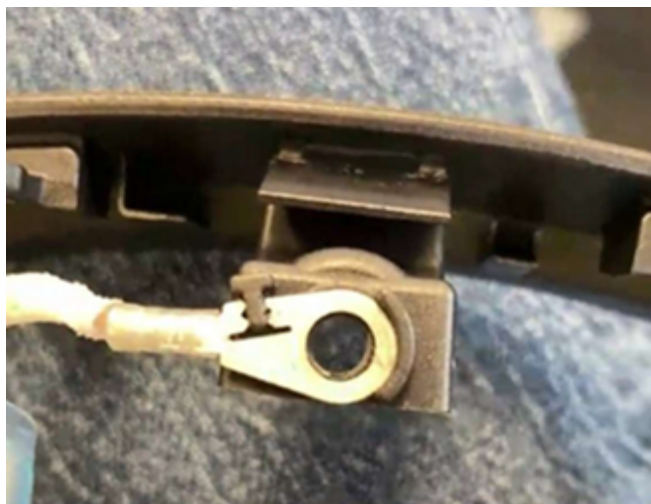
A. Press the horn cover from the inside out (upper arrows) to observe any possible movement of the horn plate bracket and screw.

B. To help determine that there is no relative movement, use a 0.1 mm feeler gauge between the bottom of the screw head and horn pad bracket (lower arrow).

**Note: The feeler gauge should not fit in between the screw head and feeler gauge IF the screw is fully seated and torqued properly.**

**Be careful when inserting the screw, because the cable lug is sensitive to force and tensile loads due to its geometry.**
