SIB 32 03 23

RECALL 23V-XXX: STEERING WHEEL GROUND CONNECTION

This Service Information Bulletin (Revision 1) replaces SI B32 03 23 **dated October 2023**.

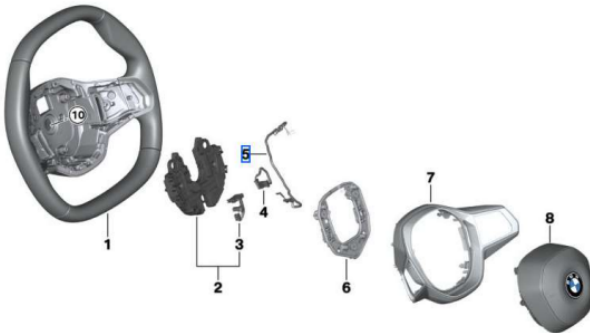
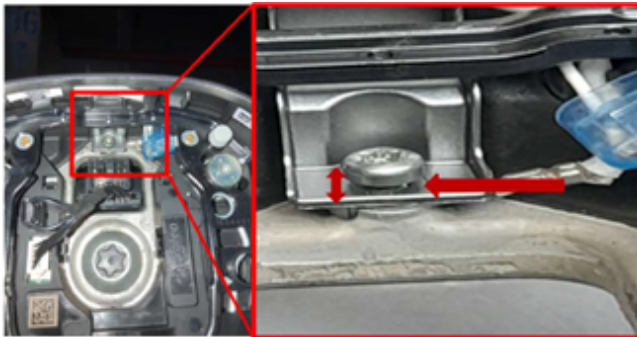
2. Remove the steering wheel airbag following the repair instructions listed in ISTA/AIR 32 34 030 and check the ground connection.

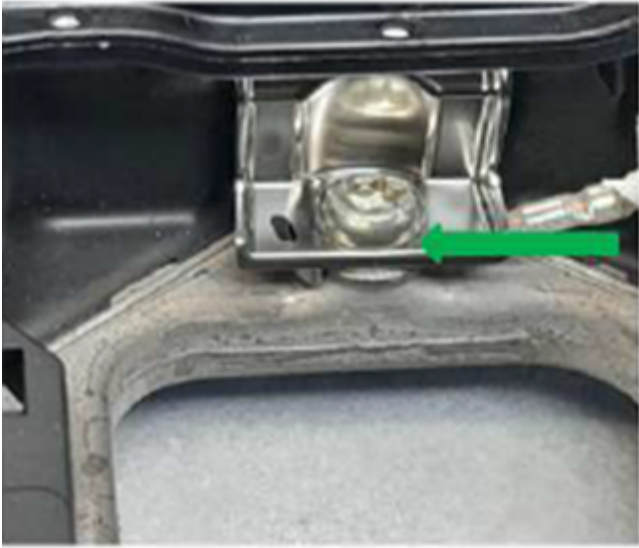
3. If the ground connection screw is not in contact with the horn plate bracket upon visual inspection but is tight and at the correct torque spec (2.5 Nm +/- 5 Nm), the screw must be removed, and the threads need to be inspected for any burr formations.

Add two (1 mm) thick washers under the screw head, then tighten screw to (2.5 Nm +/- 5 Nm).

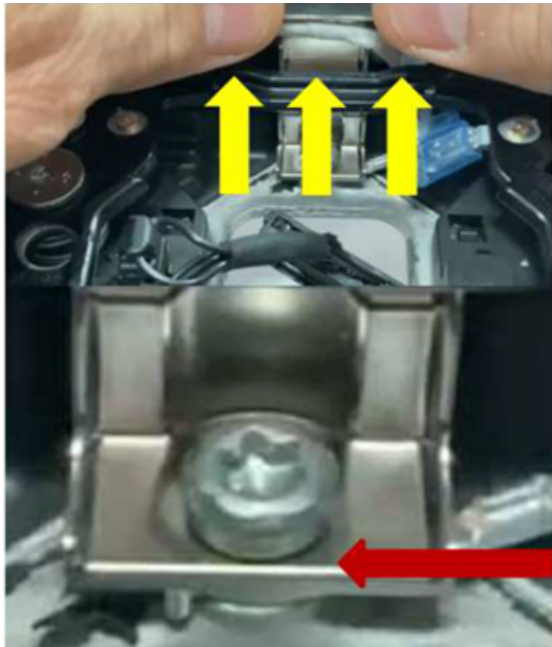
4. If the screw is already in full contact with the horn plate bracket and is tighten to (2.5 Nm + - 5 Nm), check the tightness of the connection as explained below.

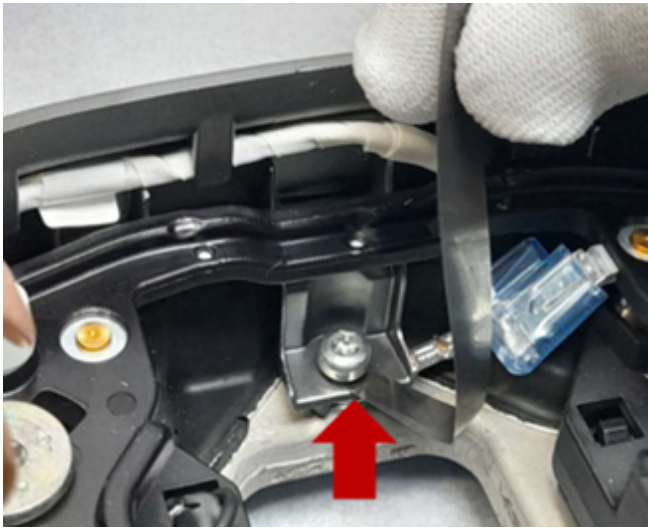
Press the horn cover from the inside out to observe any possible movement of the horn pad bracket and the screw.

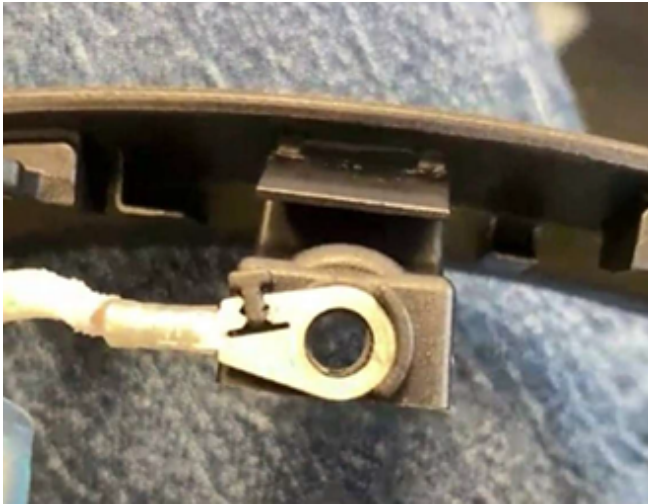
5. If there is no relative movement, use a 0.1 mm feeler gauge between the bottom of the screw head and the horn pad bracket.
