SIB 32 04 24

RECALL 23V-700: STEERING WHEEL GROUND CONNECTIONS

This Service Information Bulletin (Revision 1) replaces SI B32 04 24 **dated August 2024**.

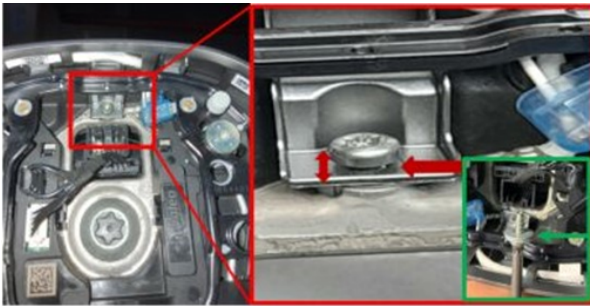
2. Remove the steering wheel airbag following the repair instructions listed in ISTA/AIR 32 34 030 and check the ground screw.

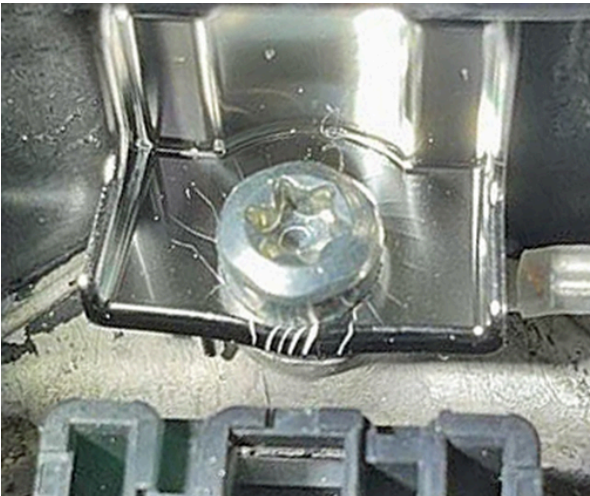
3. Using a magnifying glass, visually inspect the ground screw to determine if the screw is fully seated against the horn plate bracket.

There may be a small gap between the screw head and the bracket (right photo, arrows).

**Note:** If the chrome coating on the trim is cracked but the actual trim material is not cracked through, the trim does **NOT** need to be replaced. If the trim material **IS** cracked, it will need to be replaced following the instructions listed in ISTA/AIR (32 33 007 or 32 33 021).

4. If the ground screw is **NOT** in contact with horn plate bracket, the screw must be removed, and the threads on the screw and in the steering wheel must be inspected for any burr formation.

**Note:** If there is **ANY** burr formation on the screw itself and/or in the steering wheel, the steering wheel will need to be replaced along with the screw.

5. If there is **NO** burr formation on the screw and/or steering wheel, the screw can then be reinstalled with two (1 mm) washers (refer to Parts Information) under the screw head and tightened to 2.5 Nm +/- 0.5 Nm.

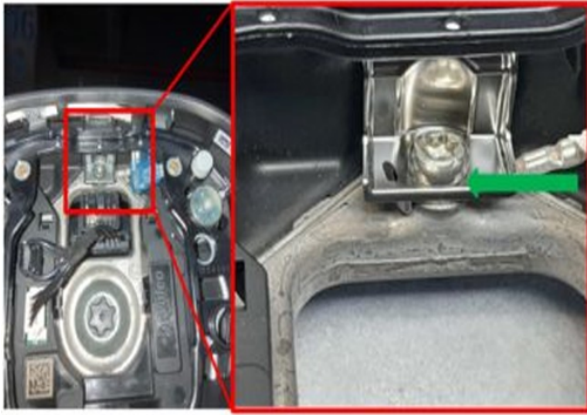
6. If the ground screw is in full contact with the horn plate bracket, check the torque of the screw using a torque wrench (2.5 Nm  $\pm$  0.5 Nm). Continue to Step 7 once completed.

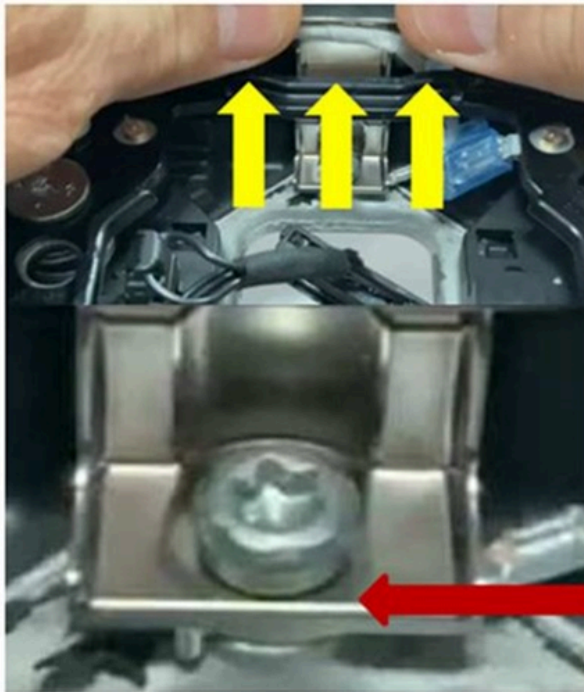
A. Press the horn cover from the inside out (upper arrows) to observe any possible movement of the horn plate bracket and screw.

To help determine that there is no relative movement, use a 0.1 mm feeler gauge between the bottom of the screw head and horn pad bracket (lower arrow).

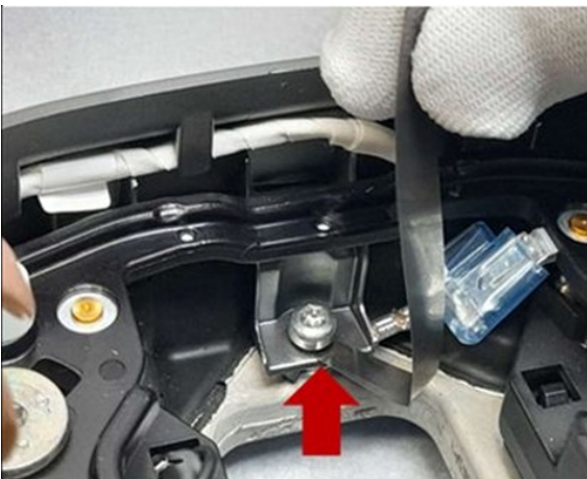
B. To help determine that there is no relative movement, use a 0.1 mm feeler gauge between the bottom of the screw head and horn pad bracket (lower arrow).

**Note: The feeler gauge should not fit in between the screw head and horn pad bracket IF the screw is fully seated and torqued properly.**

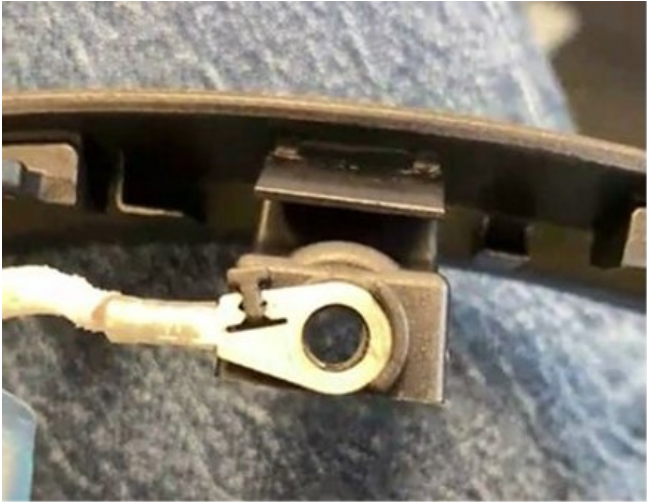
**Note: DO NOT check the tight fit on the cable shoe of the ground strap. Be careful when inserting the screw, as the geometry of the cable shoe is sensitive to compressive and tensile loads.**
