SIB 32 03 23

2023-10-25

RECALL 23V-700: STEERING WHEEL GROUND CONNECTIONS

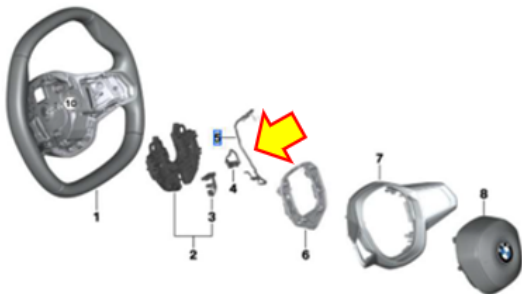
A ground wire might not be properly fastened in the steering wheel. This can cause a loose connection which indicates hands are ON the steering wheel even when being driven with hands-off.

Remove the steering wheel airbag. Check the ground wire at the steering wheel horn pad bracket for correct tightness and lack of movement.

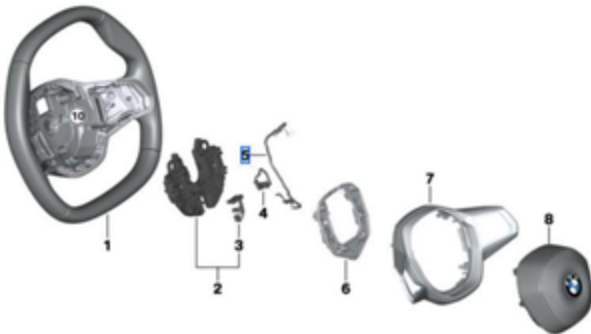
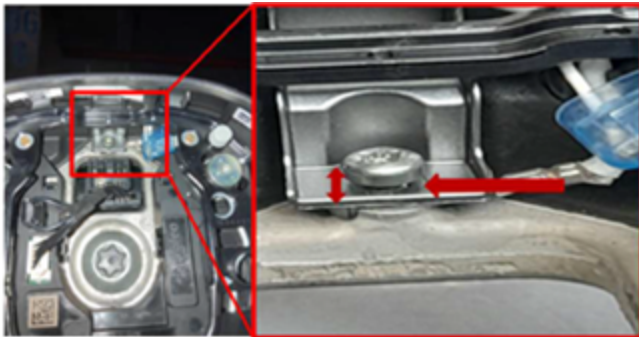
2. Remove the steering wheel airbag following the repair instructions listed in ISTA/AIR 32 34 030 and check the ground screw.

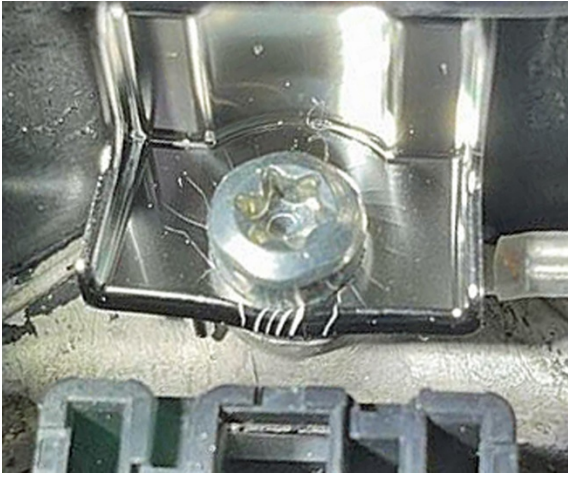
3. Using a magnifying glass, visually inspect the ground screw to determine if the screw is fully seated against the horn plate bracket.

Is the ground screw in contact with the horn plate bracket? **YES**, or **NO**?

4. If the ground screw is NOT in contact with horn plate bracket, the screw must be removed, and the threads on the screw and in the steering wheel must be inspected for any burr formation.

Note: If there is ANY burr formation on the screw itself and/or in the steering wheel, the steering wheel will need to be replaced along with the screw.

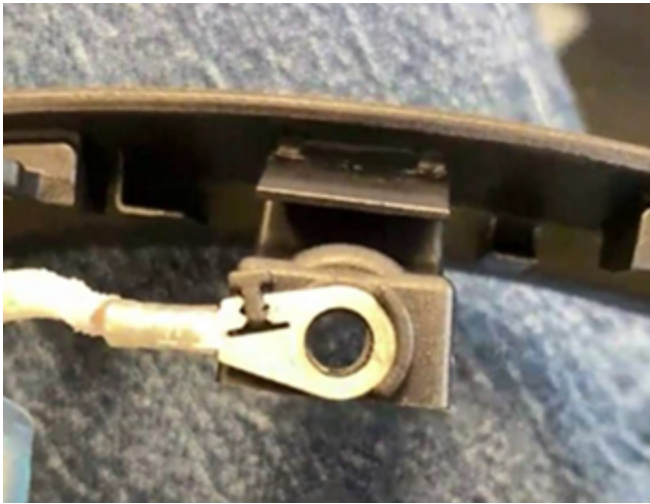
A. Press the horn cover from the inside out (upper arrows) to observe any possible movement of the horn plate bracket and screw.

B. To help determine that there is no relative movement, use a 0.1 mm feeler gauge between the bottom of the screw head and horn pad bracket (lower arrow).

Note: The feeler gauge should not fit in between the screw head and feeler gauge IF the screw is fully seated and torqued properly.

Be careful when inserting the screw, because the cable lug is sensitive to force and tensile loads due to its geometry.
