**July 26, 2024**

Version 6

## Safety Recall: 2022-24 Civic Touring/Sport EPS Inspection (Service Parts)

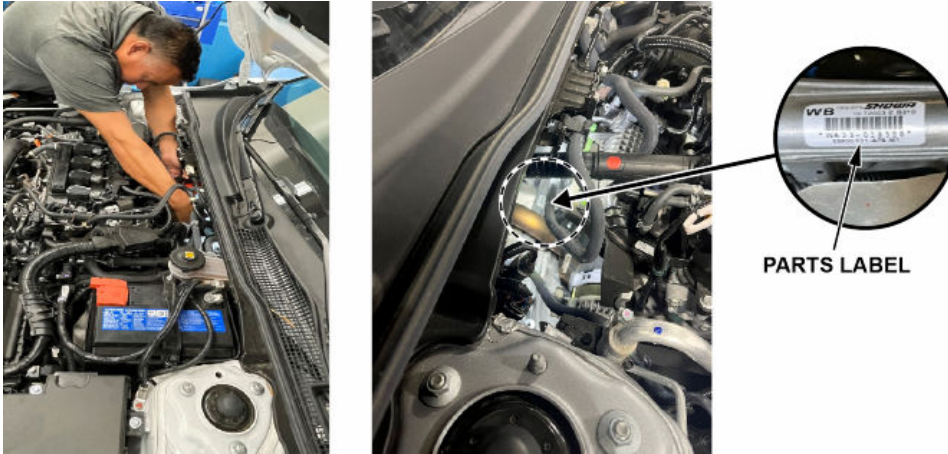
3. Inspect the label on the EPS and check the ID and part number on the label.
  - If the ID and part number is WA with P/N 53640-T21-3050-M1 or WB with P/N 53640-T21-3060-M1, take a picture of the label and attach it to the warranty claim. Then, continue to step 4.

- If the EPS has any other ID or part number, no EPS gearbox replacement is needed. Take a picture of the label and attach it to the warranty claim, no further action needed.

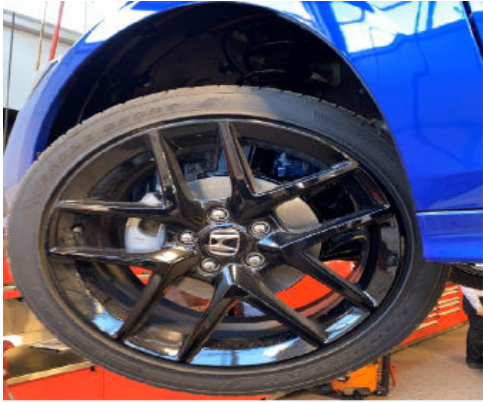
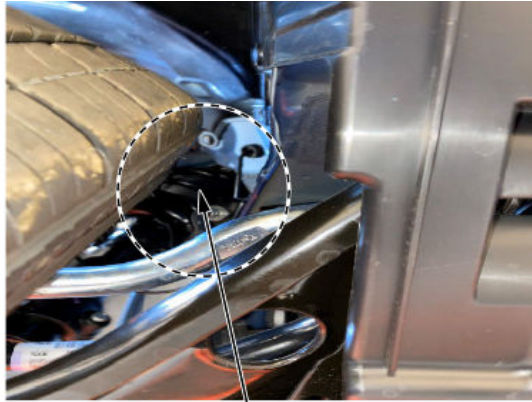
INNER TIRE CONTACT WITH LOWER  
ARM AND/OR OUTER TIE ROD

Is there any sign of interference/damage marks on the inner tire with the control arm?

**YES** - Any tire with signs/evidence of interference requires replacement. Provide a clear image showing the interference condition and write the last seven characters of the VIN on the damaged tire. Contact your DPSM for consultation/approval. Go to the REPAIR PROCEDURE.

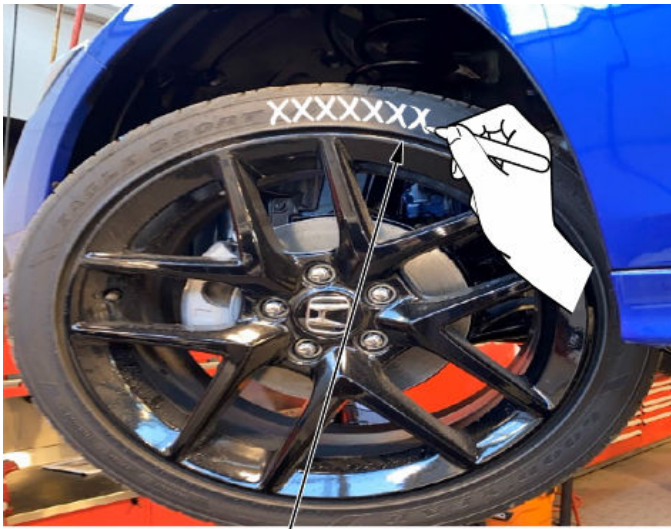
Write the last seven characters  
of the vehicles VIN.
