SIB 11 09 23

2023-12-13

RECALL 23V-707: REPLACE VANOS ADJUSTMENT UNIT SCREWS

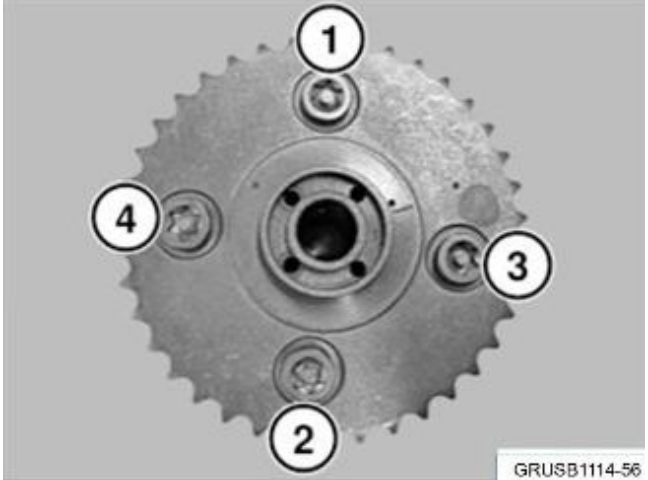
<p>GRUSB1114-56</p>	<p>3. Replace and torque the aluminum bolts (1-4) one at a time.</p> <p>Note: 1-4 is not a sequence they can be replaced in any sequence.</p>

IMPORTANT: Aluminum bolts must not be reused. If the aluminum bolts are removed then they must be replaced with new bolts.

IMPORTANT: Never loosen more than one VANOS assembly bolt (1-4) at a time.

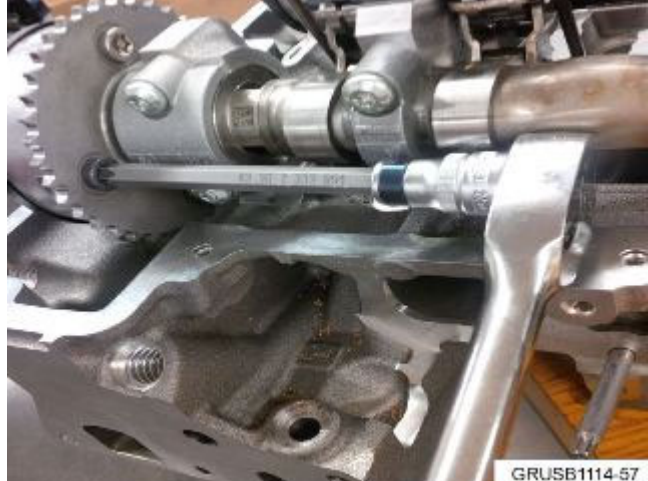
<p>GRUSB1114-57</p>	<p>4. Turn the engine by hand using a suitable tool on the crankshaft central bolt to align one of the bolts (1) as shown in the illustration.</p> <p>Remove the bolt (1) using the required special tool (2).</p>

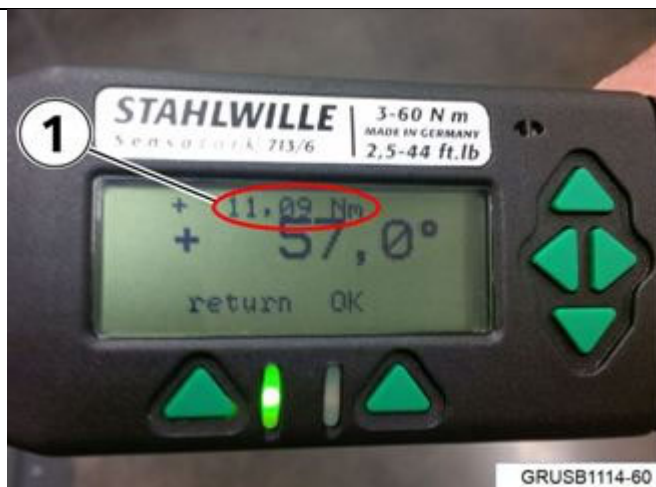
7. While performing the angle torque the digital screen on the torque wrench will display the current Nm meter value. This value should be between **8 Nm – 14 Nm**.

If the displayed value is not within the specification then the bolt will need to be removed and replaced with a new bolt again. Repeat as necessary.

8. If any of the bolts were loose or broken during this procedure then the VANOS assembly will need to be replaced. Refer to step 14.

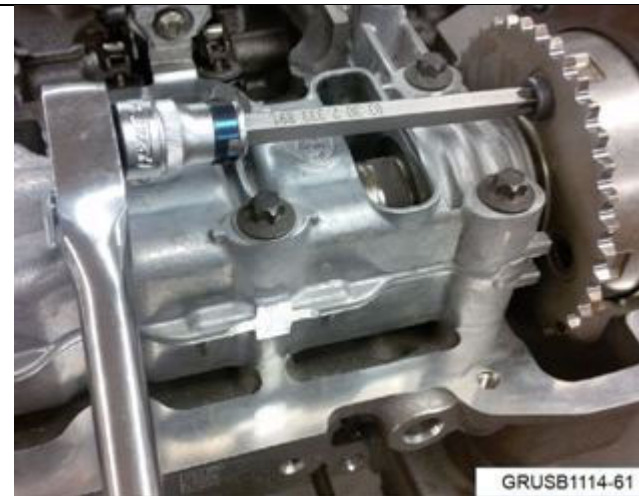
10. Turn the engine by hand using a suitable wrench on the crankshaft central bolt to align the bolt (1) with as shown in the illustration.

Remove the bolt (1) using the required special tool.

Note: The tool will be on a slight angle when loosening.

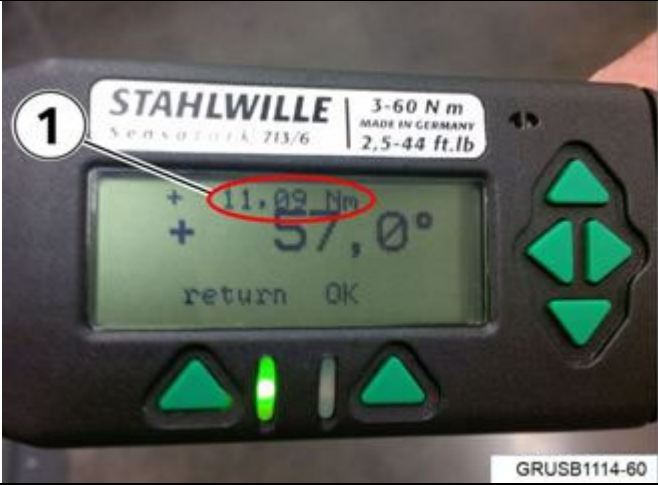
<p>13. While performing the angle torque the digital screen on the torque wrench will display the current Nm meter value. This value should be between 8 Nm – 14 Nm.</p> <p>If the displayed value is not within the specification then the bolt will need to be removed and replaced with a new bolt again. Repeat as necessary.</p> <p>To reset torque wrench and clear screen to Nm again just press the “MR” button to continue replacing additional bolts.</p>
<p>14. If any of the bolts were loose or broken during this procedure then the VANOS assembly will need to be replaced. Refer to step 15.</p> <p>If no bolts were found loose then repeat steps 4 - 6 for the remaining 3 bolts on the VANOS gear assembly. It is good practice to mark each bolt head as it is replaced with a felt marker so that one is not mistaken and removed again. Refer to step 16.</p>

<p>15. If any of the VANOS bolts were found loose or broken then that VANOS unit will need to be replaced. Refer to Repair Instruction 11 36 046 “Removing and installing or replacing intake and exhaust camshaft adjusters”</p>	
<p>16. Reassemble vehicle as per the applicable repair instructions.</p>
