SIB 11 09 23

**RECALL 23V-707: REPLACE VANOS ADJUSTMENT UNIT SCREWS**

This Service Information Bulletin (Revision 4) replaces SI B11 09 23 **dated March 2024**.

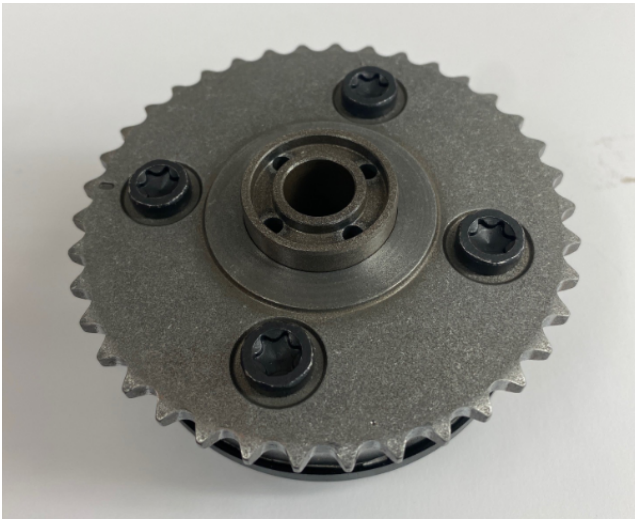
Rear view:

Affected VANOS gear example with removable bolts.

The exterior of the intake and exhaust VANOS gears are essentially identical in construction except for a part number difference.

**If a VANOS gear is installed that does not resemble these examples, then create a TSARA Hotline case with photos of identifying marks, part numbers, etc. and wait for a response.**
