SIB 11 09 23

RECALL 23V-707: REPLACE VANOS ADJUSTMENT UNIT SCREWS

This Service Information Bulletin (Revision 8) replaces SI B11 09 23 **dated March 2025**.

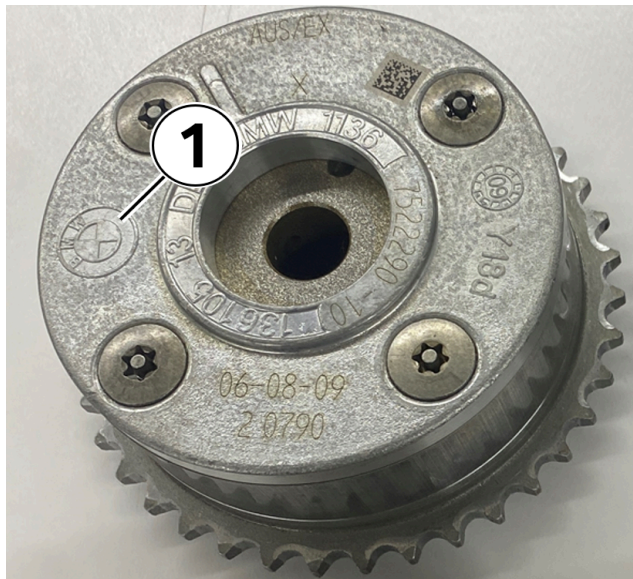
Version 1 VANOS Gears (not affected)

Version 1 VANOS gears are not affected because the 4 assembly bolts are of a different design, and are installed in the front side of the VANOS gear as shown.

Impulse wheel removed for clarity.

The BMW Roundel (1) is shown.

If version 1 VANOS gears are identified, then you do not need to make any further repairs.

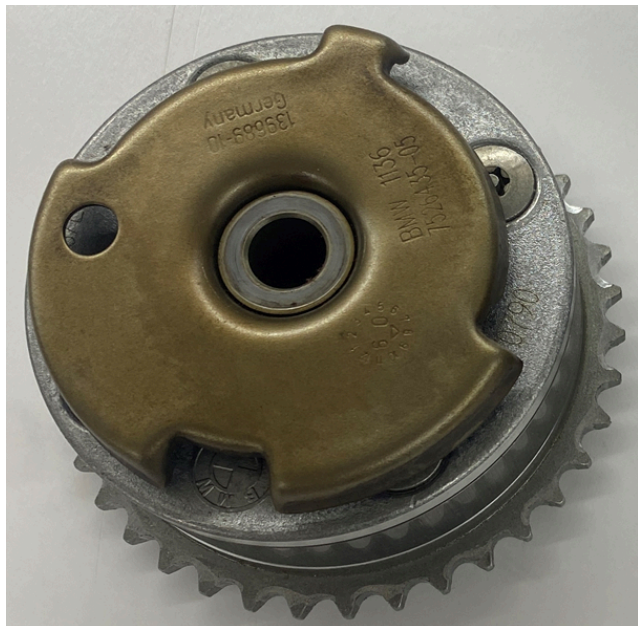
Impulse wheel installed.

To ensure it is a BMW genuine part you will need to use mirror or a borescope to look behind the impulse wheel if the BMW roundel is not already aligned with one of the segments in the impulse wheel.

Do not remove the impulse wheel.

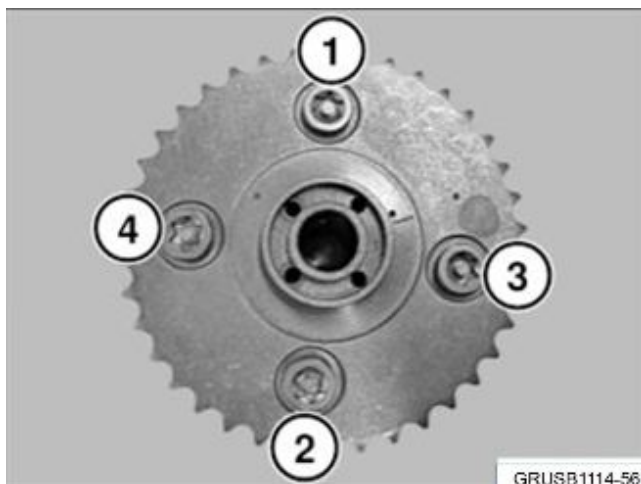
Version 2 VANOS Gears (affected)

The 4 bolts in this photo are the affected design with the tamper-resistant pin in the center of each bolt head.

These bolts are located on the rear side of the VANOS gear.

1. Replace the VANOS assembly's gear bolts on the units that **do not** have any loose and/or broken bolts (one side, or both sides as applicable).
2. If the gear bolts on a VANOS assembly are found loose and/or broken, replace the entire VANOS assembly. If the heads of the bolts are broken, the missing pieces must be found and removed from the engine before the engine repairs are completed.

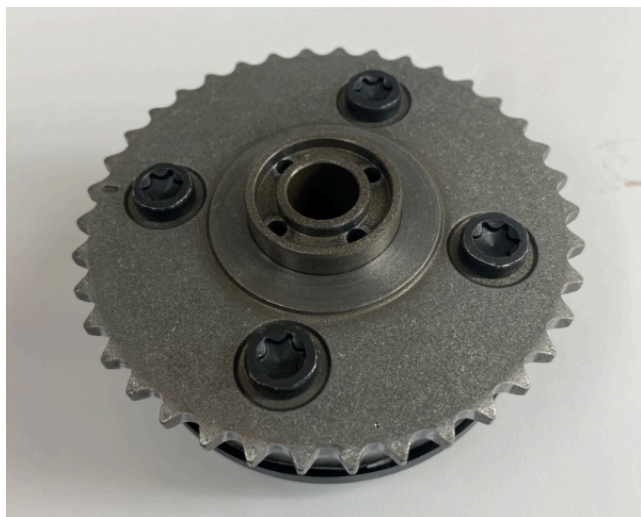
Rear view:

Affected VANOS gear example with removable bolts.

The 4 bolts in this photo are the new updated design without the tamper resistant pin in the center of each bolt head.
