SIB 11 09 23

RECALL 23V-707: REPLACE VANOS ADJUSTMENT UNIT SCREWS

This Service Information Bulletin (Revision 7) replaces SI B11 09 23 **dated October 2024**.

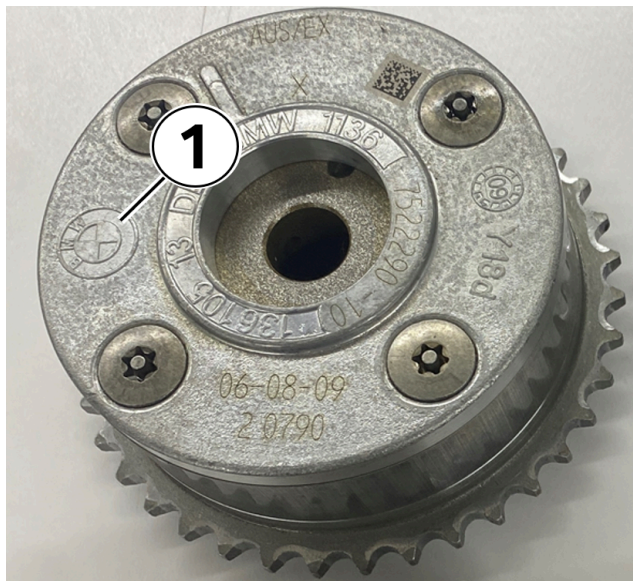
Version 1 VANOS Gears (not affected)

Version 1 VANOS gears are not affected because the 4 assembly bolts are of a different design, and are installed in the front side of the VANOS gear as shown.

Impulse wheel removed for clarity.

The BMW Roundel (1) is shown.

If version 1 VANOS gears are identified, then you do not need to make any further repairs.

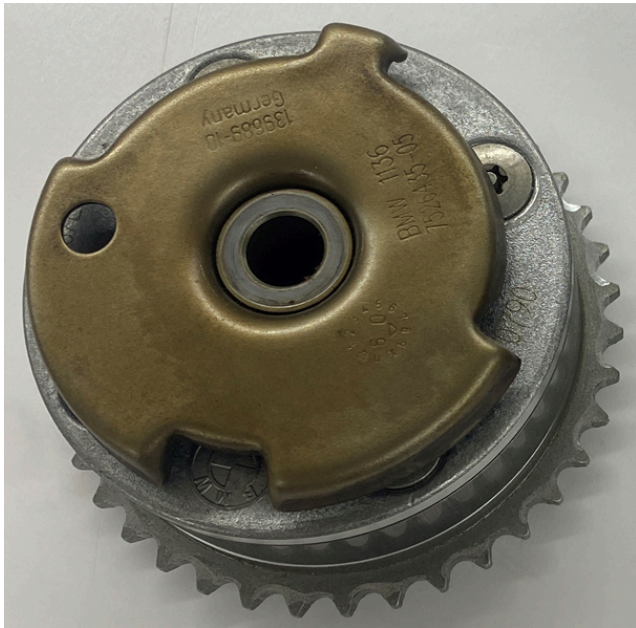
Impulse wheel installed.

To ensure it is a BMW genuine part you will need to use mirror or a borescope to look behind the impulse wheel if the BMW roundel is not already aligned with one of the segments in the impulse wheel.

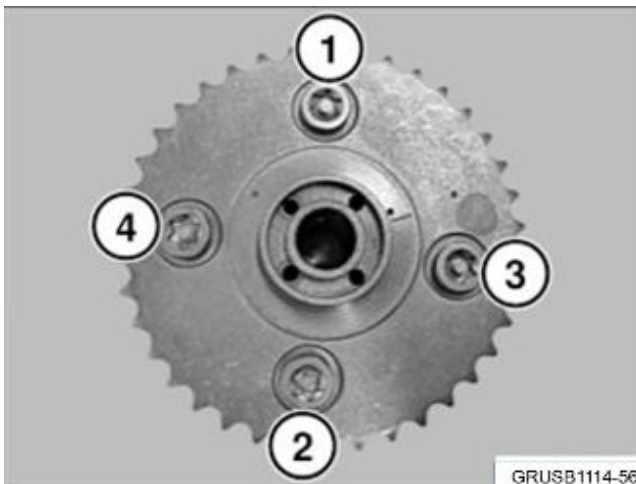
Version 2 VANOS Gears (affected)

The 4 bolts in this photo are the affected design with the tamper-resistant pin in the center of each bolt head.

These bolts are located on the rear side of the VANOS gear.

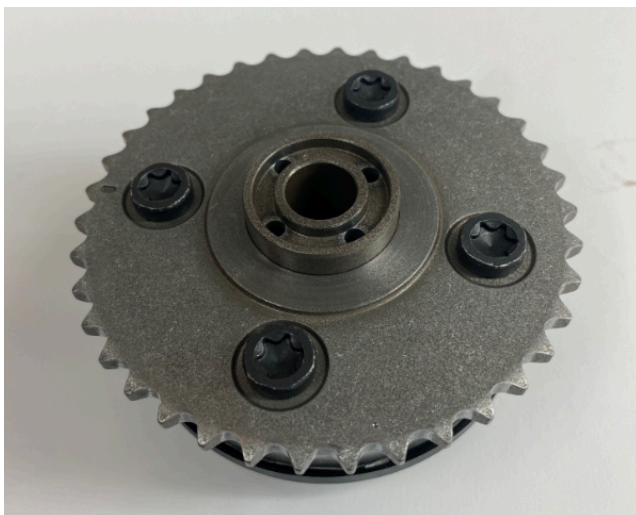
Rear view:

Affected VANOS gear example with removable bolts.

The 4 bolts in this photo are the new updated design without the tamper resistant pin in the center of each bolt head.

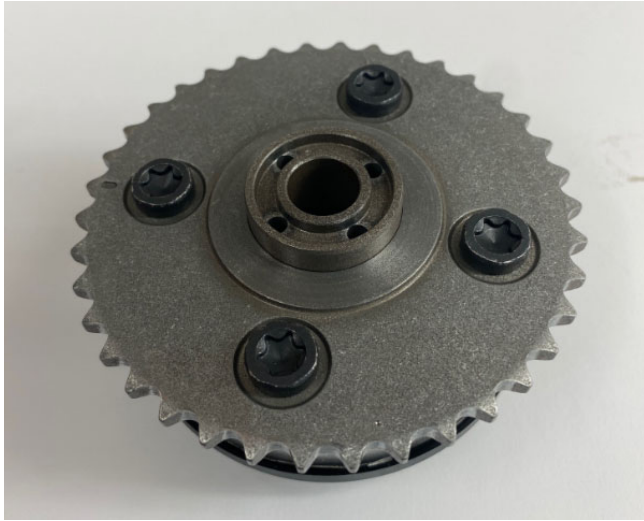
Rear view:

Affected VANOS gear example with removable bolts.

If a VANOS gear is installed that does not resemble these examples, then create a **Standard TSARA Hotline case with photos of identifying marks, part numbers, etc. and wait for a response.**
