SIB 11 09 23

RECALL 23V-707: REPLACE VANOS ADJUSTMENT UNIT SCREWS

This Service Information Bulletin (Revision 6) replaces SI B11 09 23 **dated October 2024**.

BMW AG is conducting a Voluntary Safety Recall (effective October 23, 2023) on a certain number of Model Year 2010 - 2013 BMW vehicles that were produced between September 2, 2009, and July 12, 2012.

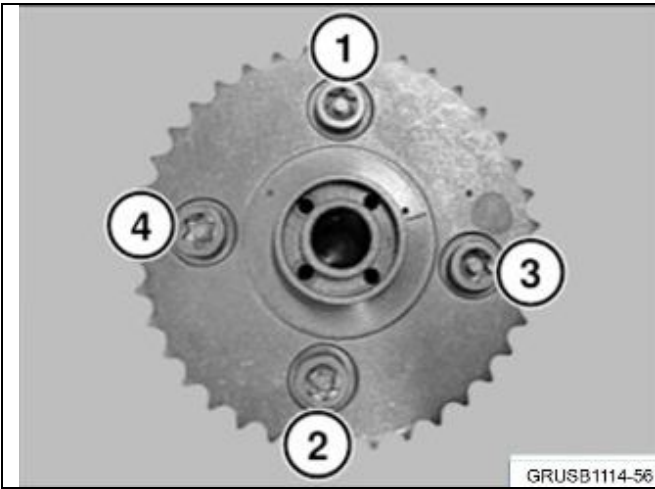
The 4 bolts in this photo are the old design with the tamper resistant pin in the center of each bolt head.

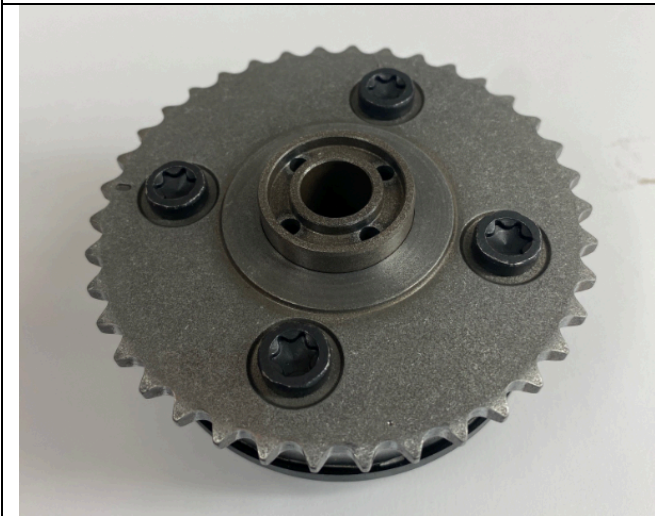
Rear view:

Affected VANOS gear example with removable bolts.

If a VANOS gear is installed that does not resemble these examples, then create a Standard TSARA Hotline case with photos of identifying marks, part numbers, etc. and wait for a response.

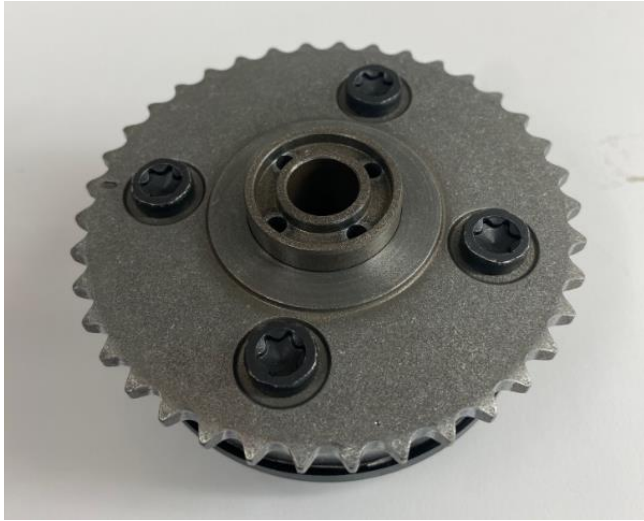
Rear view:

Affected VANOS gear example with removable bolts.

If a VANOS gear is installed that does not resemble these examples, then create a TSARA Hotline case with photos of identifying marks, part numbers, etc. and wait for a response.

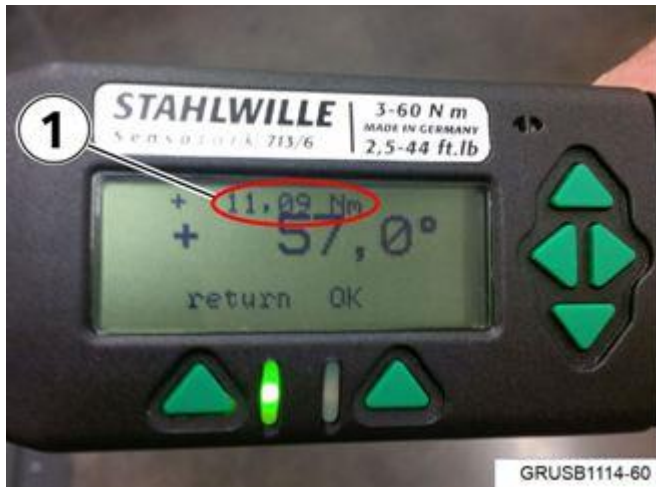
7. While performing the angle torque the digital screen on the torque wrench will display the current Nm meter value. This value should be between **8 Nm – 14 Nm**.

If the displayed value is not within the specification, then the bolt will need to be removed and replaced with a new bolt again. Repeat as necessary.

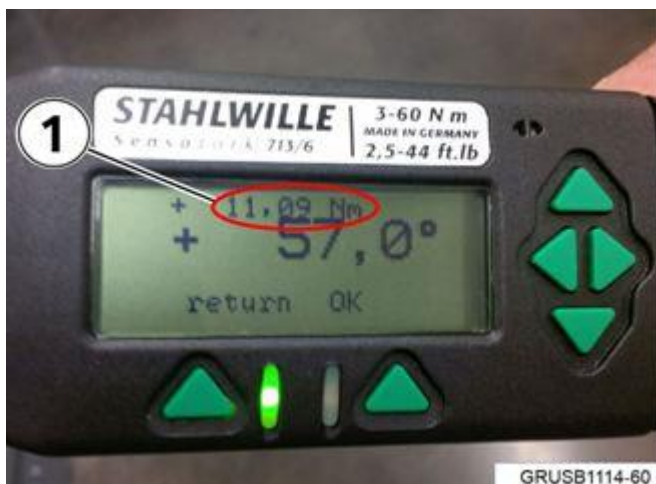
13. While performing the angle torque the digital screen on the torque wrench will display the current Nm meter value. This value should be between 8 Nm – 14 Nm.

If the displayed value is not within the specification, then the bolt will need to be removed and replaced with a new bolt again. Repeat as necessary.

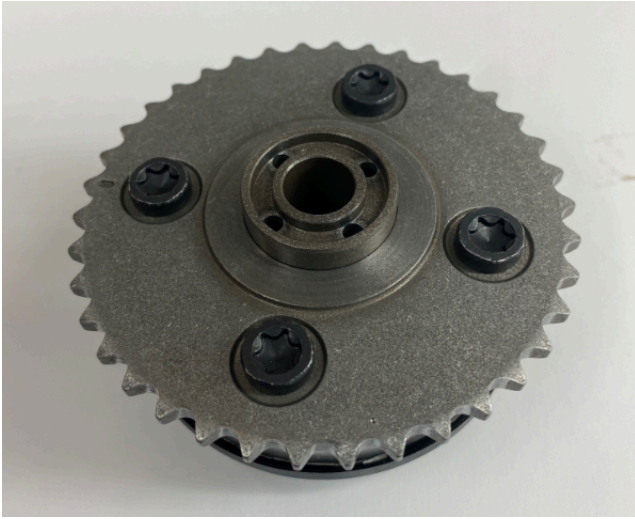
Rear view:

Affected VANOS gear example with removable bolts.

If a VANOS gear is installed that does not resemble these examples, then create a TSARA Hotline case with photos of identifying marks, part numbers, etc. and wait for a response.
