# SAFETY RECALL

Mack Trucks Inc.  
Greensboro, NC USA

Date	Number	Release	Page
10.2023	SC0451	01	1(6)

## LR Power Steering Assist Cylinder Castle Nut Torque LR

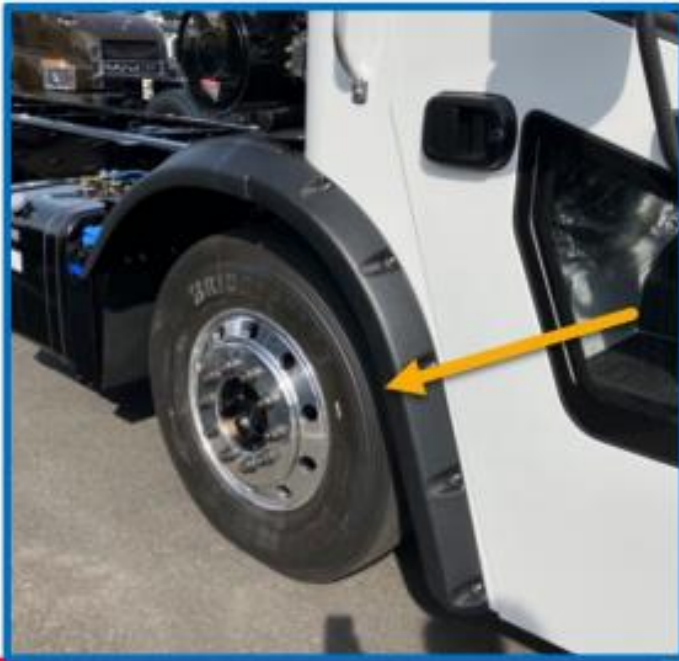
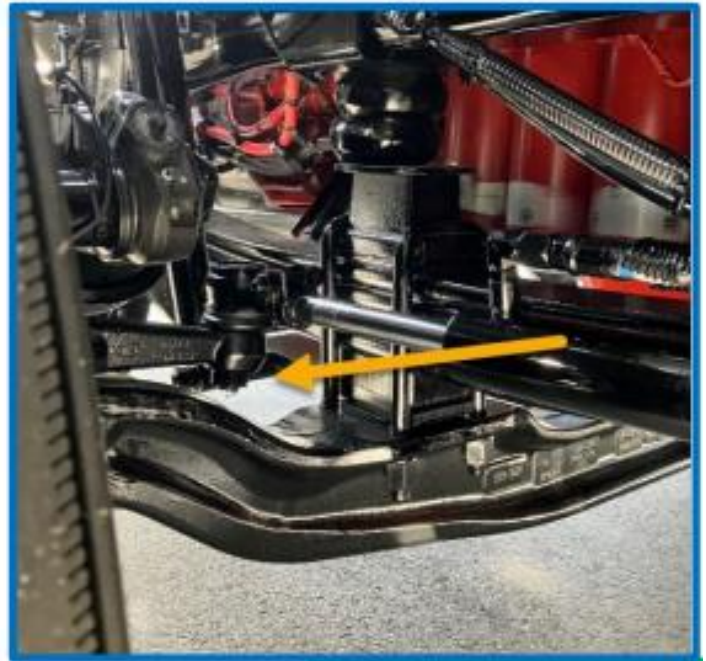
The castellated nut on the power steering assist cylinder to steering arm may have insufficient torque. If the power steering assist cylinder to steering arm connection should fail in operation, there could be a loss of vehicle control which could result in a crash.

7. Locate the castle nut on the power steering assist cylinder connected to the steering arm on the right side of the vehicle.

8. Torque tighten the castle nut to specified torque.

<b>Tightening Torque</b>
<b>238-264 Nm (176-195 lb-ft)</b>
