SAFETY RECALL 23TA12

Front Lower Bumper Cover Assembly May Detach While Driving

CERTAIN 2020-2023 MODEL YEAR HIGHLANDER AND HIGHLANDER HV

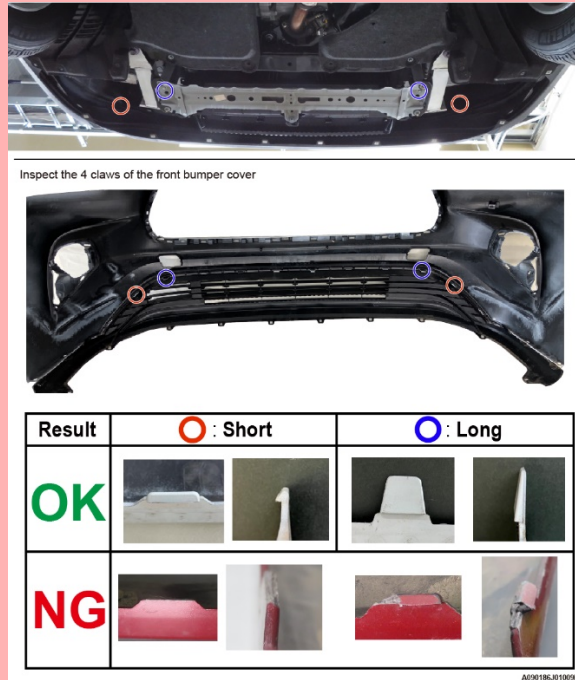
a) Check for damage on the 4 claws (shown in the picture) and check that all the claws are engaged.

b) If disengaged claws were found in step “a”, properly engage them.

Inspection Result	Damaged Claws	Action				Go to
		Install NEW nuts and NEW screws w/ washers	[Vehicles manufactured through April 2023] Install NEW outside retainers.	[Vehicles manufactured from May 2023] Install NEW outside retainers.	Replace the front bumper cover and front bumper lower cover with a NEW one*	
OK	Not Found	●	●	-	-	GO TO SECTION VII
NG	Found	●	●	●	●	GO TO SECTION X
