SAFETY RECALL 23TA12

Front Lower Bumper Cover Assembly May Detach While Driving

CERTAIN 2020-2023 MODEL YEAR HIGHLANDER AND HIGHLANDER HV

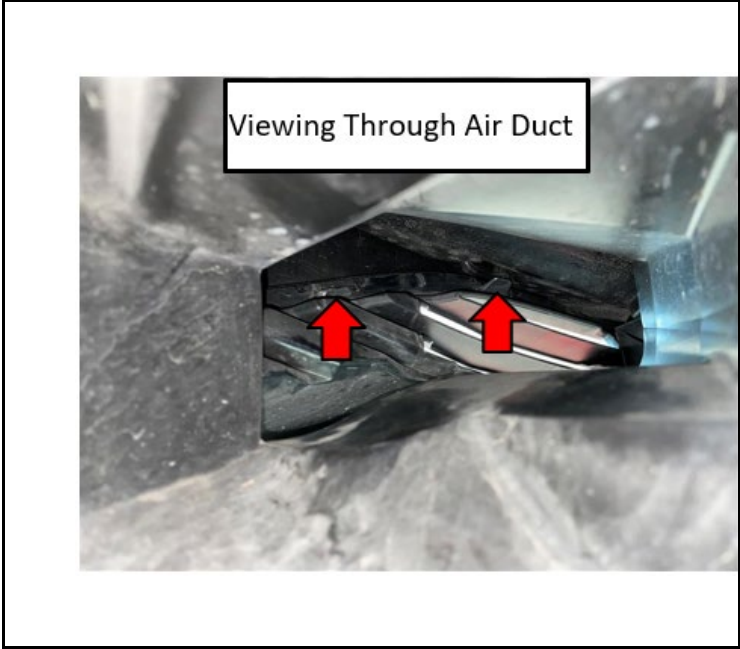
a) Check for damage on the 4 claws (shown in the picture) and check that all the claws are engaged.

b) If disengaged claws were found in the inspection instructed in step a), engage them.
