TECHNICAL INSTRUCTIONS

SAFETY RECALL 23TA12

Front Lower Bumper Cover Assembly May Detach While Driving

CERTAIN 2020-2023 MODEL YEAR HIGHLANDER AND HIGHLANDER HV

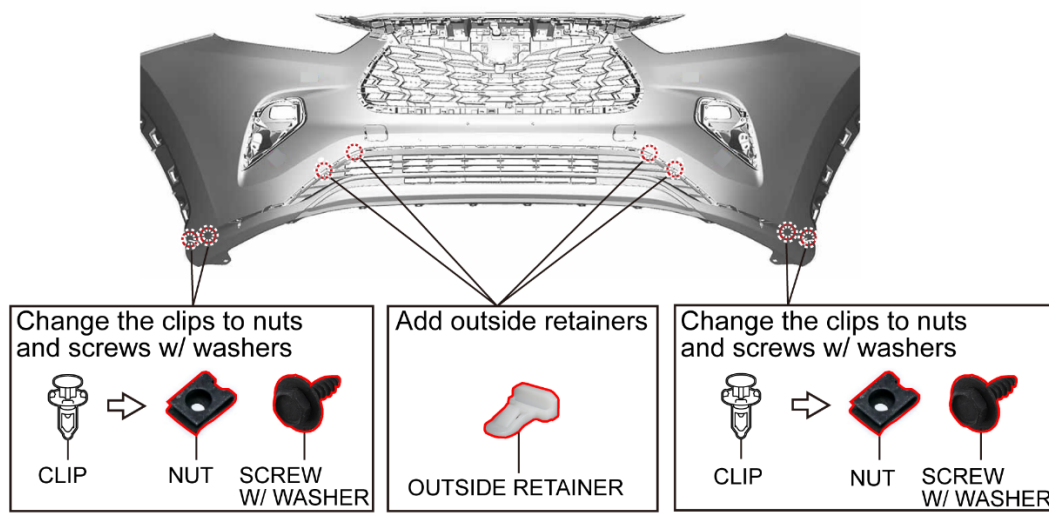
Add fasteners to the front bumper cover

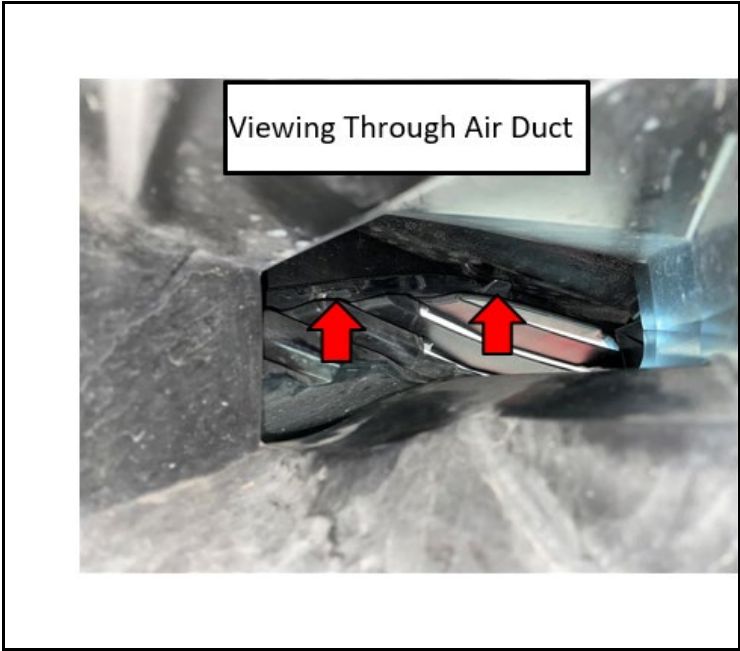
a) Check for damage on the 4 claws (shown in the picture) and check that all the claws are engaged.

b) If disengaged claws were found in step “a”, properly engage them.

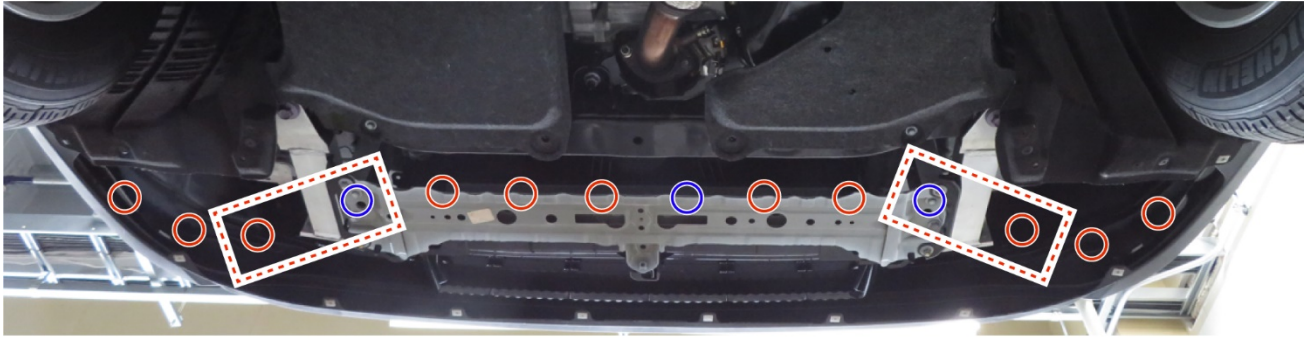
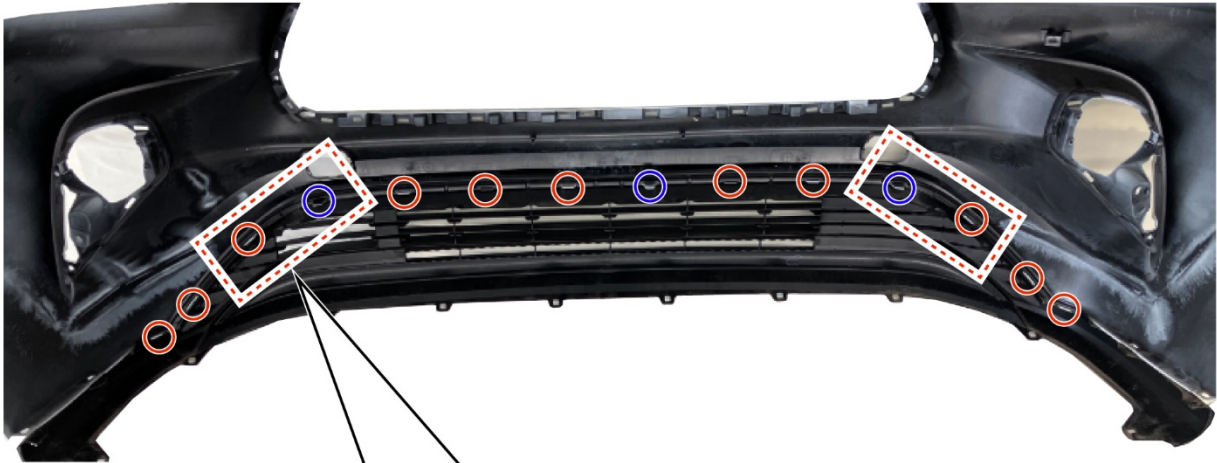
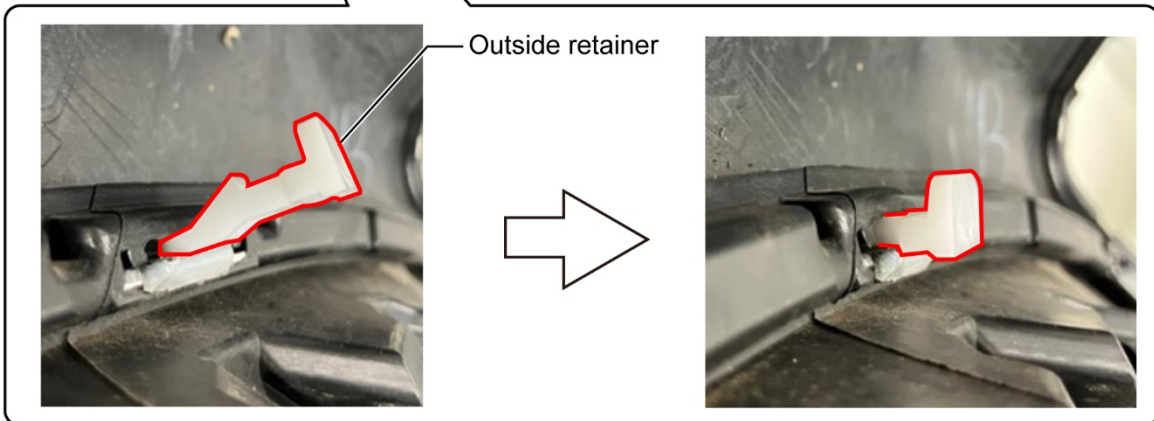
Install the 4 **NEW** outside retainers to the front bumper cover

- a) Install the 4 **NEW** outside retainers to the locations shown in the picture.
