PRODUCT CAMPAIGN BULLETIN

APPLICABILITY: 2023MY WRX
 2024MY Crosstrek
 2024MY Impreza
 2023-2024MY Forester

NUMBER: WRP-23
DATE: 12/19/23
NHTSA ID: 23V-754

SUBJECT: Safety Recall – Driveshaft Failure

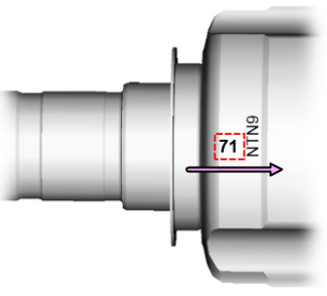
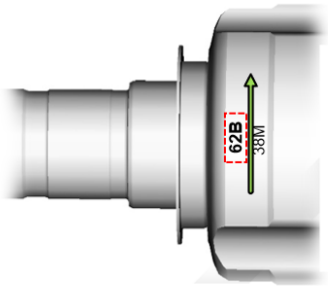
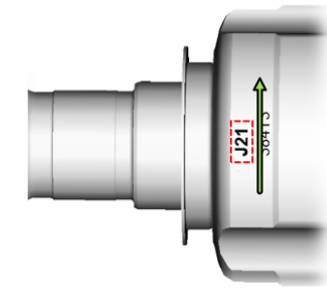
Engraving Type 1	Engraving Type 2	Engraving Type 3
2-digit number is engraved in the axis direction.	3 digit-character starting with a number is engraved in the circumferential direction.	3 digit-character starting with a letter is engraved in the circumferential direction.

Results		
Engraving style 1	Refer to the table below for further details.	
Engraving style 2 or 3	The drive shaft is a good part. Record and include the lot number to the repair order.
